# Home Evaluation Services

## Home Inspection Report

Sample Report 100+ Year Old Home

Inspected on Tue, Aug 4 2020 at 12:00 PM

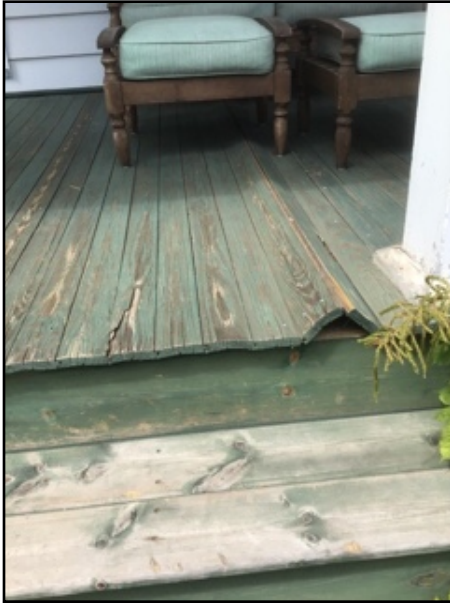
Figure 1-1

The front porch will need repair, lifting boards and loose peeling paint .

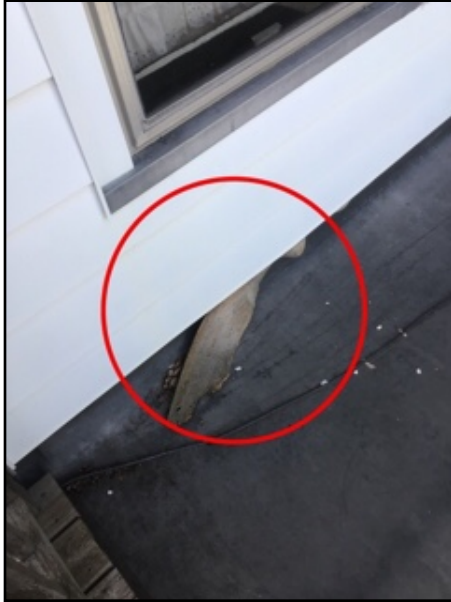
Figure 3-1

The loose hanging backing material at the siding by the upper back roof will need repair, ( sealing this area is also recommended .

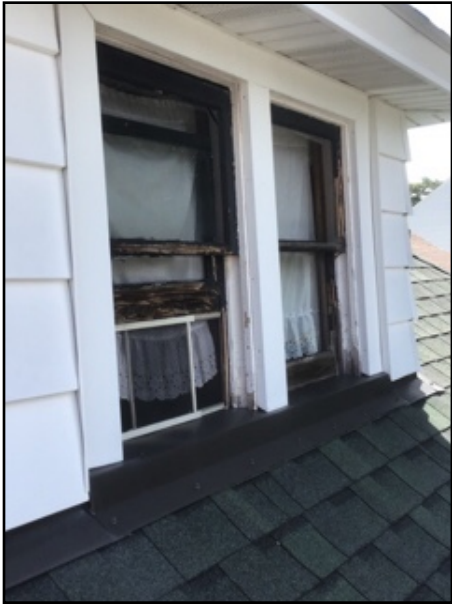
Figure 4-1

The back windows in the attic area are in poor condition, these will need repair or replacement .

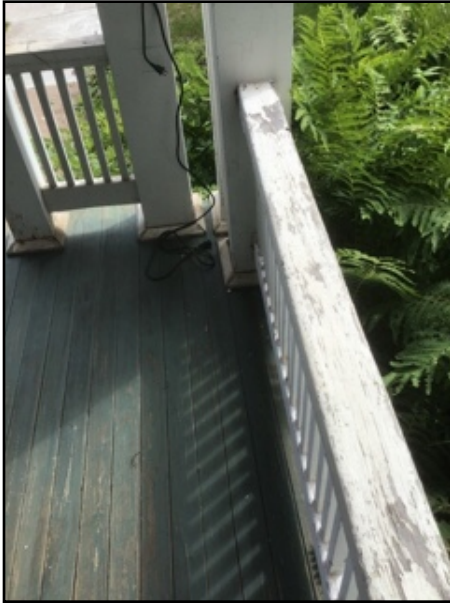
Figure 5-1

This photo shows a sample of the loose peeling paint .

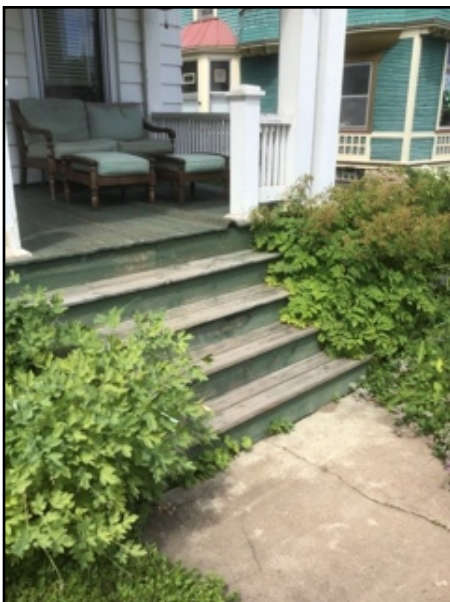
Figure 6-1

Safety hand railings are recommended at all stairways with 3 treads or more, also most insurance providers will require them. this safety item was missing at the front stairway,

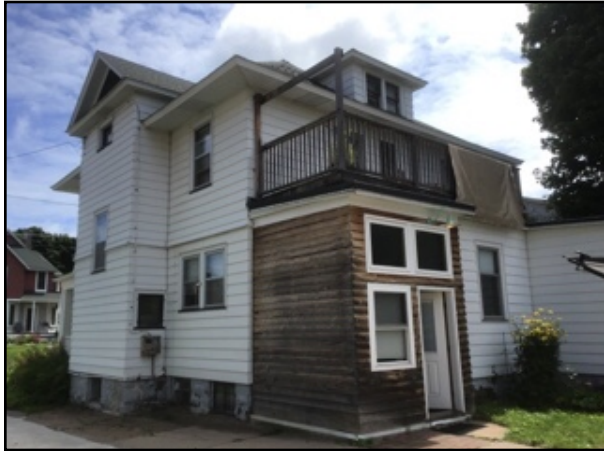
Figure 7-1

**Comment 7:**  
Overall the exterior of this property was in good general condition, no major damage or deterioration .

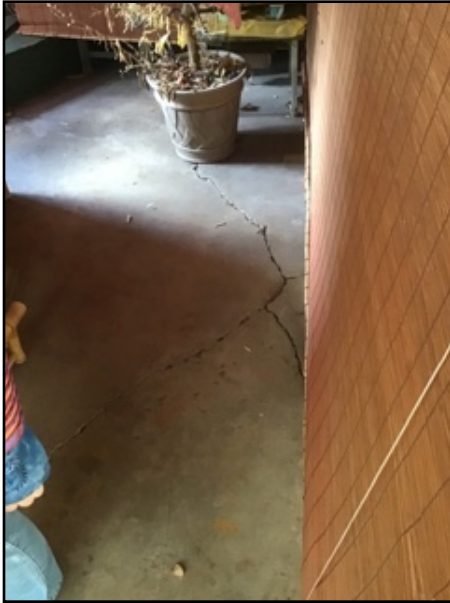
Figure 8-1

Some floor cracks are present, but the foundation was stable .

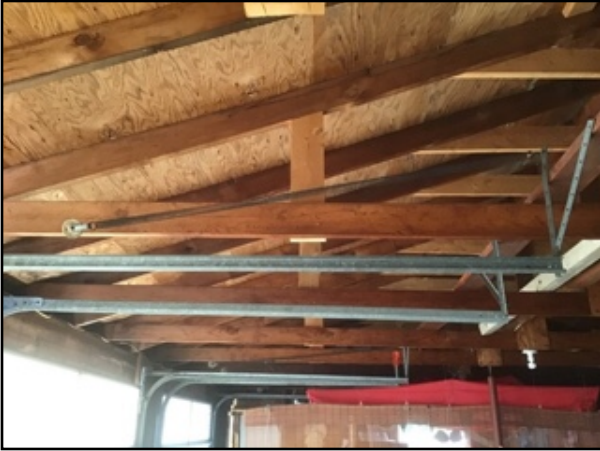
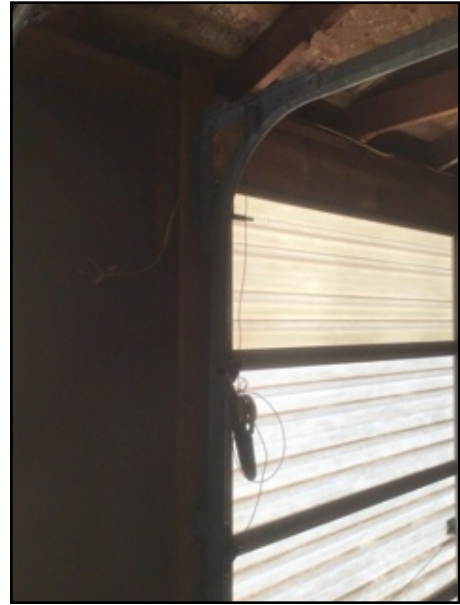
Garage door springs should have a safety cable running through them., also the spring system was broken on the center door,

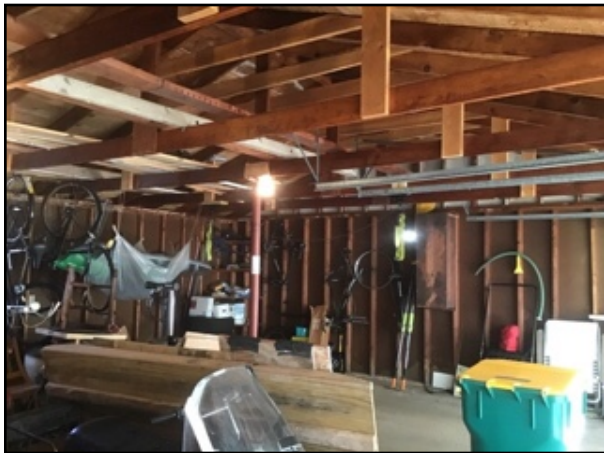
Figure 10-1

The garage structure was in good general condition, but the exterior of this building will need repair .

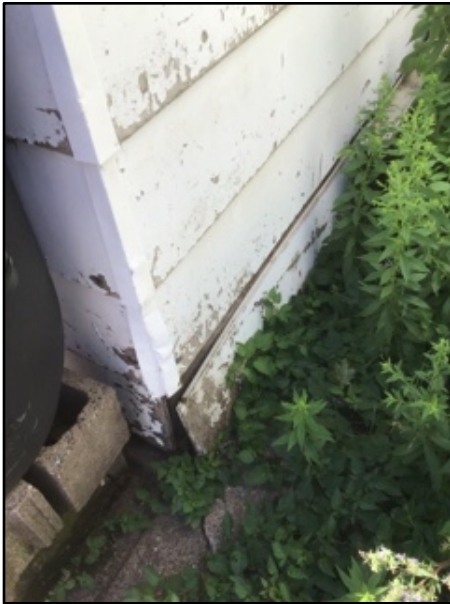
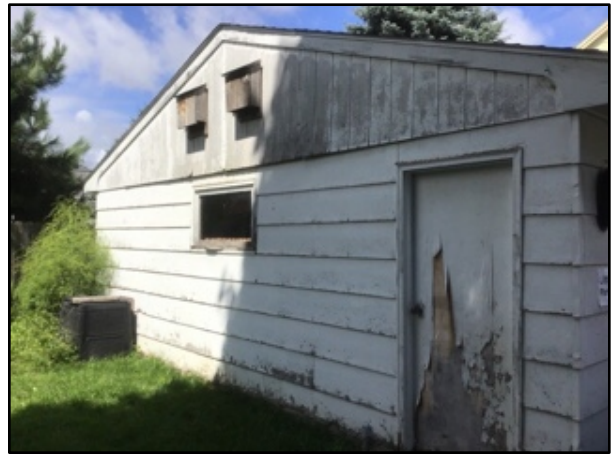
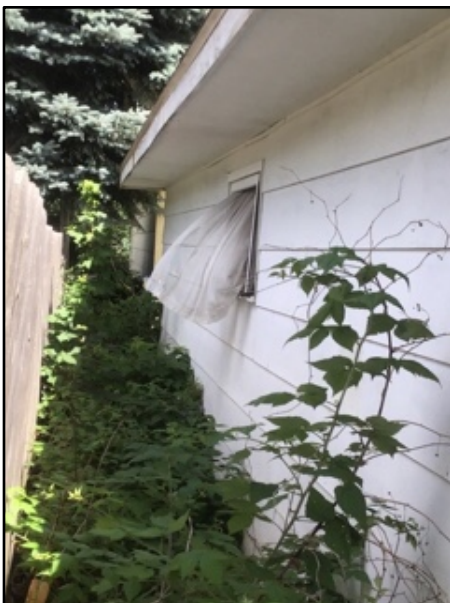
The siding on this building was in poor condition, also note the back window was broken .

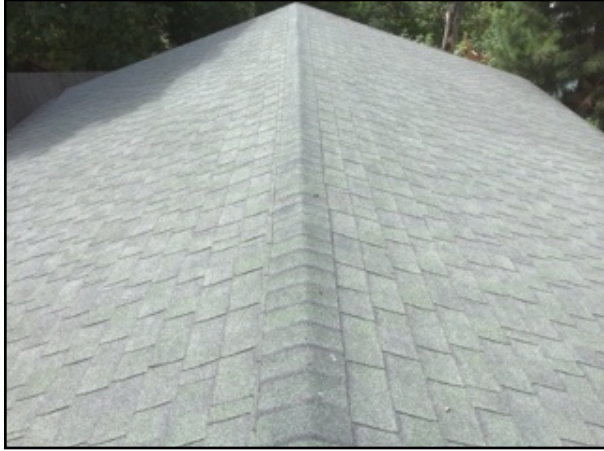
Figure 12-1

The garage roof was in good condition .

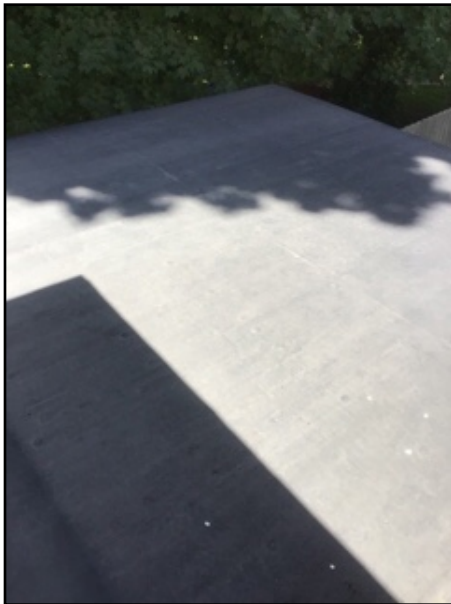
Figure 13-1

The rubber roof area was in good general condition .

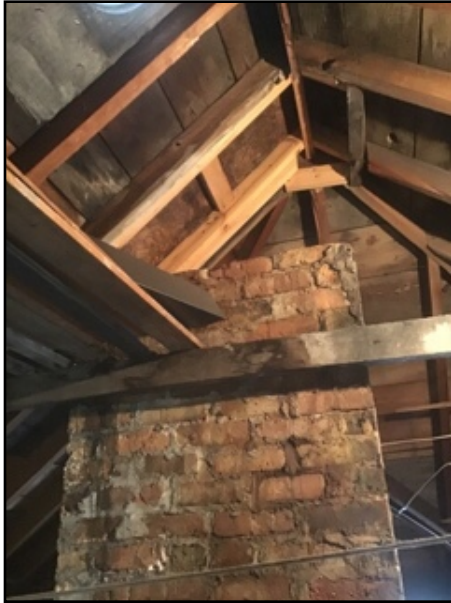
Figure 14-1

Note ; the chimney top has been removed and is capped, .

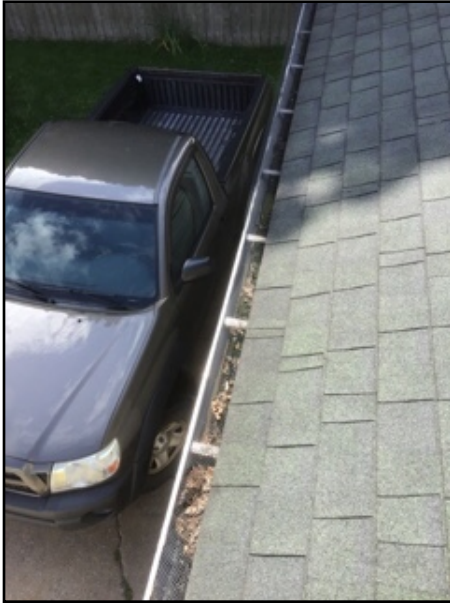
Figure 15-1

Only on the garage, these do need cleaning .

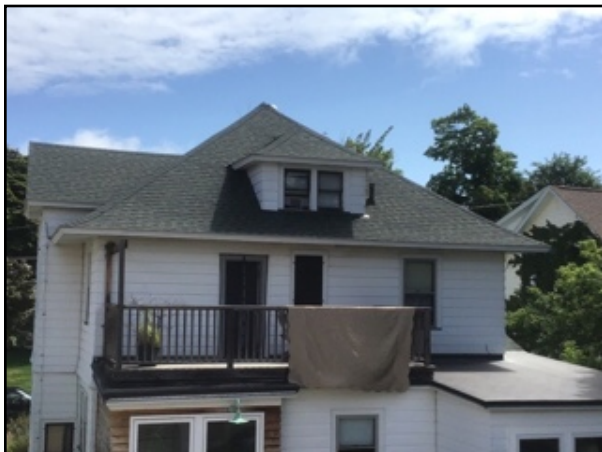
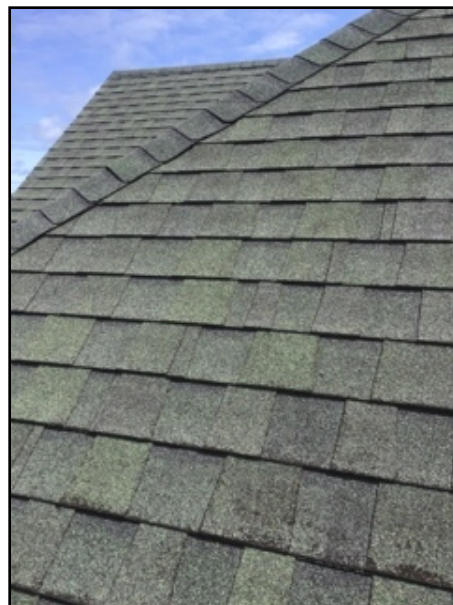
The house roof areas are in good general condition, no visible damage or deterioration to both the shingles or rubber roof area,.

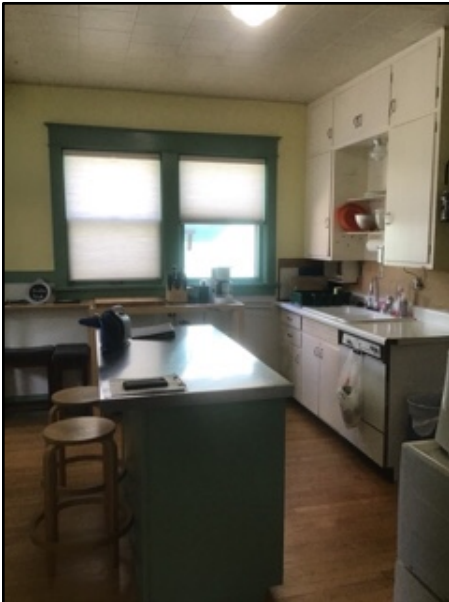
Figure 18-1

The kitchen area was found to be in good general working condition , the ceiling area where upper cabinets were removed will need to be finished .

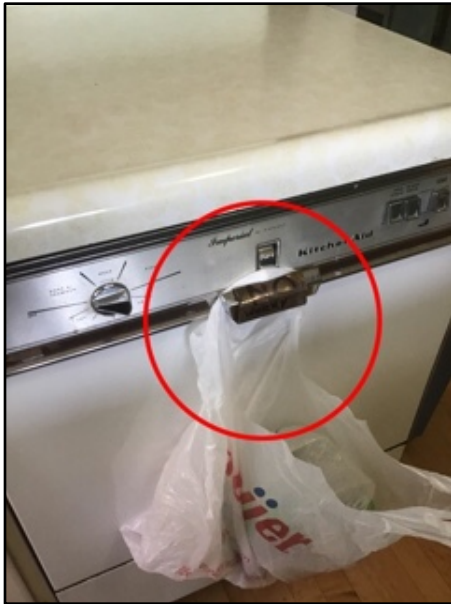
Figure 19-1

This unit was not working at time of inspection .

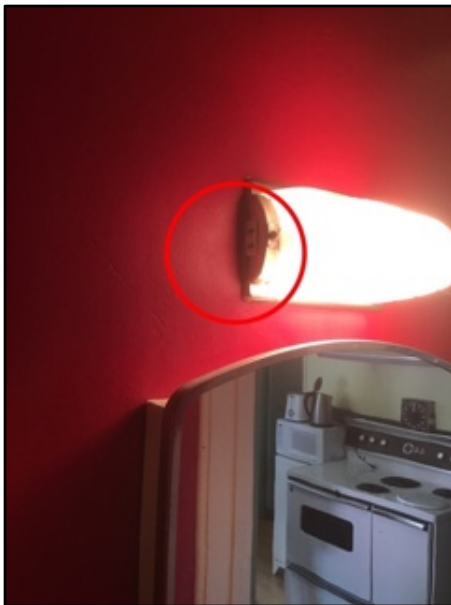
Figure 21-1

Comment 21:  
A new GFCI outlet should be installed within 6' of a water source.

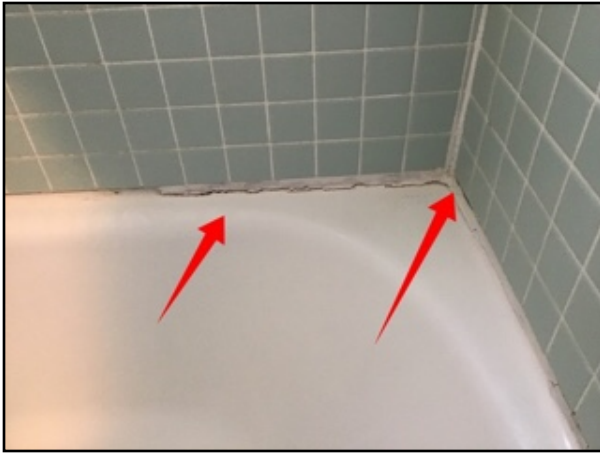
Figure 23-1

The tub shower was in good condition, but needs new sealing around the base.

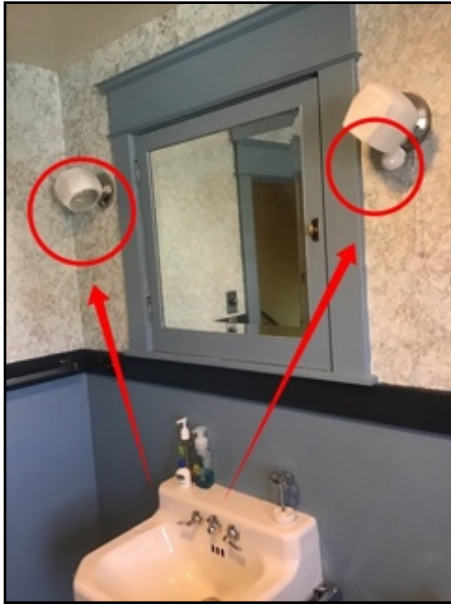
Figure 24-1

I recommend a GFCI type outlet be installed at any outlet within 6' of a water source. Such as in kitchens, bathrooms and laundry sink areas, this was not code until the mid 80's ( bathrooms) and 90's ( kitchen)

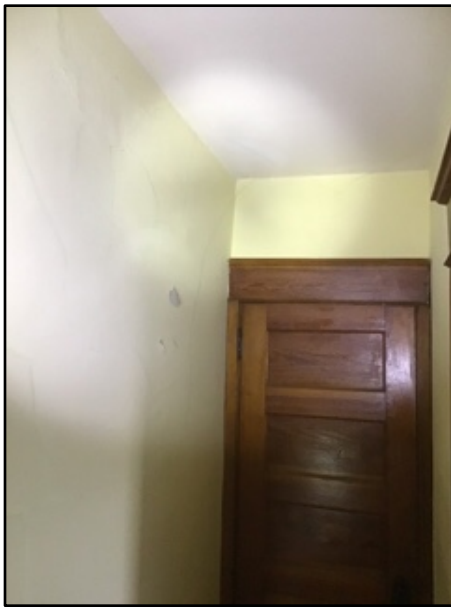
Figure 26-1

This photo shows the upper hallway by the chimney with the most peeling plaster.

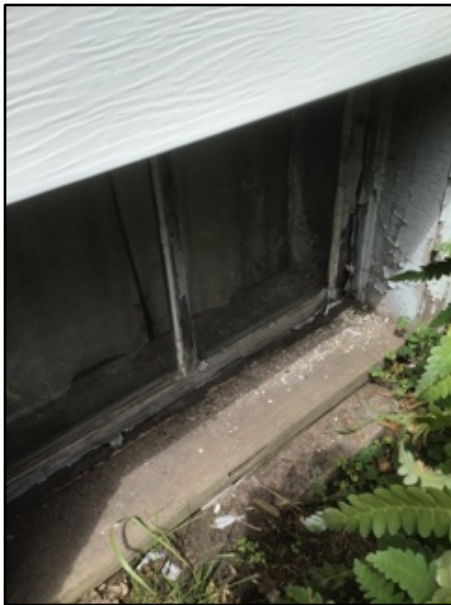
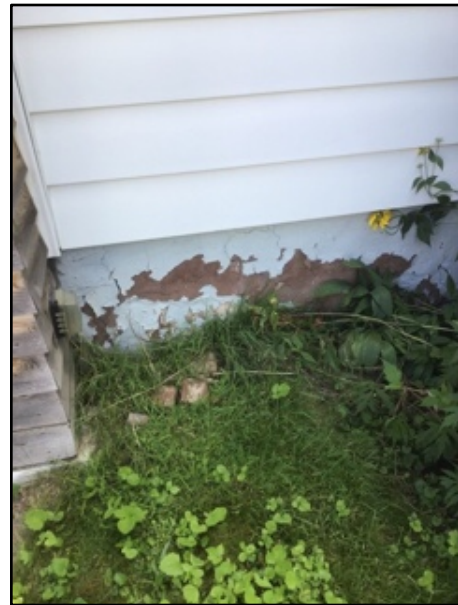
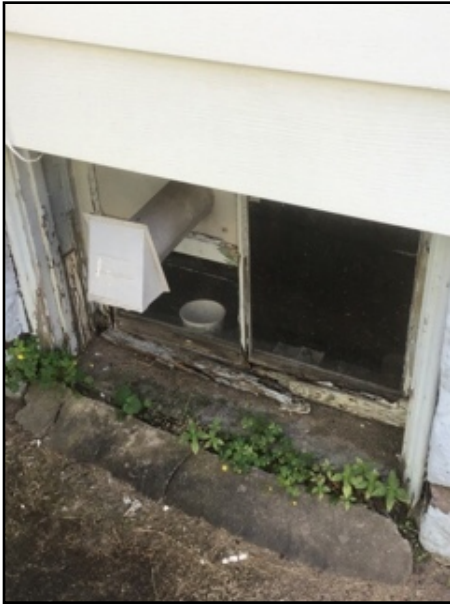
The basement wood window units are in poor condition, the exterior foundation paint was peeling, these items should be taken care of .

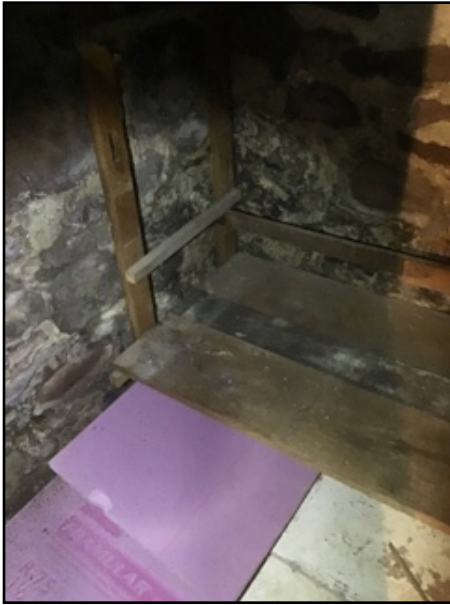
Figure 29-1

Some dampness was found in the front corner area, this will need to be monitored, I also recommend a de- humidity unit be operating in the basement during the summer .

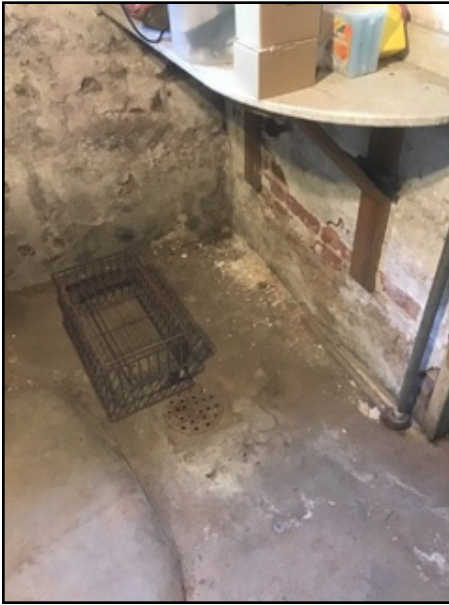
Figure 30-1

The basement/foundation was in good general condition, normal minor deterioration at the interior walls , some evidence of minor seeping, but no signs of water intrusion issues, .

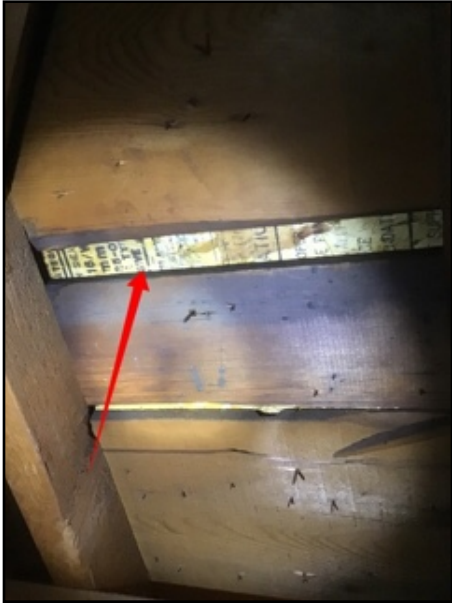
Figure 31-1

Modern new roofing sub sheeting was in place .

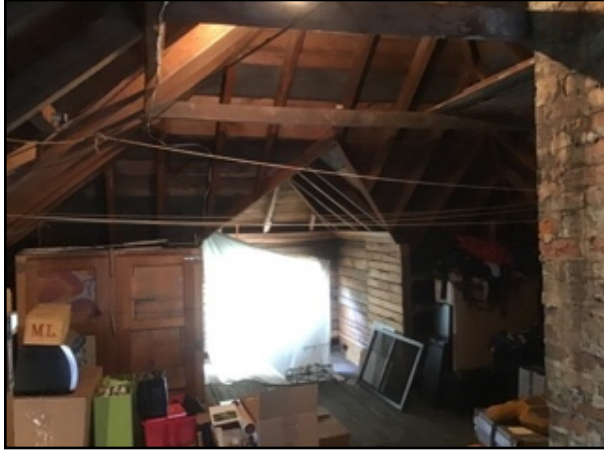
Figure 32-1

The walk up attic area was in good condition .

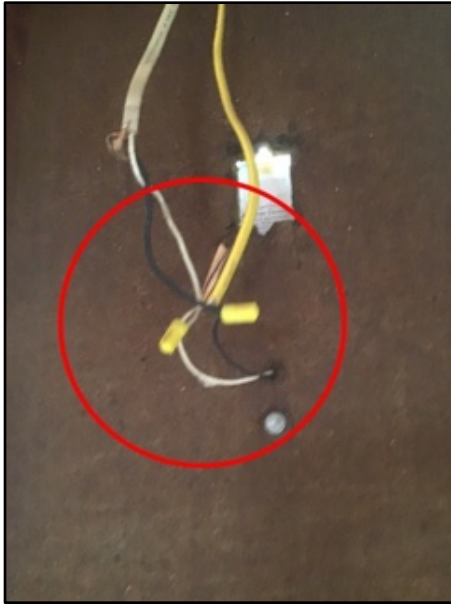
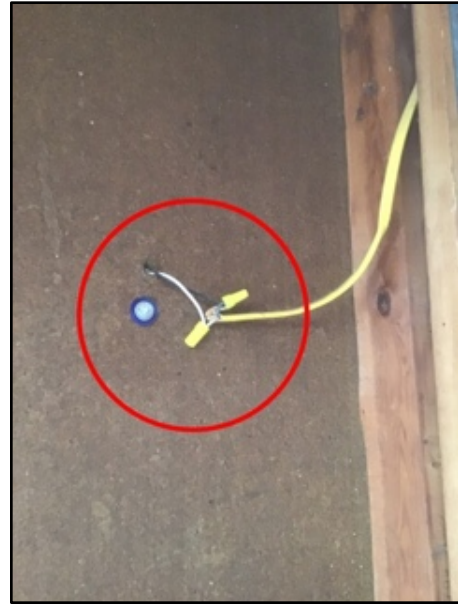
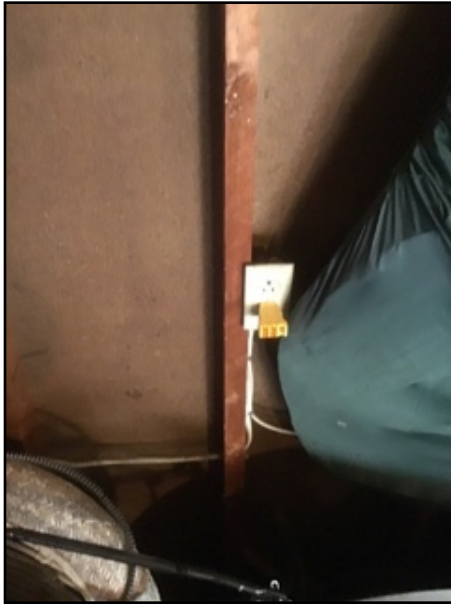
The wiring in the garage will also need to be repaired ( with proper junction box connections), Also, the back wall outlets were not energized .

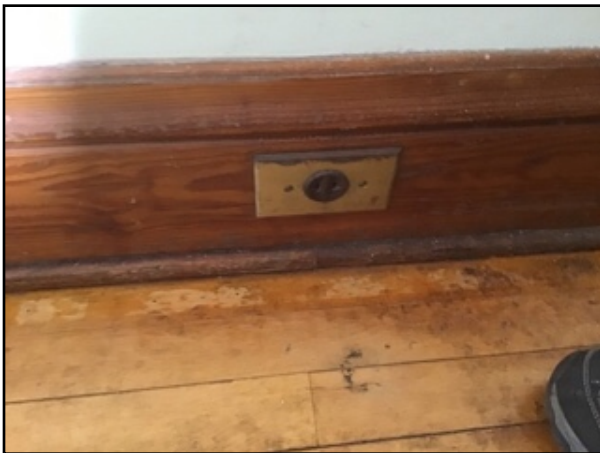
Figure 34-1

The home has a mix of two prong non-grounded outlets and three prong non-grounded outlets along with some grounded 3 prong outlets. Non grounded outlets will not protect three pronged appliances. Adding GFCI outlets to non grounded outlets will protect three pronged appliances. An electrician could review and make recommendations.

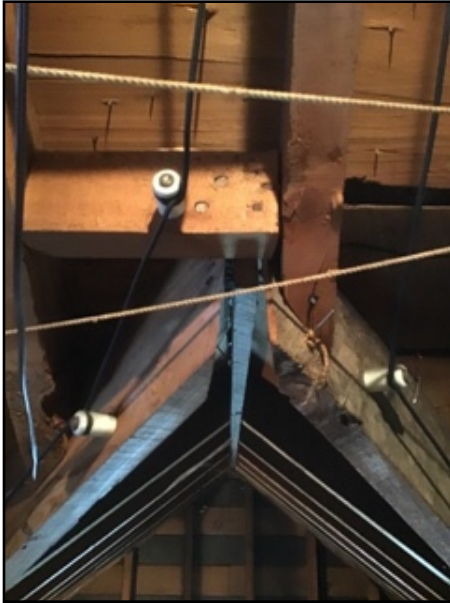
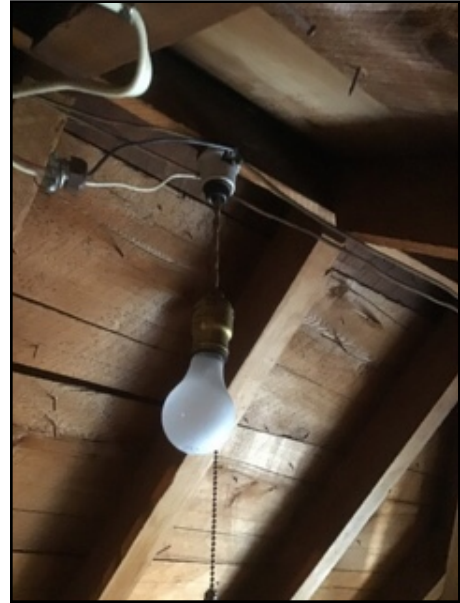
Knob and tube wiring is in attic and is charged.

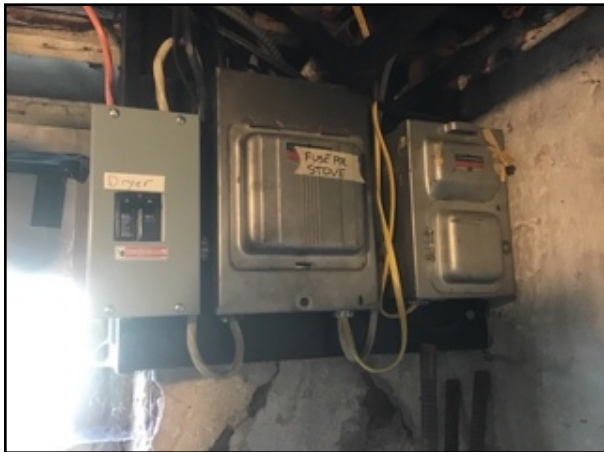
Figure 40-1

The electric system will need to be updated as you know,.

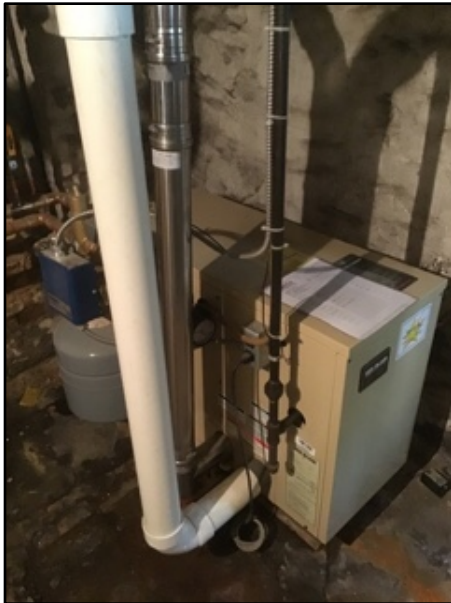
Figure 41-1

The boiler heating system was operating as designed at inspection .

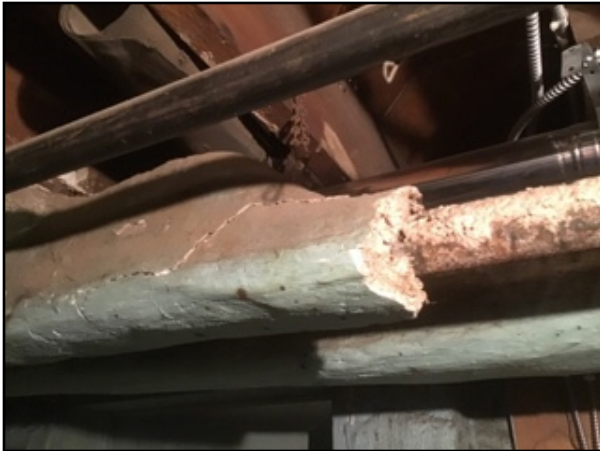
Figure 44-1

Some of the homes boiler piping has asbestos type insulation wrapped around it. Asbestos insulation is harmful if handled or removed without the proper safety equipment. If removal is desired, it should be handled by a licensed abatement contractor.

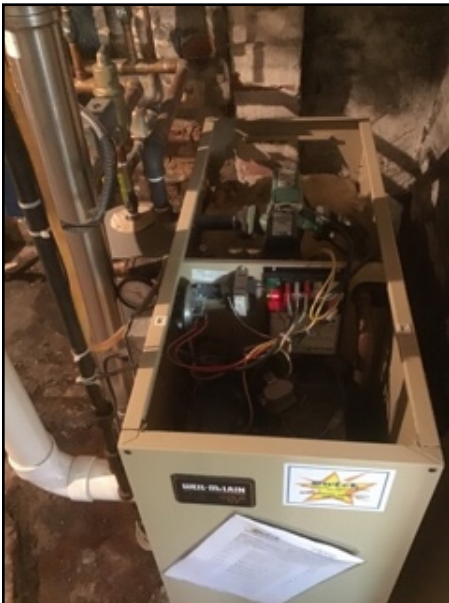
Figure 45-1

The boiler heating system was operating as designed at inspection .

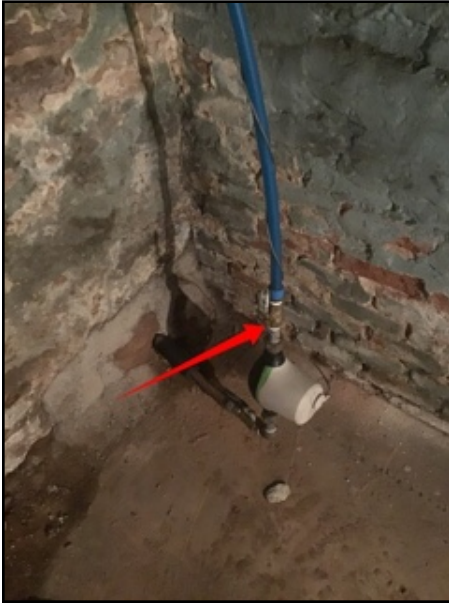
Figure 46-1

Comment 46:  
Copper water line and main shut off valve .

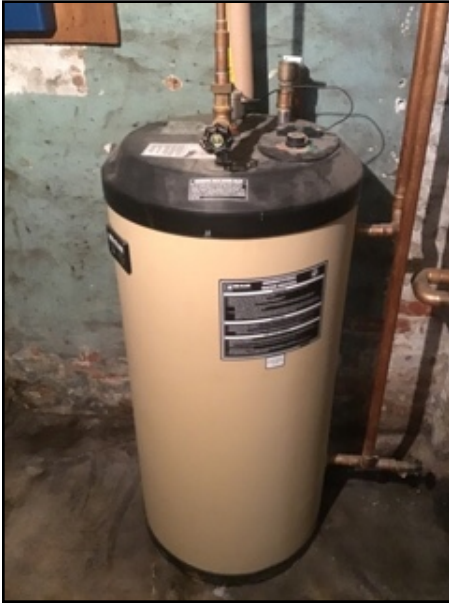
Figure 47-1

**Comment 47:**  
The boiler operating water heater was operating as designed at inspection .

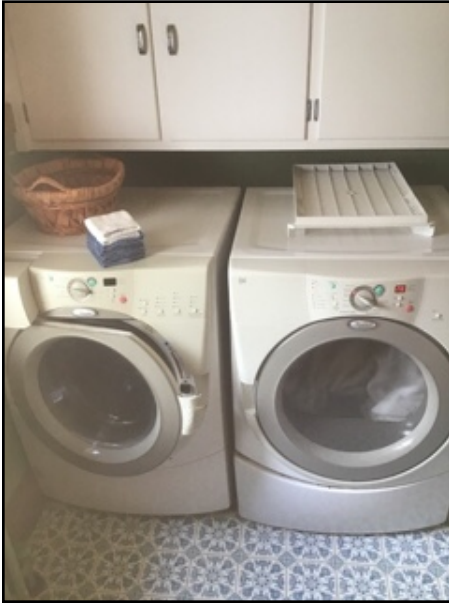
Figure 48-1

Comment 48:  
Main floor laundry area .
