Home Evaluation Services

Home Inspection Report

Inspected on Wed, Jan 13 2021 at 9:10 PM

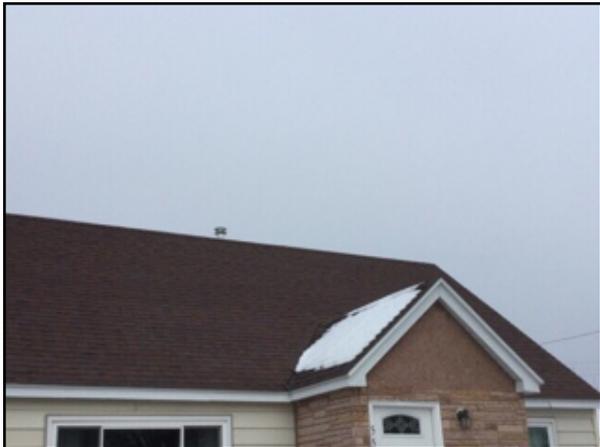
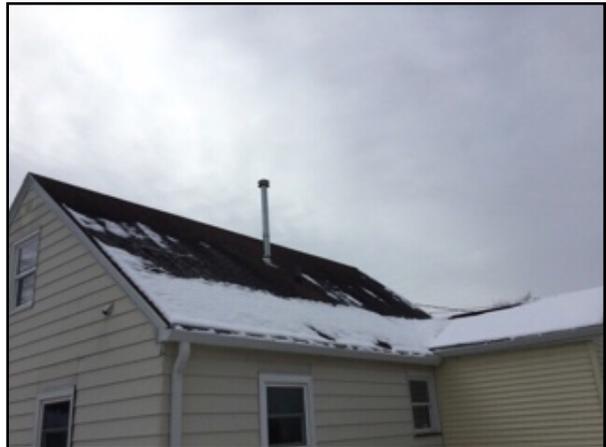
The roof covering was found to be in good general condition, with no major damage or deterioration. Snow prevented a full inspection of the roof.

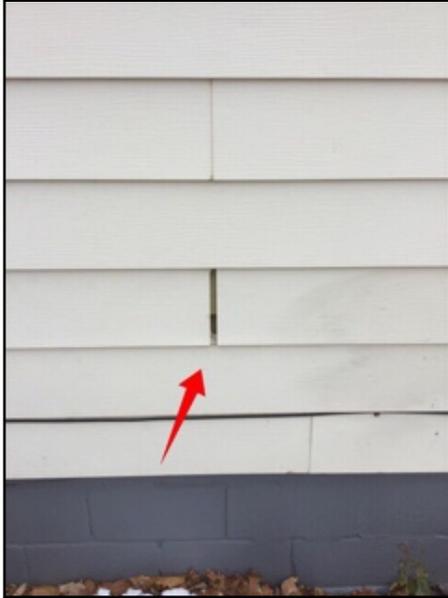
Figure 3-1

The siding was in good condition but there were a few blemishes around the home.

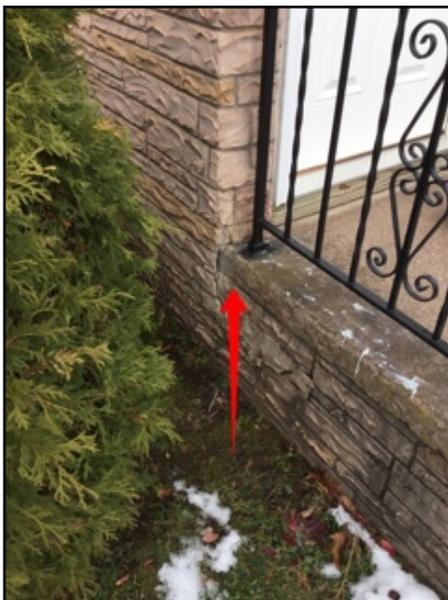
Figure 4-1

The mortar in the brick work at this location could use some attention as there is a little deterioration occurring.

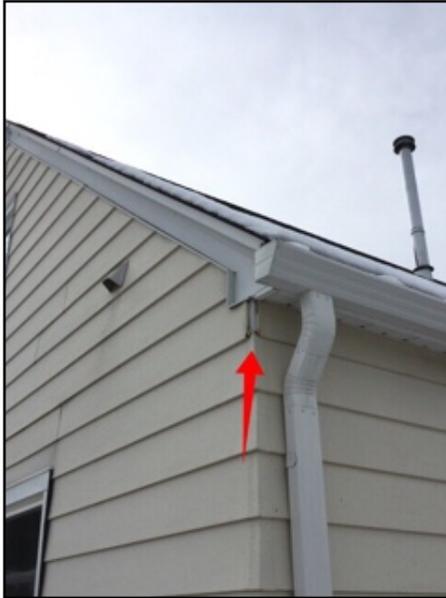
Figure 5-1

There is a corner piece of aluminum trim missing on the back of the home.

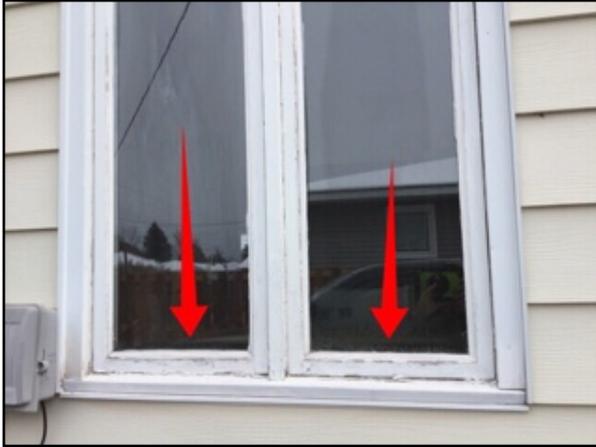
Figure 6-1

This wood widow needs to be prepped and painted o protect the wood from water damage.

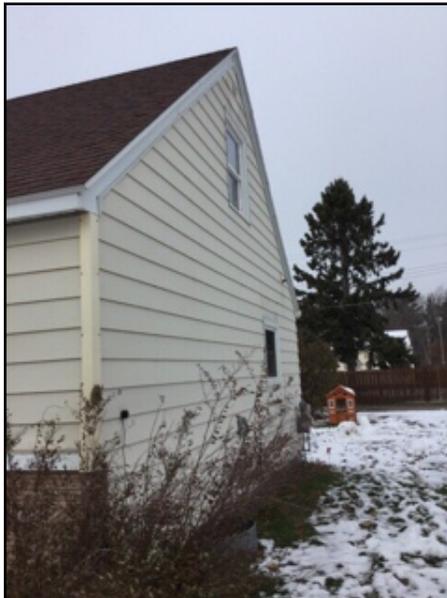
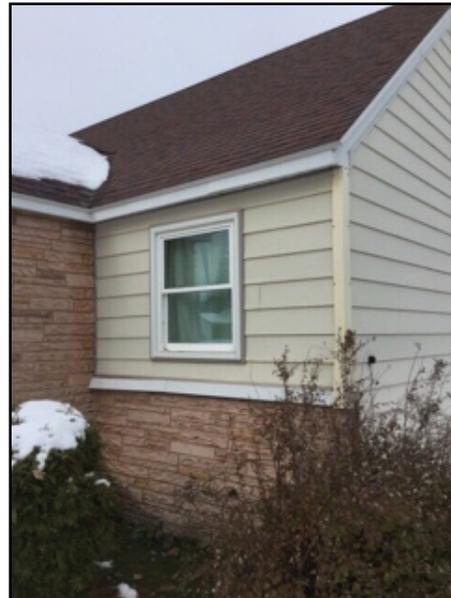
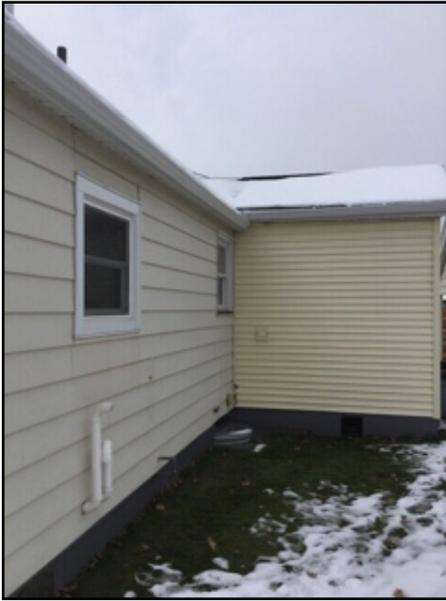
Comment 7:
The homes siding was in good condition overall at the time of inspection.

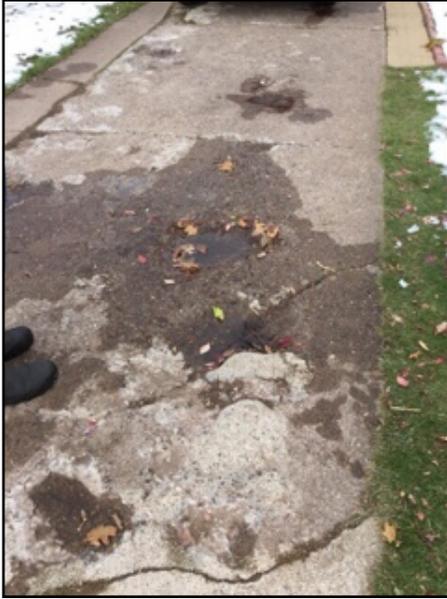
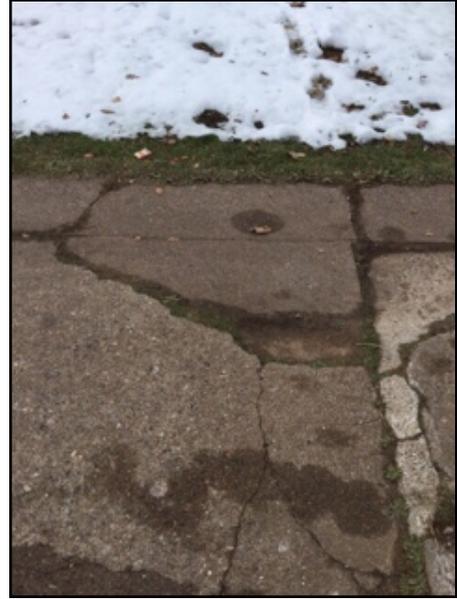
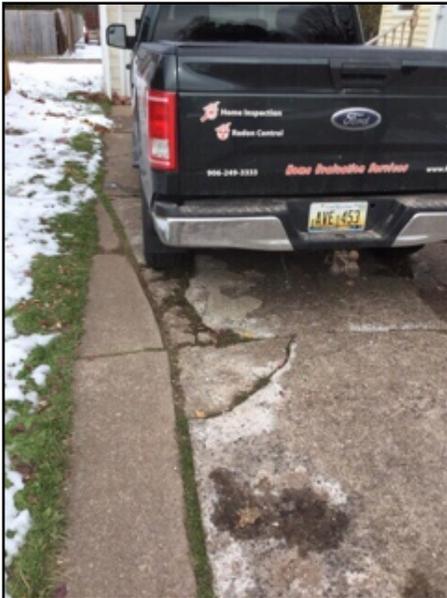
The drive has settlement cracks. These should be sealed to prevent moisture intrusion which can cause further deterioration. It maybe too late to save this driveway and replacement may be a possible option.

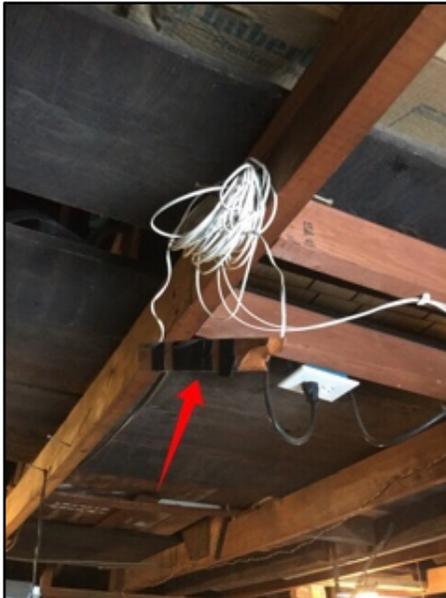
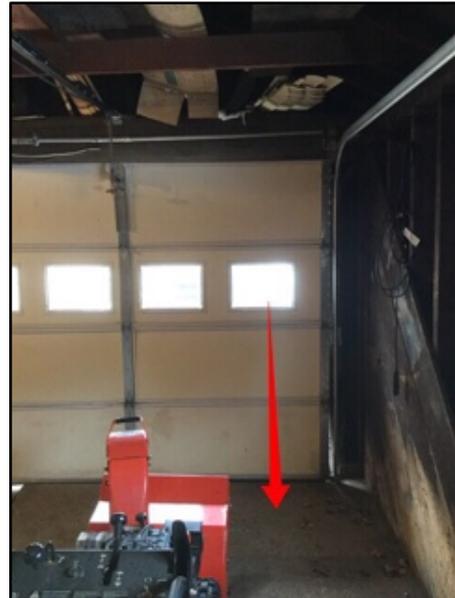
Force sensitivity setting needs adjustment on the garage door. The light beam worked as designed but if the door meets resistance it should go back up. A garage door contractor could adjust this and lube and tune the door at the same time. Also, the safety eyes are installed incorrectly. The proper location is down on the door tracks, 4-6" off of the floor.

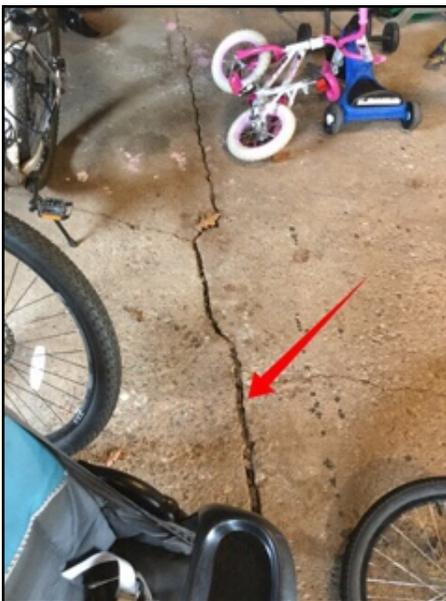
Figure 11-1

Comment 11:
There is a settlement crack in the floor of the garage.

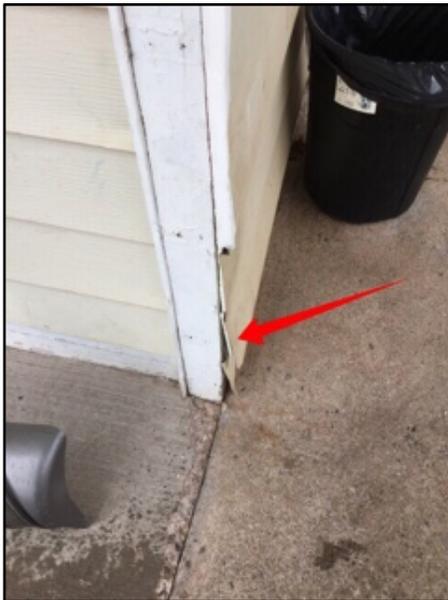
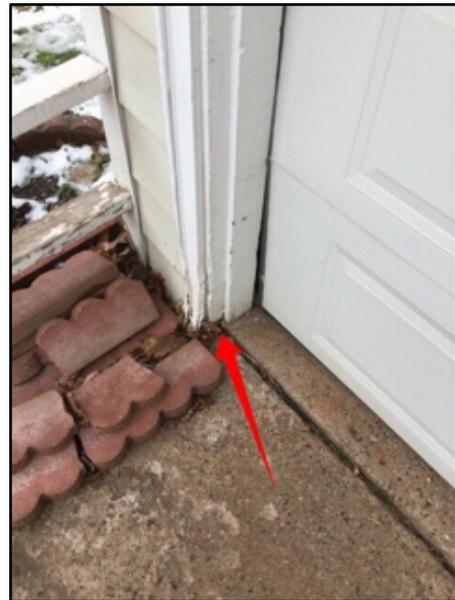
Some of the garages trim areas are damaged and in need of repair.

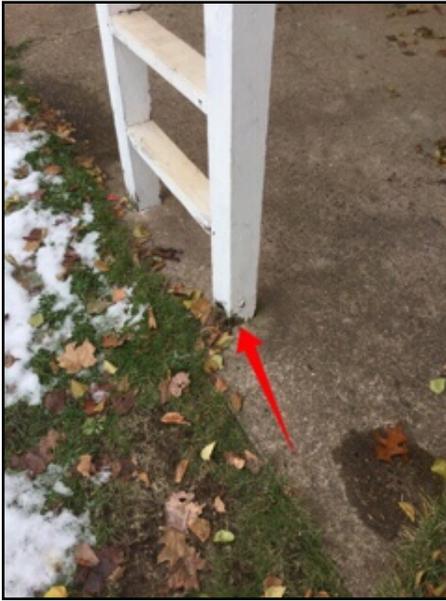
Figure 13-1

This post for the garage overhang has water damage. It is not all the way through yet and with some work as in sealing and protection of the this area the post could last for a long time.

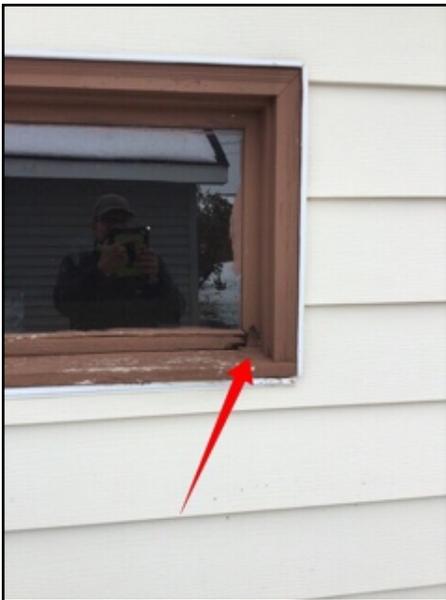
Figure 14-1

There is water damage to the wood window in the garage.

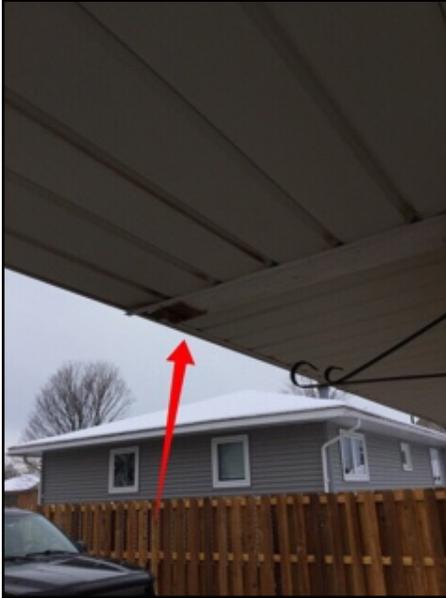
Figure 15-1

A post has been removed from the garage overhang. I did to see any signs of issues deriving from this but I would keep an eye on this area.

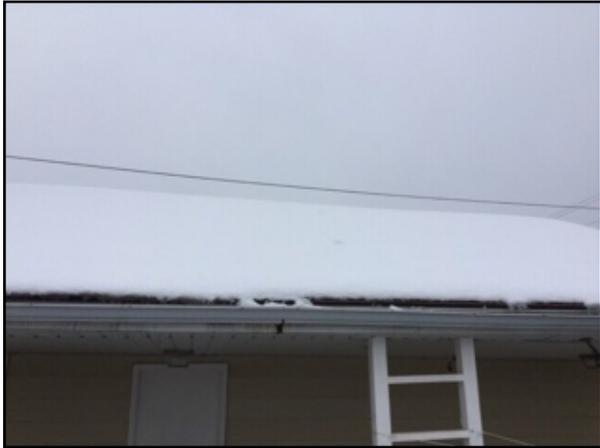
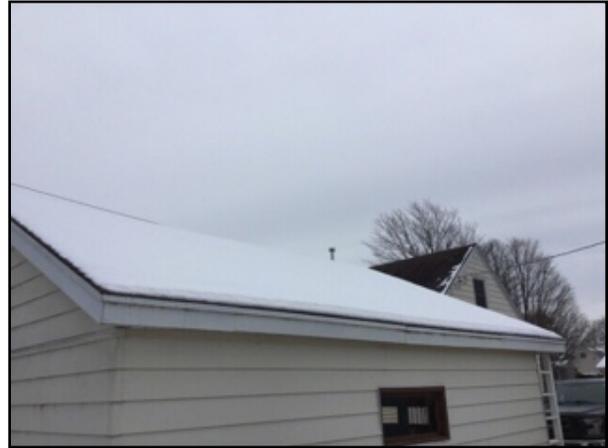
The garage roof was in good condition and appears to have been replaced when the homes roof was done.

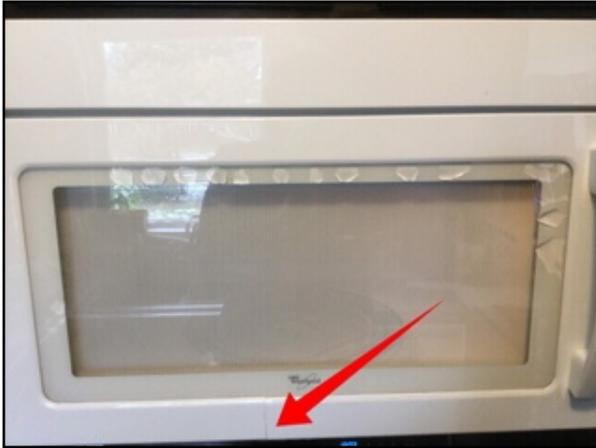
Figure 18-1

There were some blemishes on the micro wave door but the microwave did work as designed at the time of inspection.

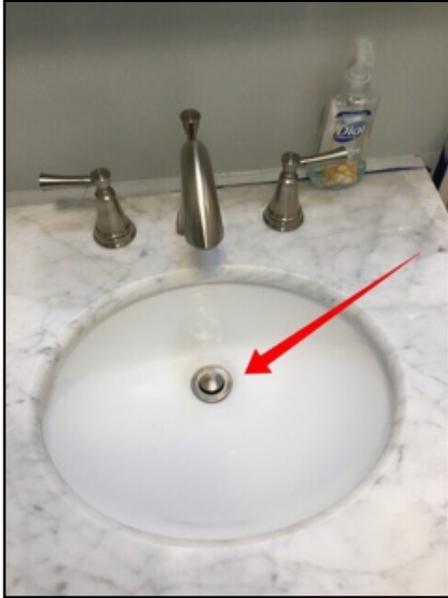
Figure 19-1

The bathroom sinks drain stopper does not operate properly.

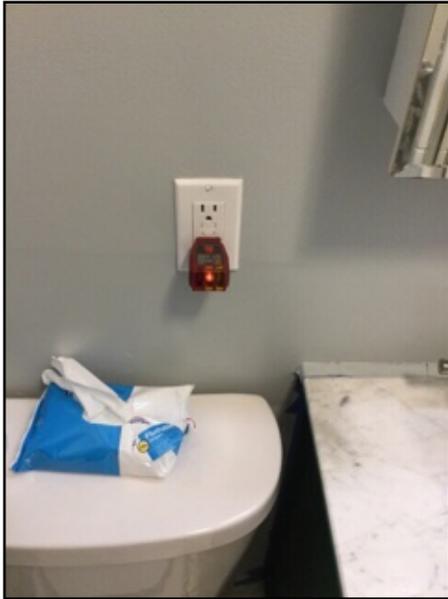
Figure 20-1

The bathroom outlet is non grounded. These types of outlets will work but will not protect three pronged appliances like computers or televisions. The good is the outlet is protect by a GFCI which is required within 6' of a water source.

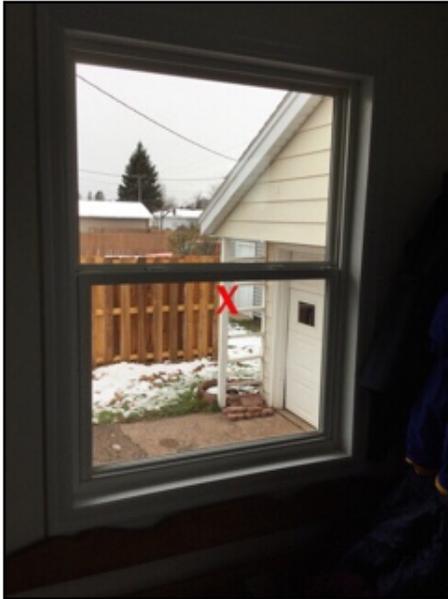
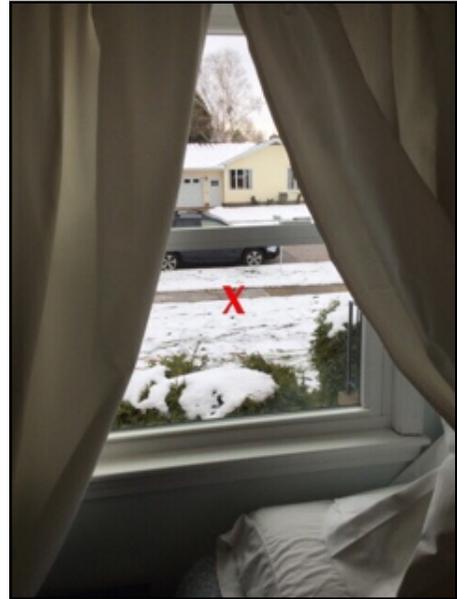
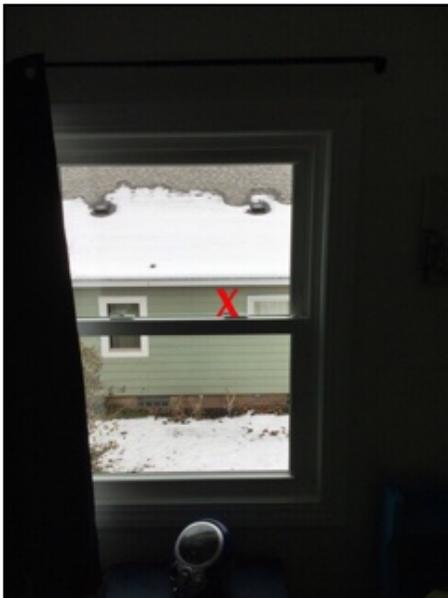
Some of the windows in the home were missing screens. A request could be made for them to be installed by the seller for the final walk through of the home.

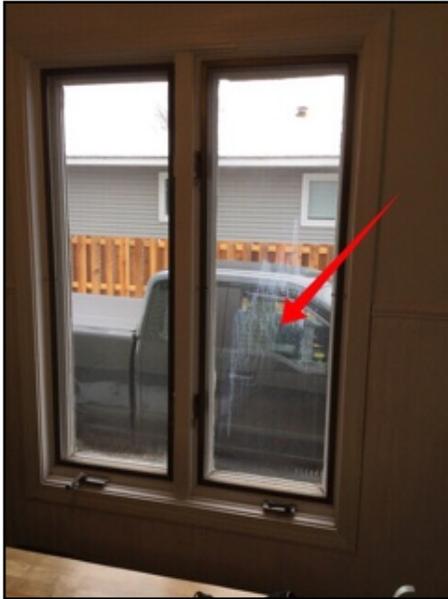
Figure 26-1

The window has lost its seal causing a fog like appearance between the panes of glass. Replacement of the window or pane needs to be done to repair this situation.

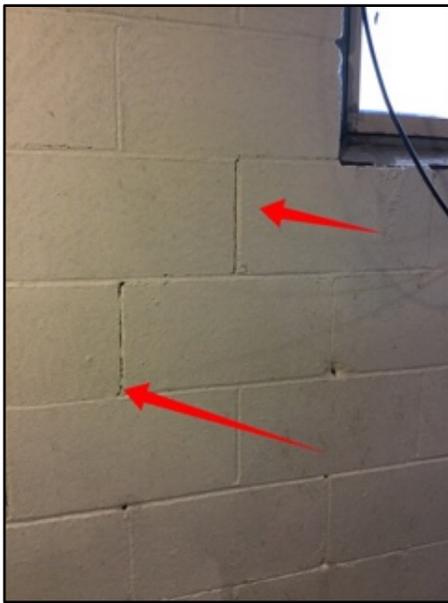
Figure 27-1

There are some cracks in the basement foundation. This is not an uncommon occurrence and i would monitor for growth. These cracks could have happened a long time ago.

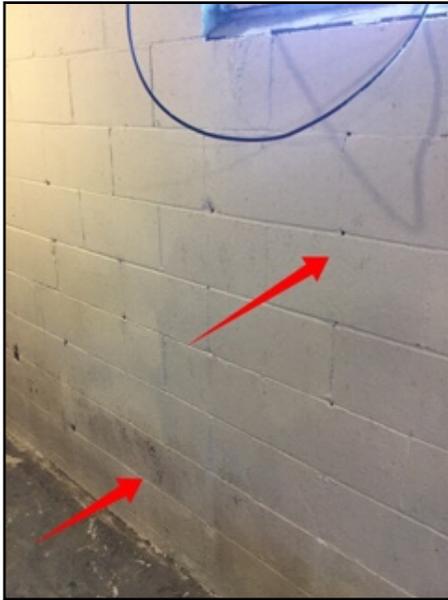
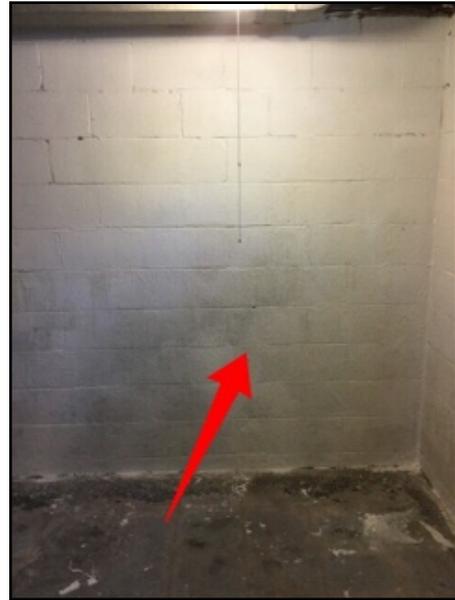
There are some staining in the walls that indicate some water intrusion although it was dry at the time of inspection. Gutters would help alleviate this problem. There are also some holes drilled in the mortar joints the driveway side wall. Im not sure what this was for it could have been a finished wall at one time.

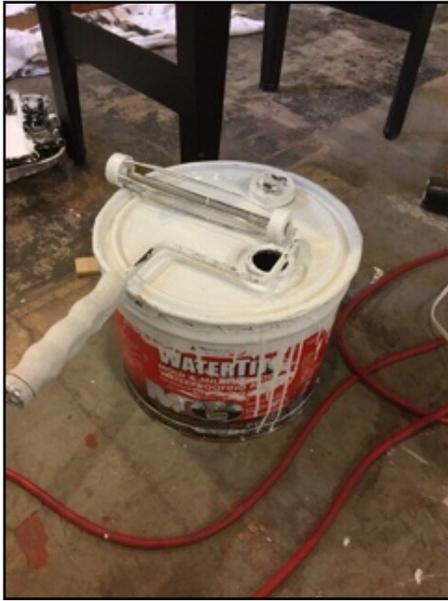
Figure 29-1

The basement walls have been painted with mold and water resistant paint. This was being done during my last inspection. Also, it appears a tile floor has been removed from the basement at some time. Water intrusion? The basement was dry at the time of inspection.

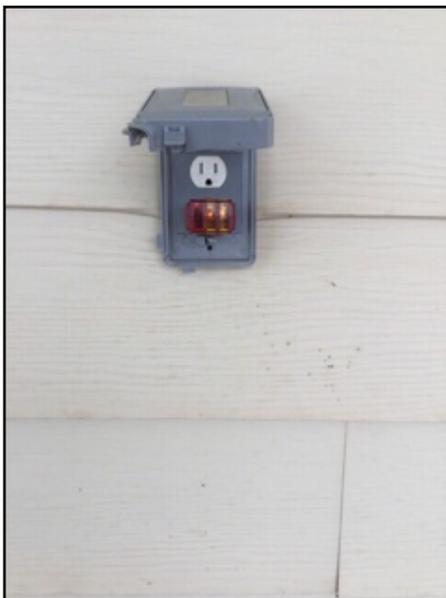
Figure 33-1

It is a good idea that outside outlets be of the GFCI type to protect people from shock. This is now standard code on newer homes. An electrician could review and make repairs.

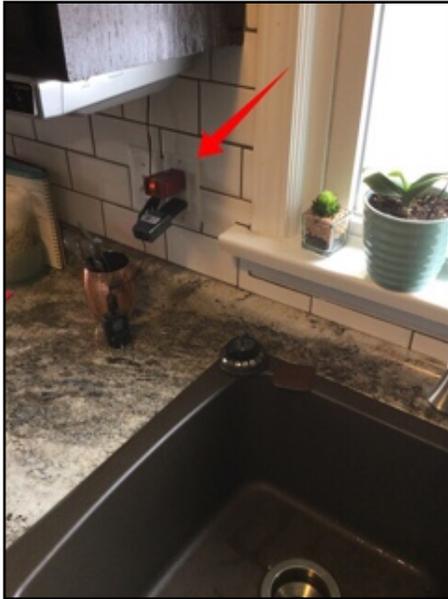
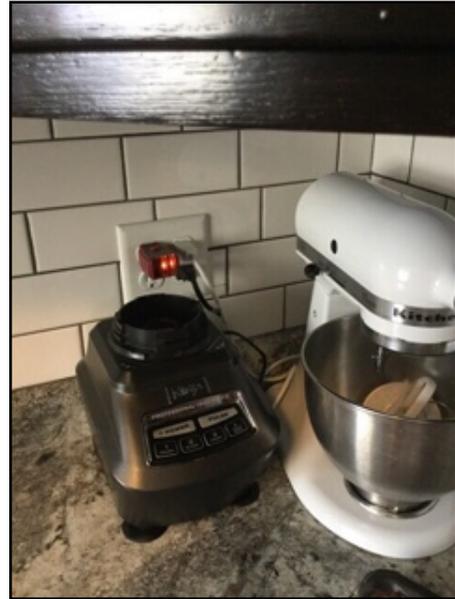
The home has a some non-grounded outlets. Non grounded outlets do not protect three pronged outlets. The red arrow shows a non grounded outlet by the kitchen sink.

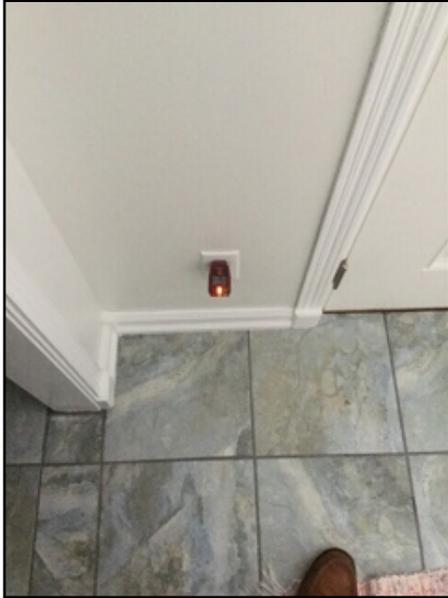
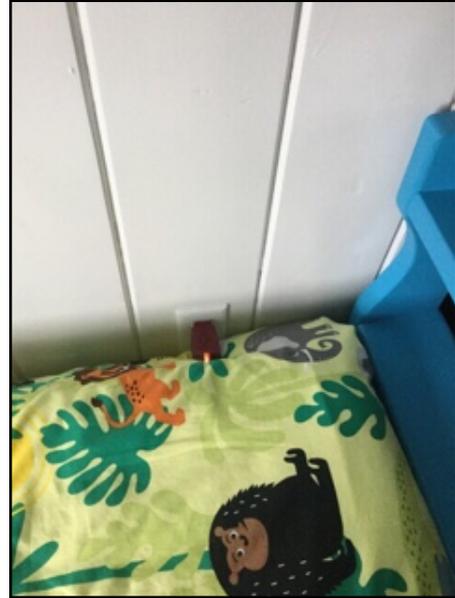
Comment 35:
More non grounded outlets.

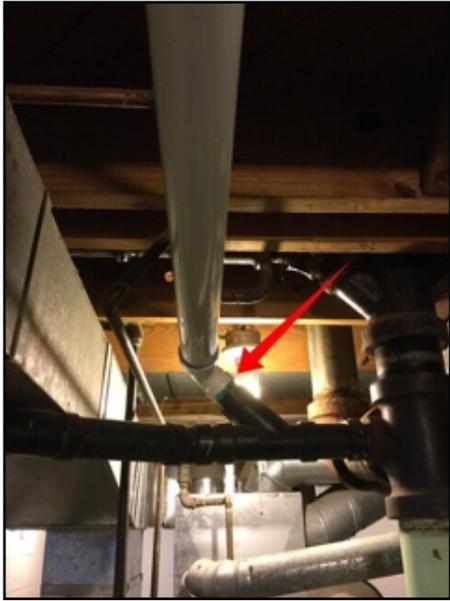
Figure 39-1

The home has both PVC and ABS waste pipe joined together. These two products are not mad to be joined together unless there is a fernco coupler used. I see this regularly and this joint was not leaking at the time of inspection.

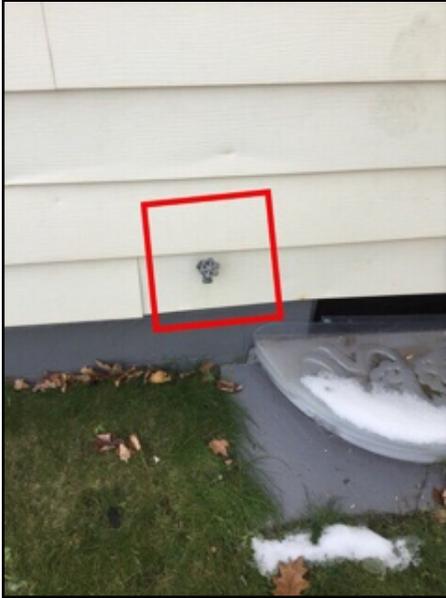
Figure 41-1

The outside faucets are not the anti frost type. They will need to be turned off inside the home and drained before winter each fall.

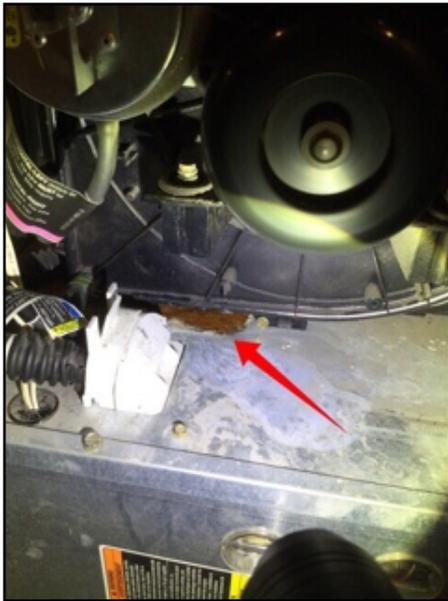
Figure 43-1

I always recommend an HVAC technician come and perform a clean and tune on all furnace units and boilers, This will allow for a complete inspection of heat exchanger and other internal components of the heater I am not able to inspect. Sometimes there are rebates from your gas company for this service which almost covers the cost of the inspection. This function should be performed regularly on your homes heating system. The unit was leaking inside the cabinet at the time of the inspection causing some rust to occur.

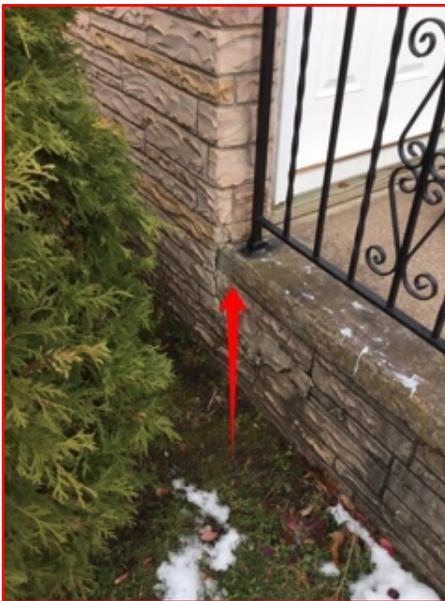
Figure 4-1

1) The mortar in the brick work at this location could use some attention as there is a little deterioration occurring.

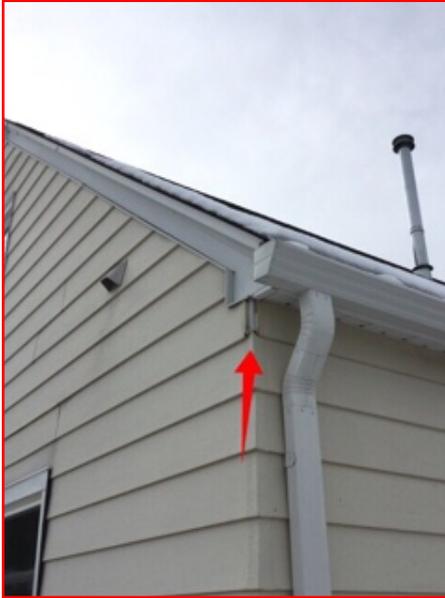
Figure 5-1

2) There is a corner piece of aluminum trim missing on the back of the home.

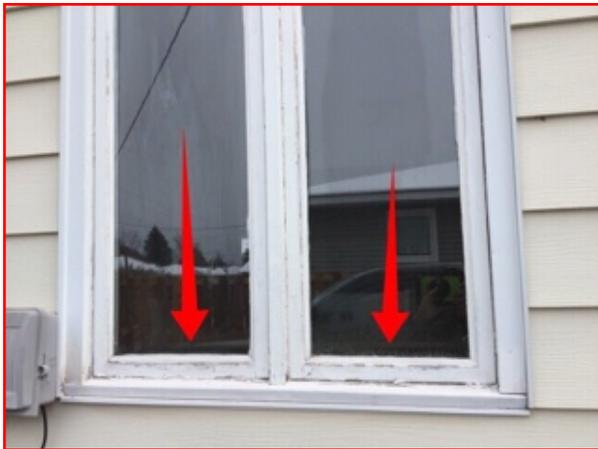
Figure 6-1

3) This wood widow needs to be prepped and painted o protect the wood from water damage.

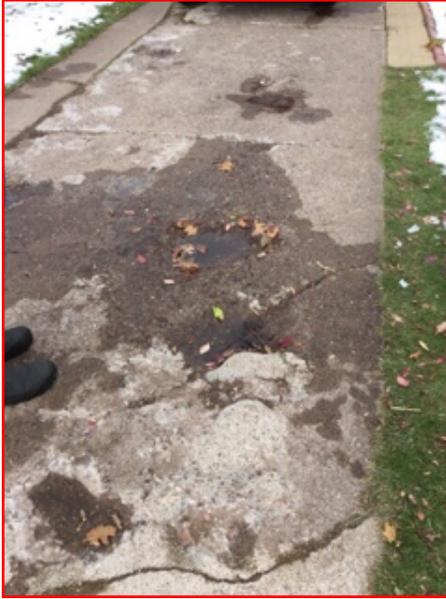
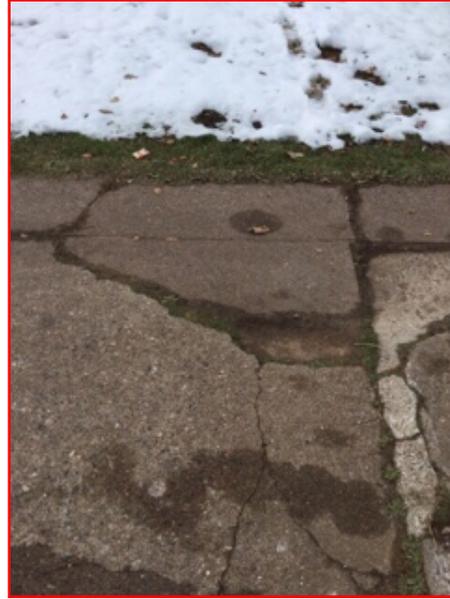
4) The drive has settlement cracks. These should be sealed to prevent moisture intrusion which can cause further deterioration. It maybe too late to save this driveway and replacement may be a possible option.

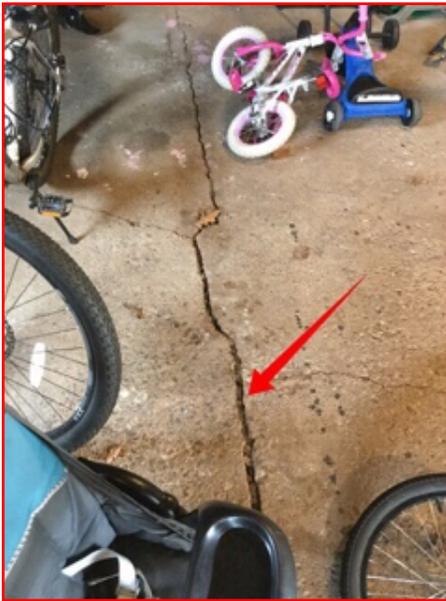
Figure 11-1

5) There is a settlement crack in the floor of the garage.

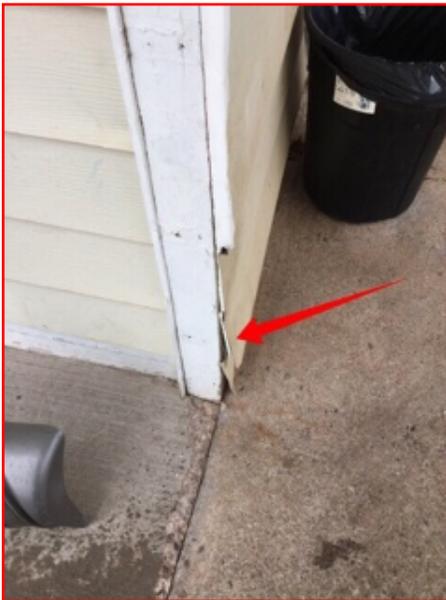
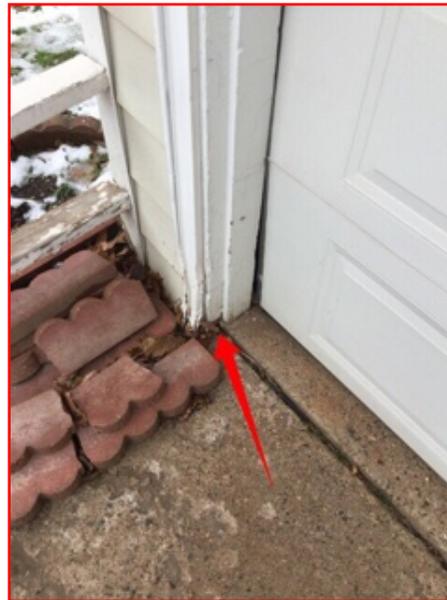
6) Some of the garages trim areas are damaged and in need of repair.

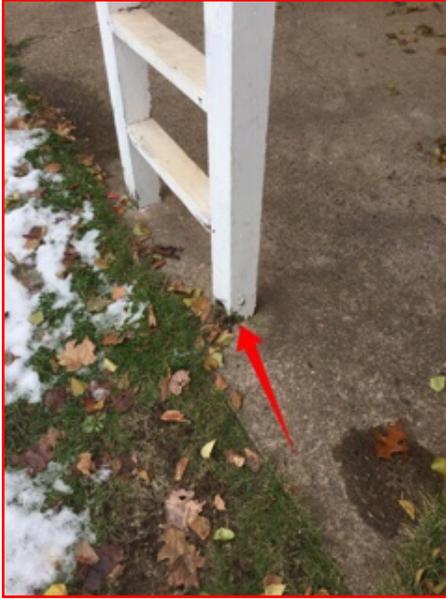
Figure 13-1

7) This post for the garage overhang has water damage. It is not all the way through yet and with some work as in sealing and protection of the this area the post could last for a long time.

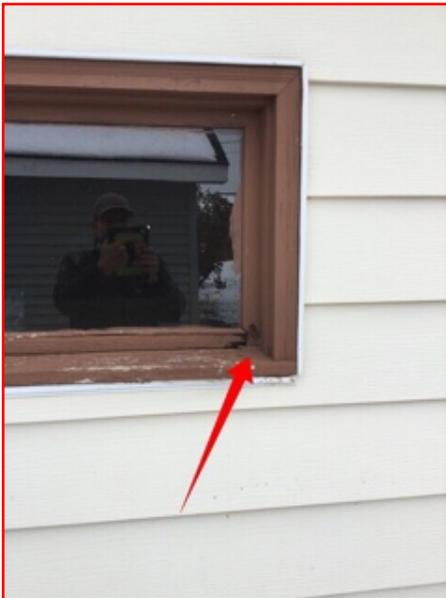
Figure 14-1

8) There is water damage to the wood window in the garage.

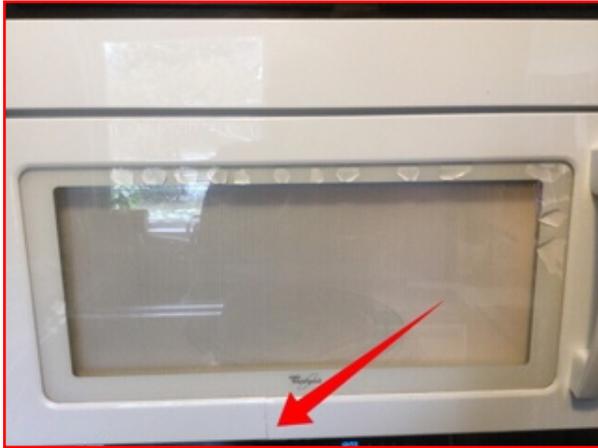
Figure 18-1

9) There were some blemishes on the micro wave door but the microwave did work as designed at the time of inspection.

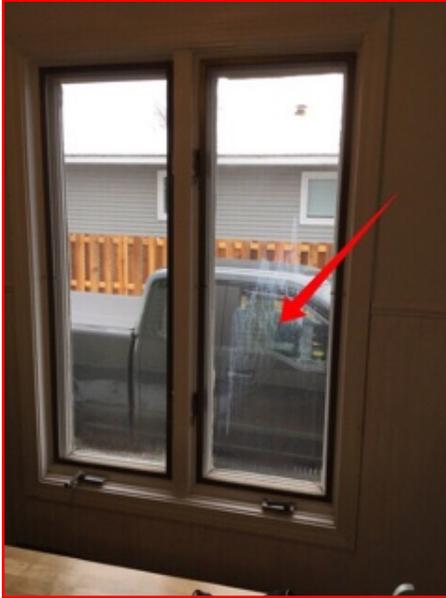
Figure 26-1

11) The window has lost its seal causing a fog like appearance between the panes of glass. Replacement of the window or pane needs to be done to repair this situation.

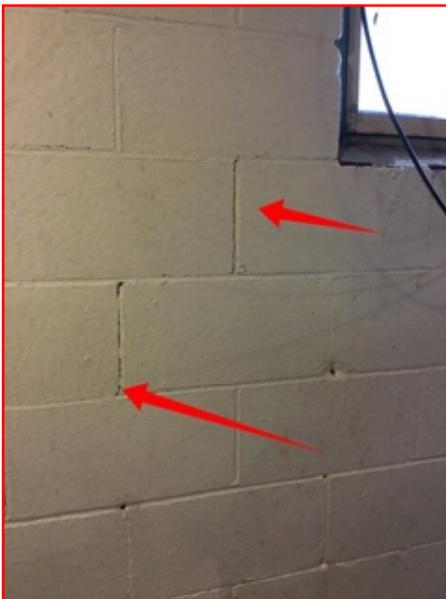
Figure 27-1

12) There are some cracks in the basement foundation. This is not an uncommon occurrence and I would monitor for growth. These cracks could have happened a long time ago.

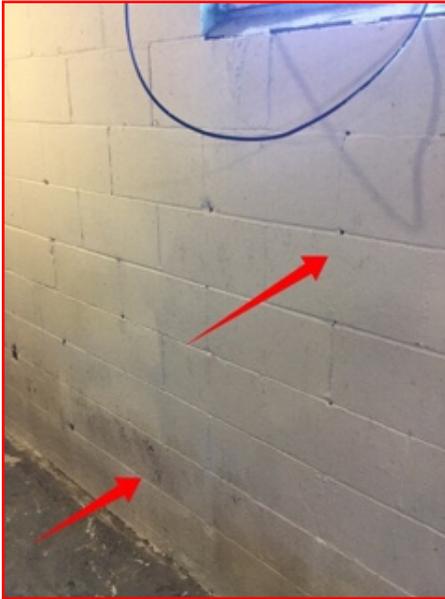
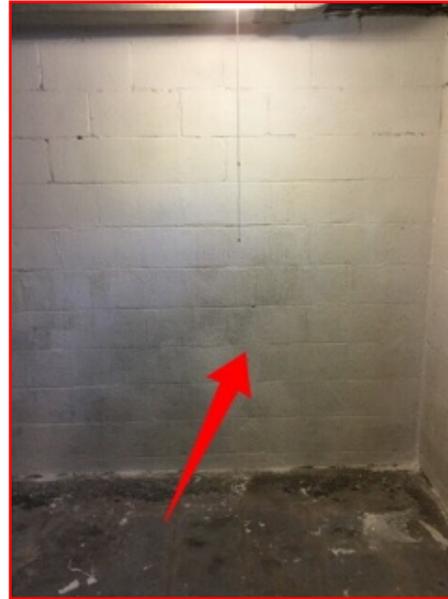
13) There are some staining in the walls that indicate some water intrusion although it was dry at the time of inspection. Gutters would help alleviate this problem. There are also some holes drilled in the mortar joints the driveway side wall. Im not sure what this was for it could have been a finished wall at one time.

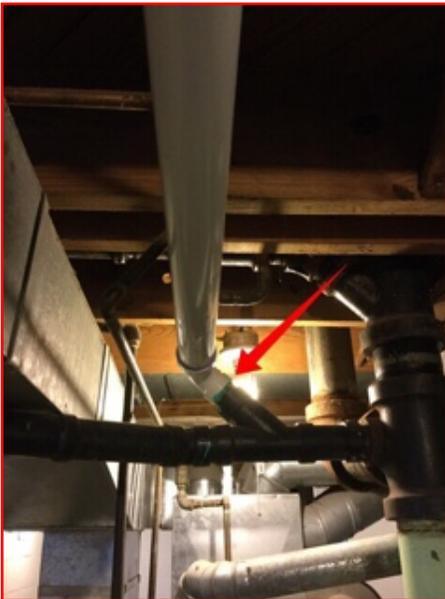
Figure 39-1

15) The home has both PVC and ABS waste pipe joined together. These two products are not mad to be joined together unless there is a fernco coupler used. I see this regularly and this joint was not leaking at the time of inspection.
