# Home Evaluation Services

## Home Inspection Report

**Sample Report Camp Or Cottage**

Inspected on Mon, Aug 24 2020 at 2:16 PM

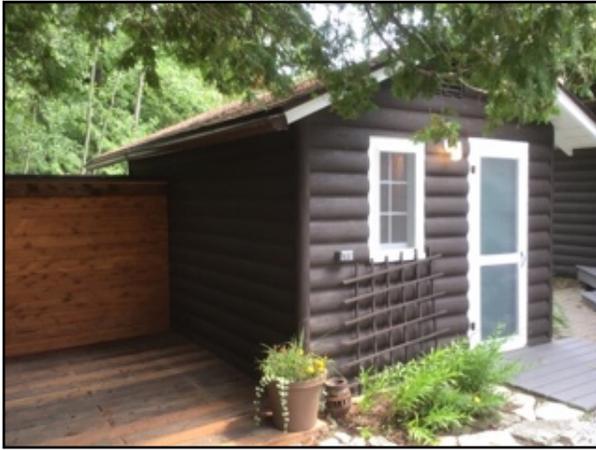
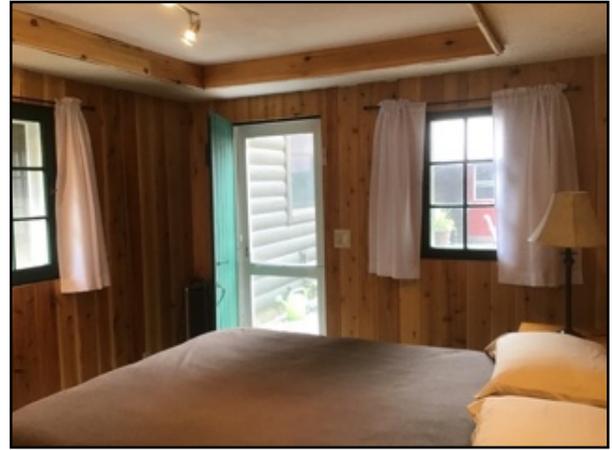
The bunkhouse building was in good general condition .

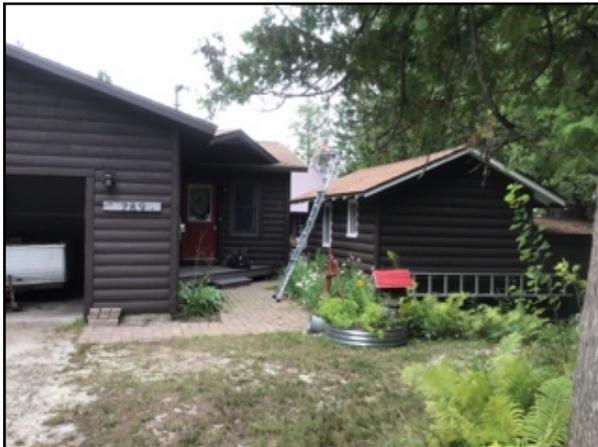
Figure 3-1

The grounds were well kept and in good general condition .

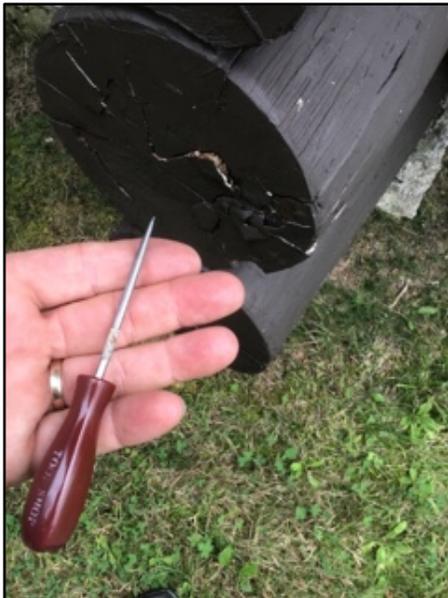
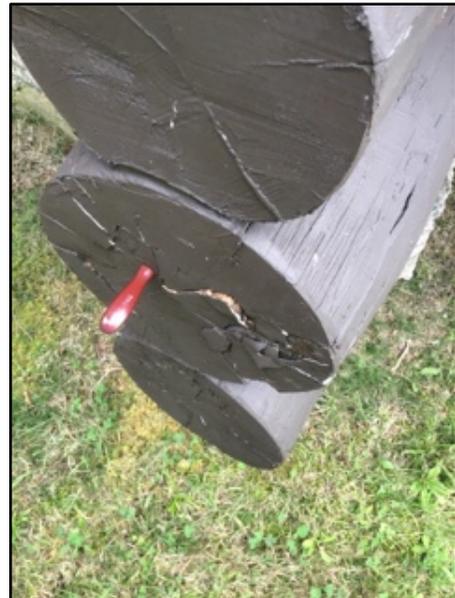
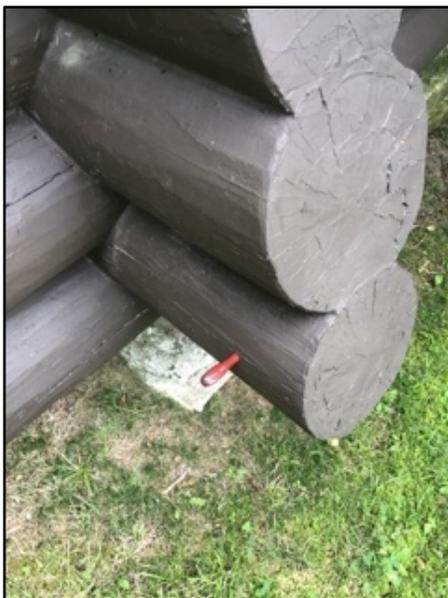
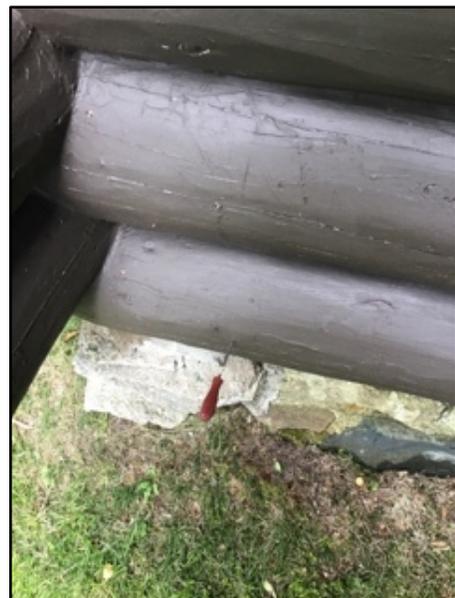
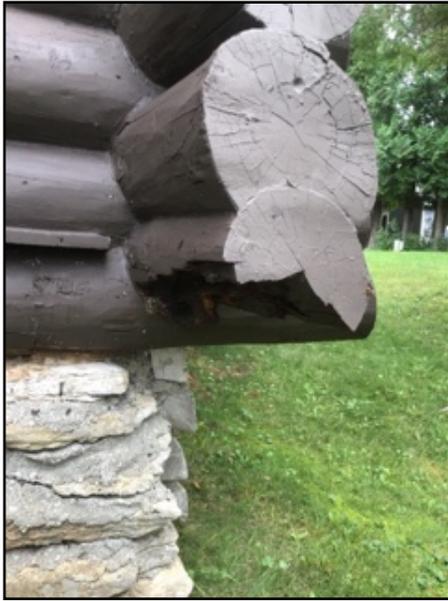
With log home , I use a pick to determine log integrity, the wall logs all tested ok, but do note: the tails are soft, repair of these areas will be needed in the future .

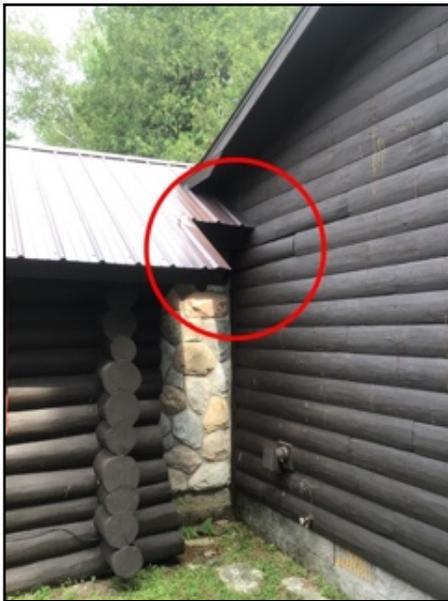
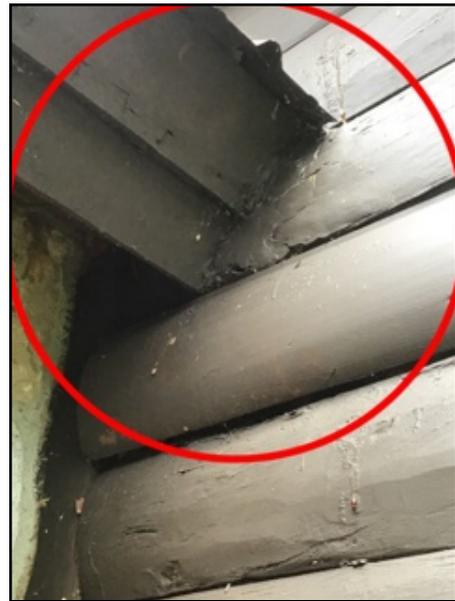
Roof runoff is causing some deterioration in this area, it has been patched once, a gutter here may be an improvement .

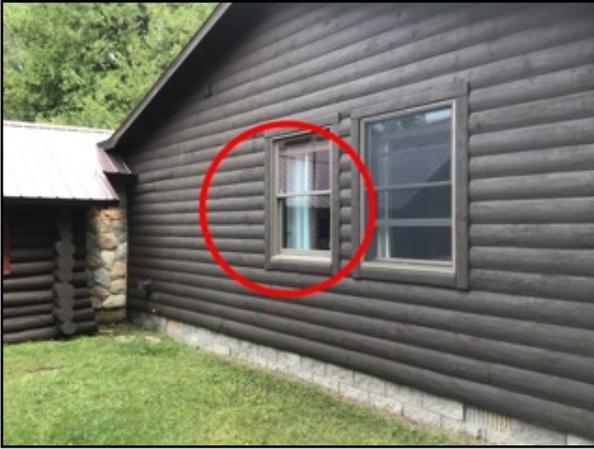
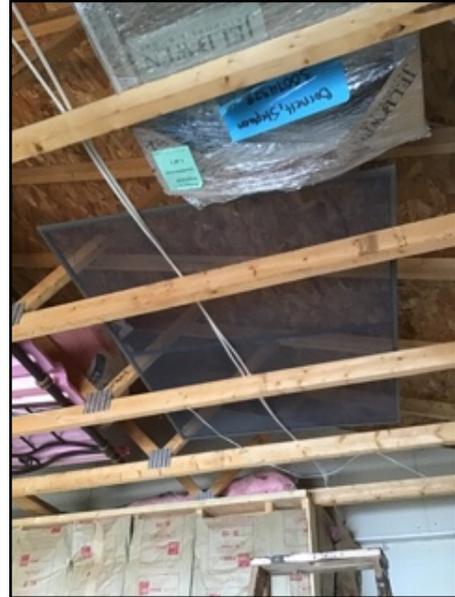
One window was missing a screen, however it appears to be stored in the garage rafters .

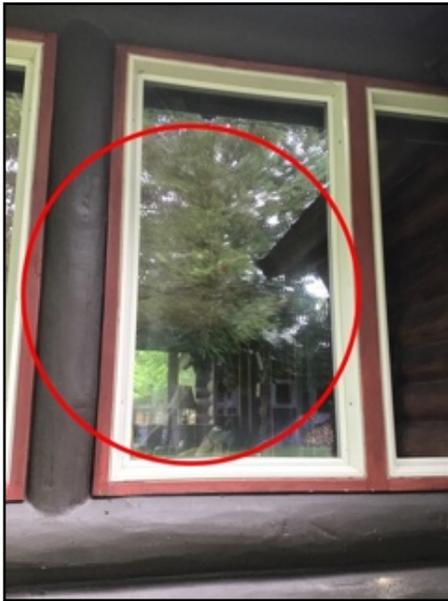
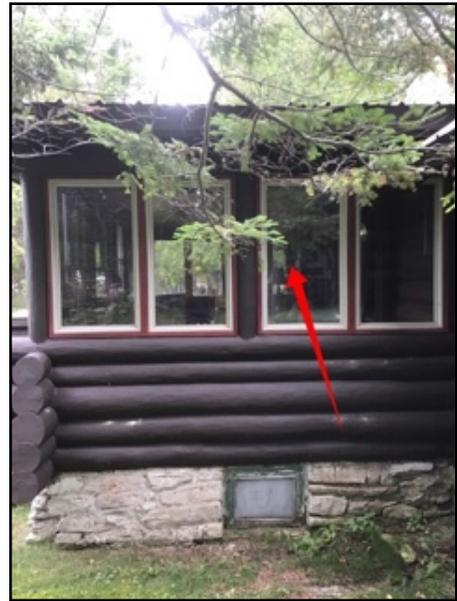
One front porch area window was broken, this will need to be repaired .

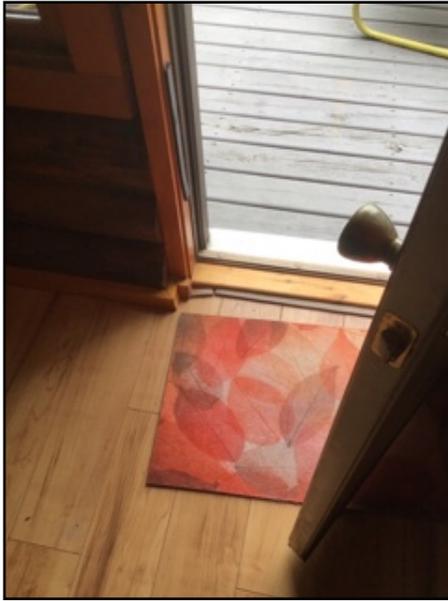
Figure 8-1

The front porch entry door fit and sealed poorly, this should be evaluated, and repaired as needed,.

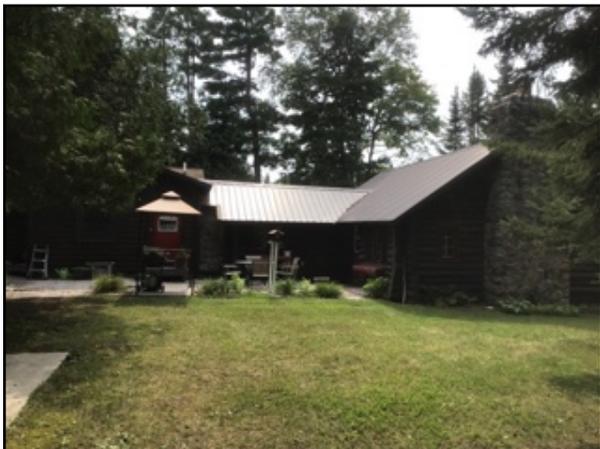
Figure 9-1

Overall the exterior of this property was in good general condition, see notes for log condition .

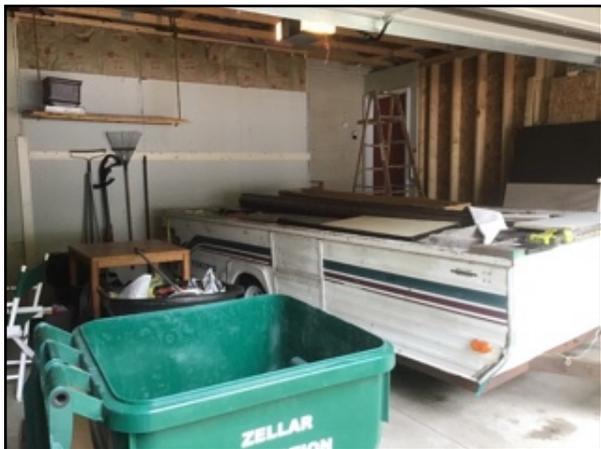
Figure 11-1

The garage was well built and in good condition,.

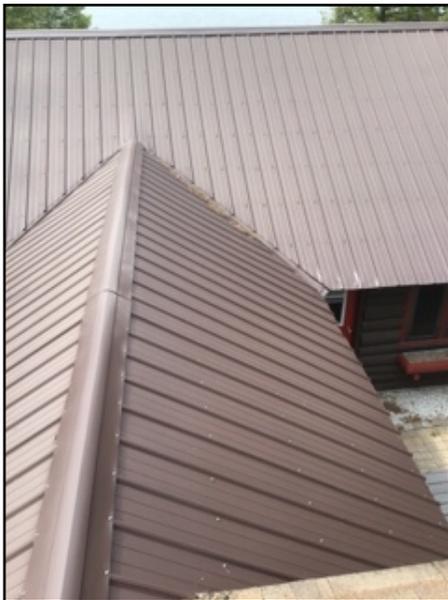
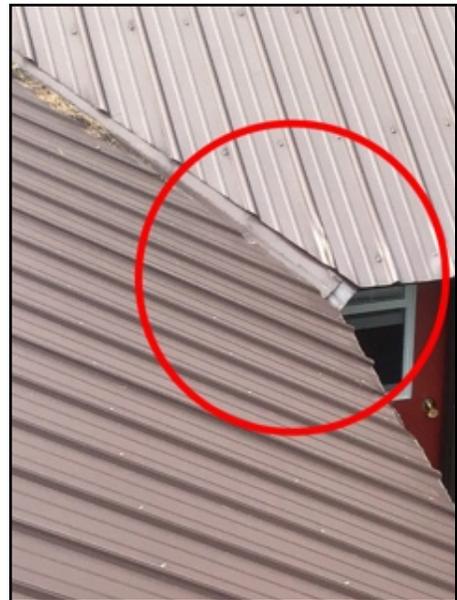
Some minor ice damage is starting in the valley, this will need to be monitored .

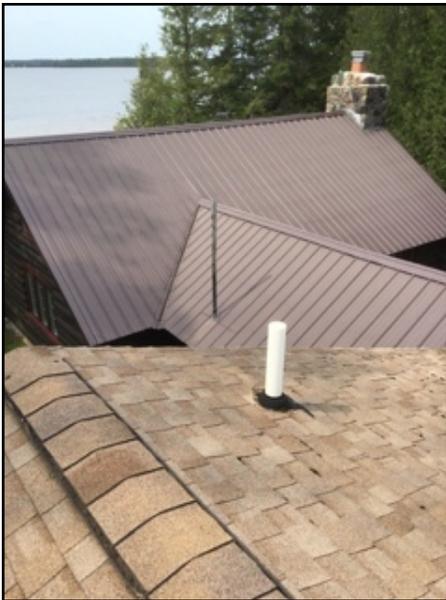
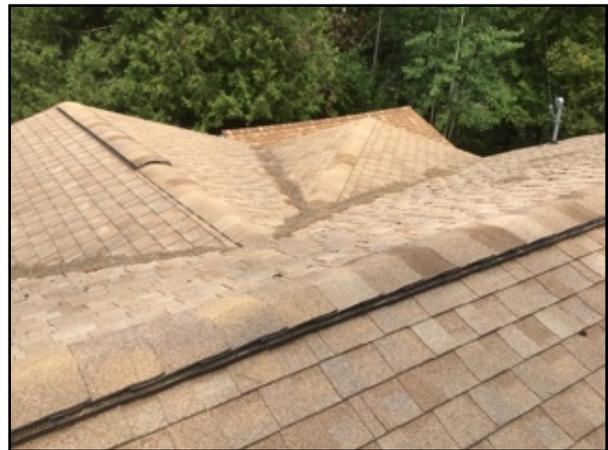
The shingles and metal roof covering was found to be in good general condition, .

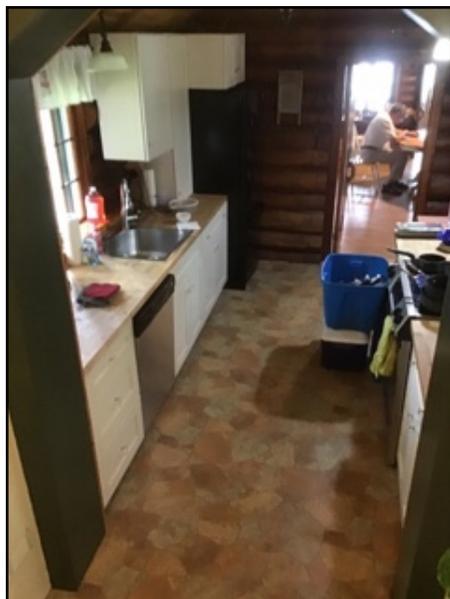
Figure 15-1

Comment 15:  
The kitchen was in good condition .

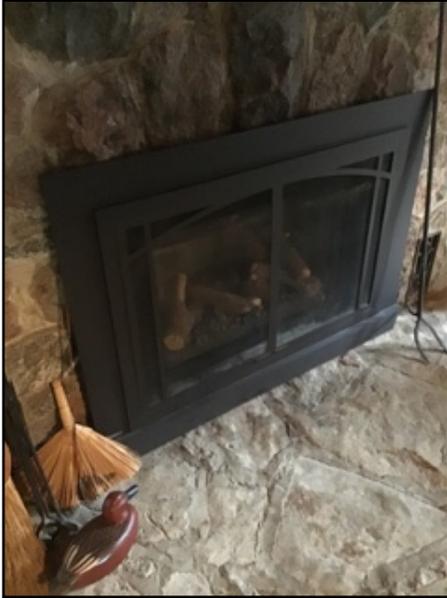
Figure 19-1

The gas fireplace was not in use at time of inspection, ( gas turned off ) I recommend asking that this be on fir your final walk through,.

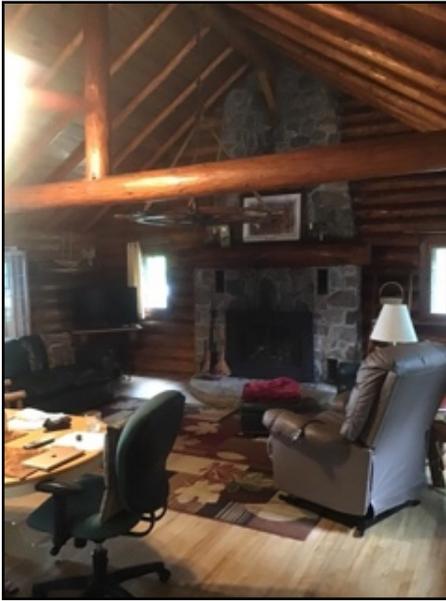
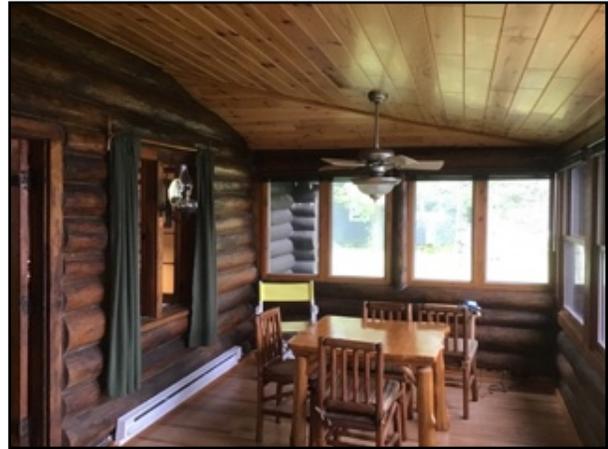
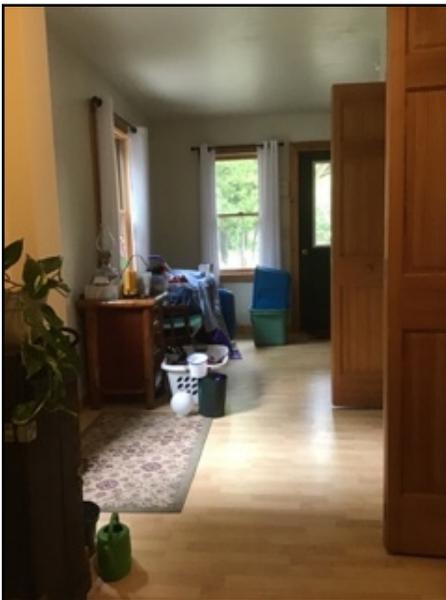
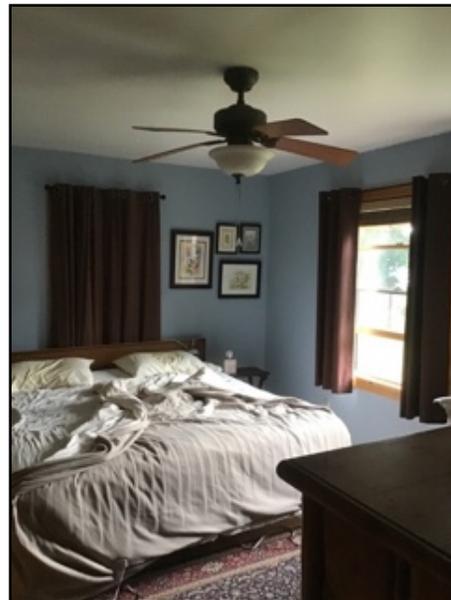
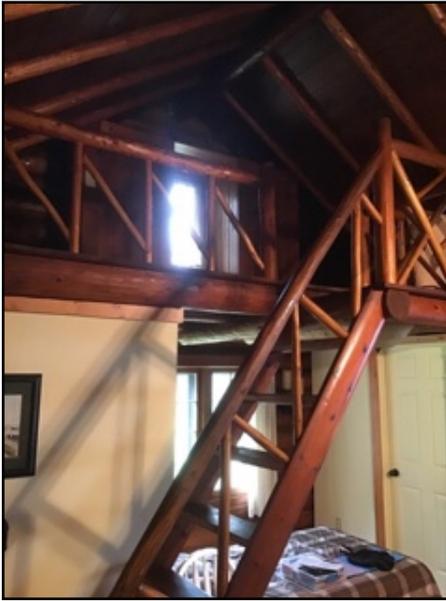
The interior room areas were found to be in very good condition condition, no repair items to note,.

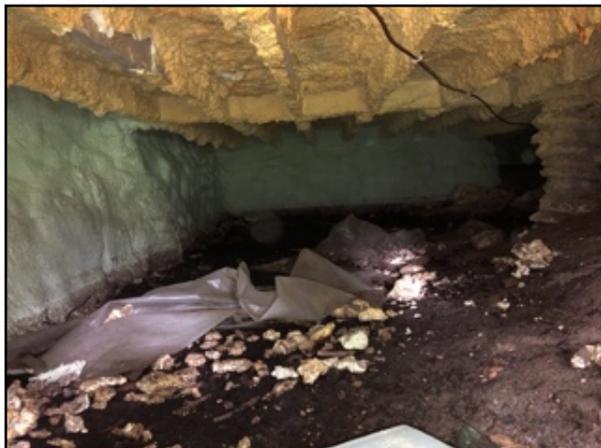
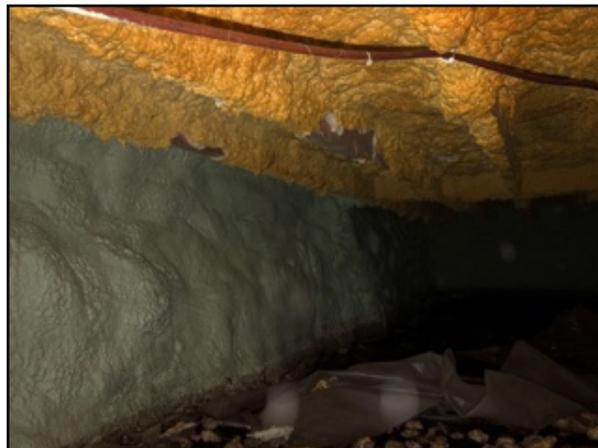
The original area and the addition area have been insulated by closed cell spray foam, this is a very good measure for this type home.

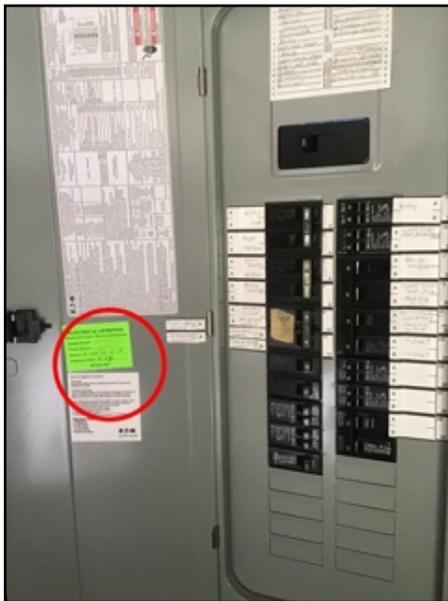
Figure 27-1

New 200 amp service panel located in the garage .

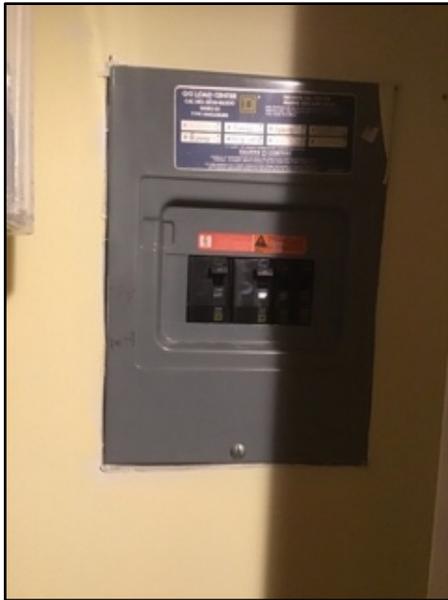
Figure 28-1

Comment 28:  
The original cabin area has a sub panel .

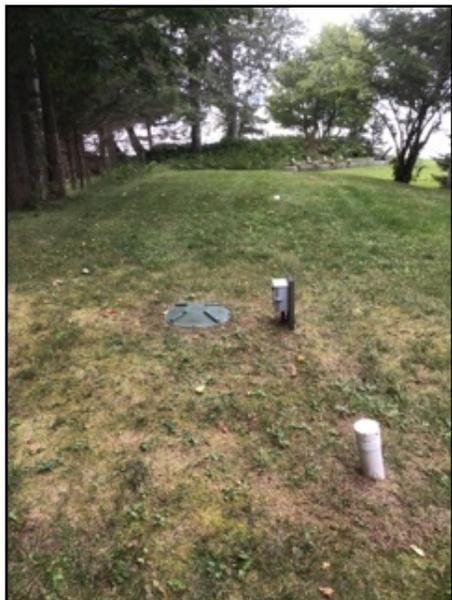
Figure 31-1

I performed a 20 minute push test on the septic field and water source. During this test, the water flow remained good and there was no sign of the septic field not being able to handle the water load.

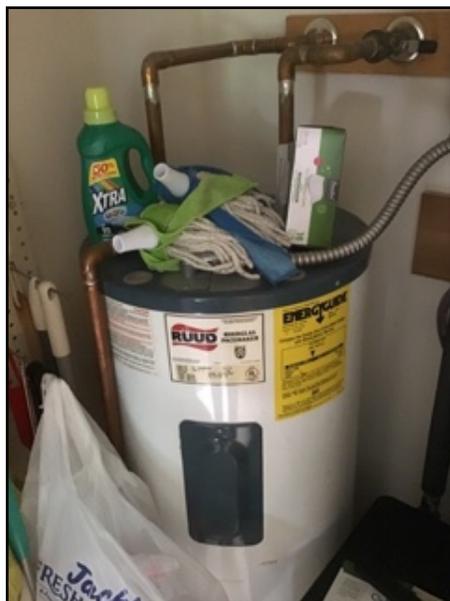
Figure 36-1

The electric water heater was operating as designed at inspection .

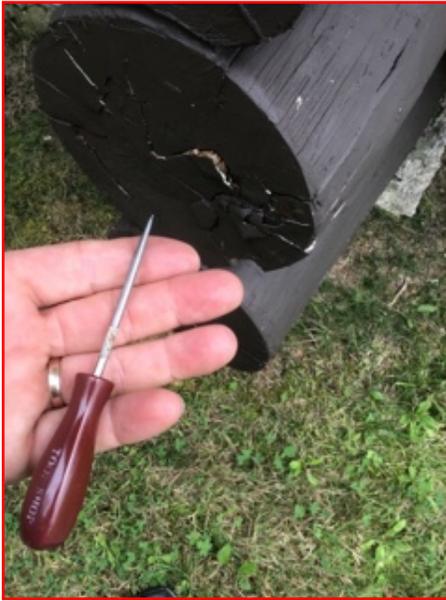
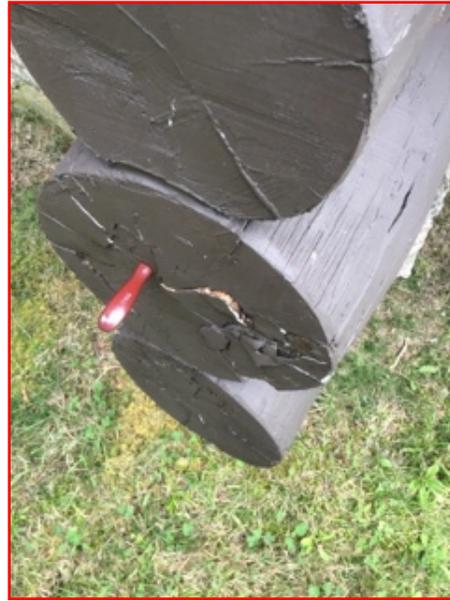
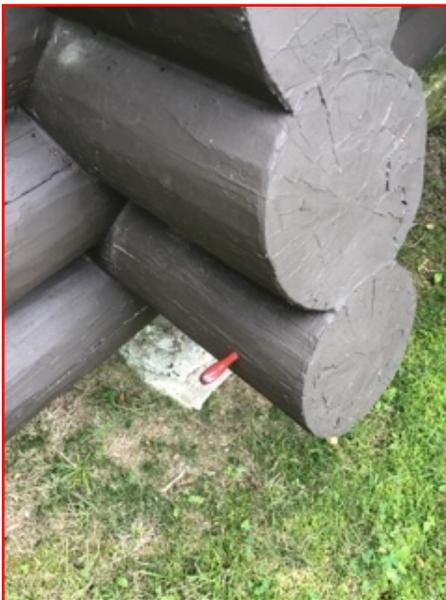
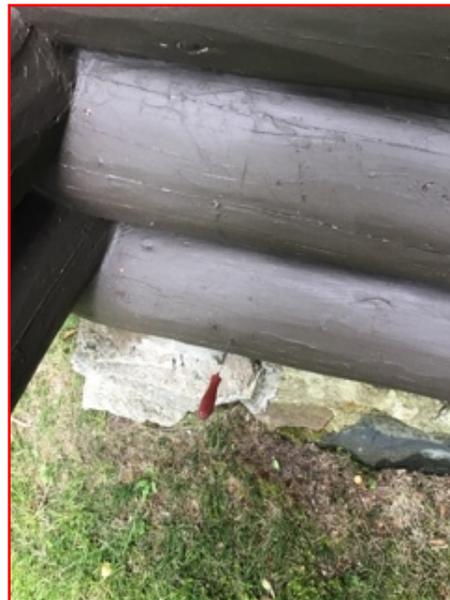
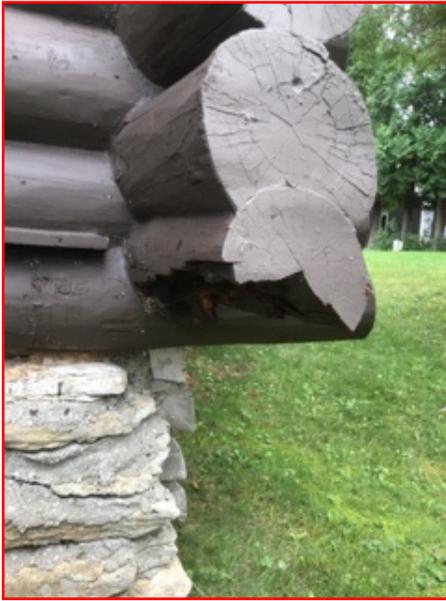
2) With log home , I use a pick to determine log integrity, the wall logs all tested ok, but do note: the tails are soft, repair of these areas will be needed in the future .

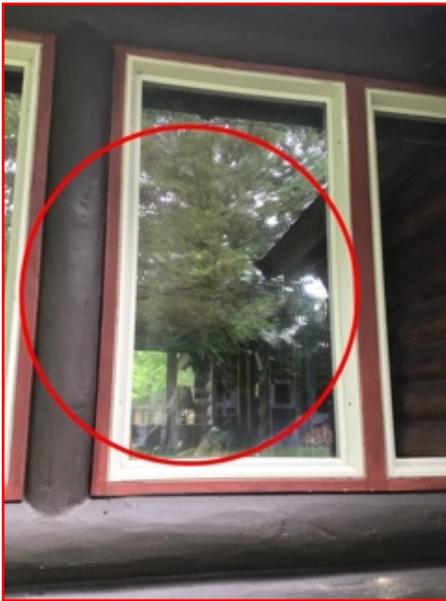
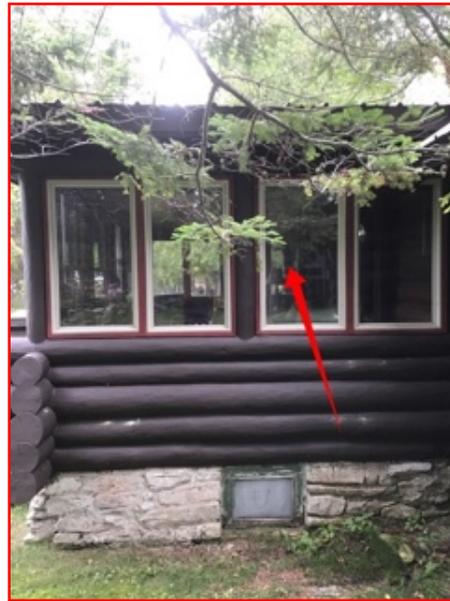
3) One front porch area window was broken, this will need to be repaired .

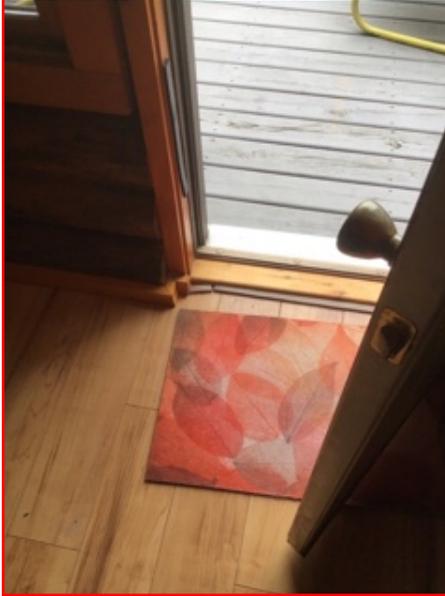
Figure 8-1

4) The front porch entry door fit and sealed poorly, this should be evaluated, and repaired as needed,.
