Home Evaluation Services

Home Inspection Report

Sample Report Multi Family

Inspected on Wed, Jan 13 2021 at 8:37 PM

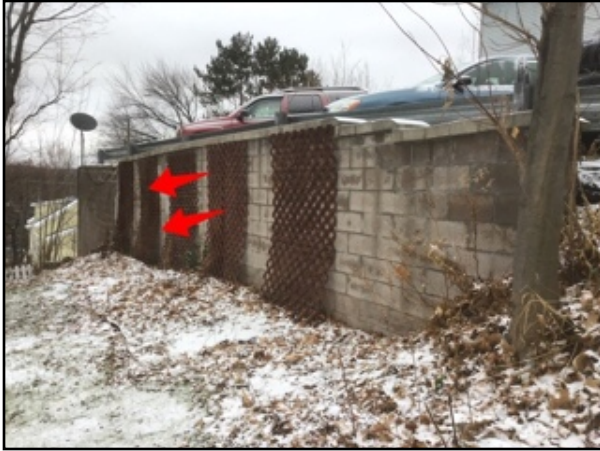
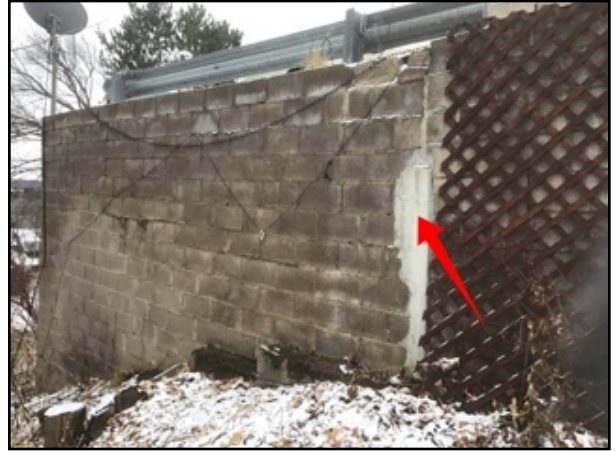
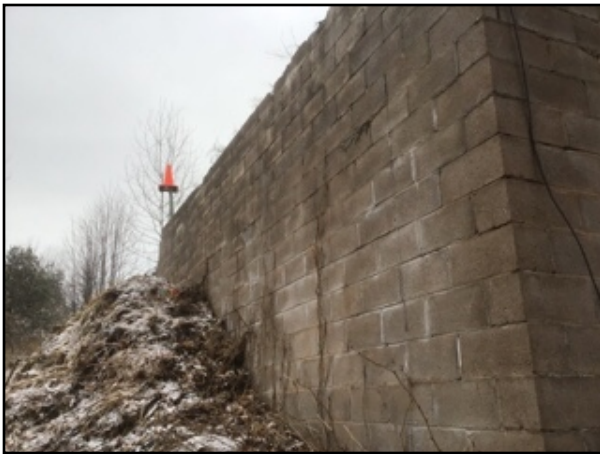
The retaining wall on the east end of the property has had some repairs. The wall has a slight bow that I would recommend monitoring. These can be seen in the attached photos.

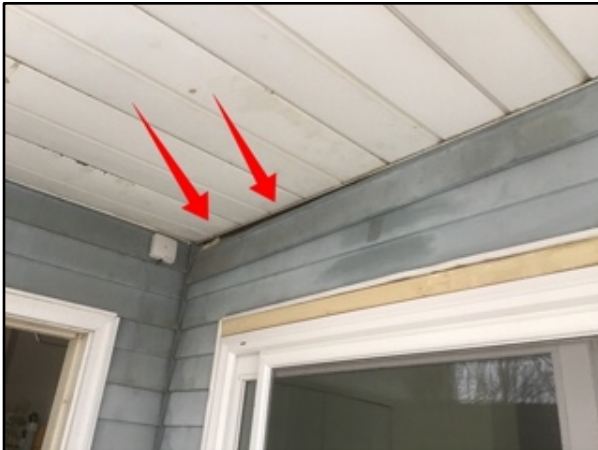
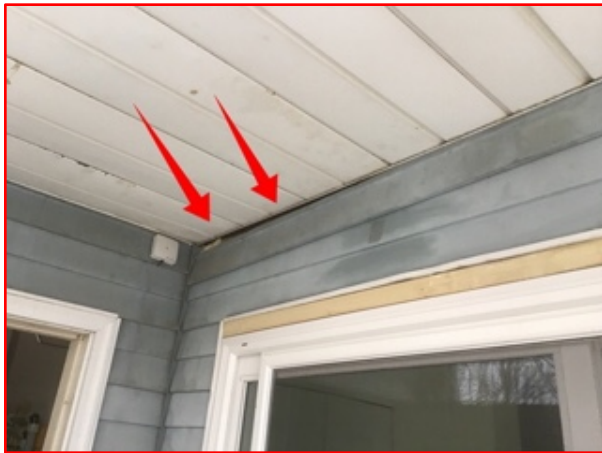
Figure 3-1

Loose aluminum siding on back balcony of unit number six.

1) Loose aluminum siding on back balcony of unit number six.

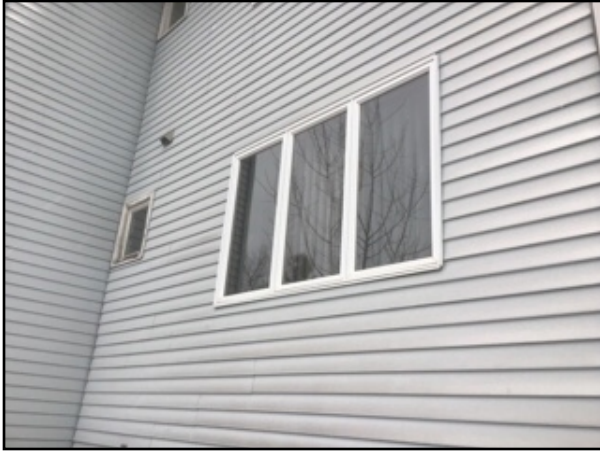
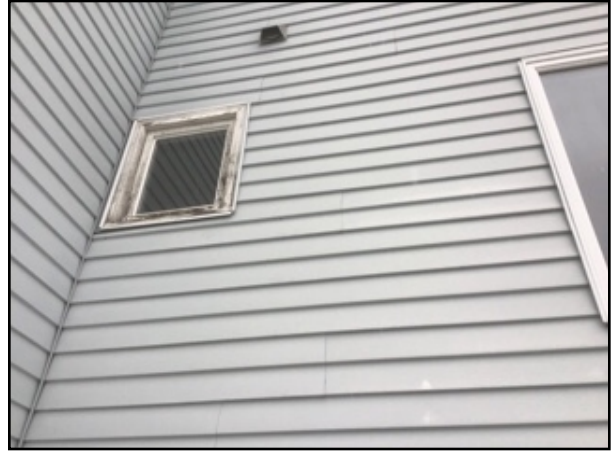
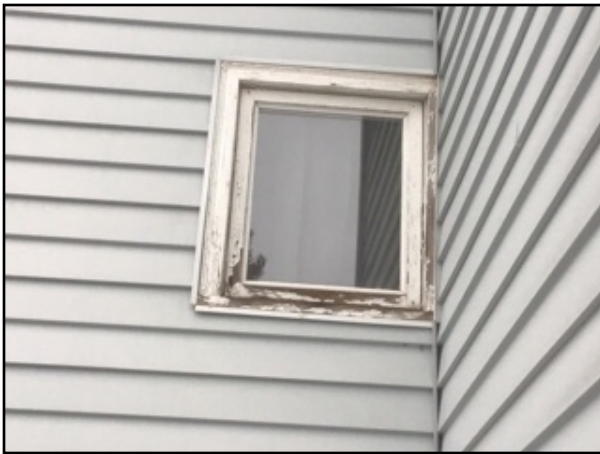
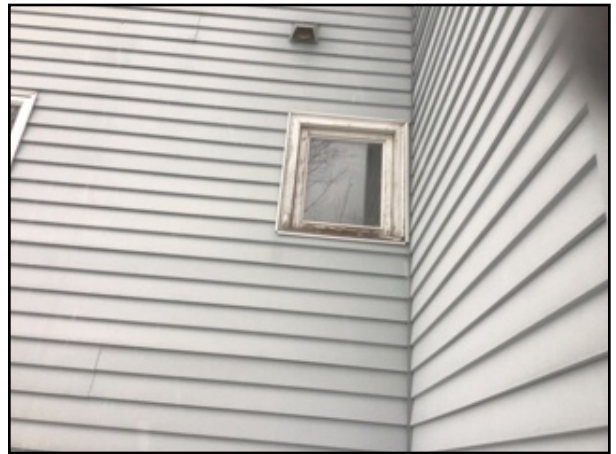
Main windows are vinyl, bathroom windows are wood. The wood windows will need to be scraped, cleaned, and painted in the near future to prevent further deterioration. A long term fix would be replacement with vinyl units,

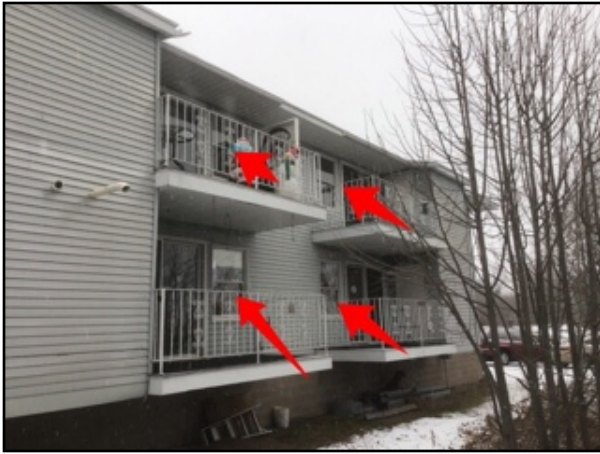
Figure 5-1

Missing screens on all four units of the east end of the complex.

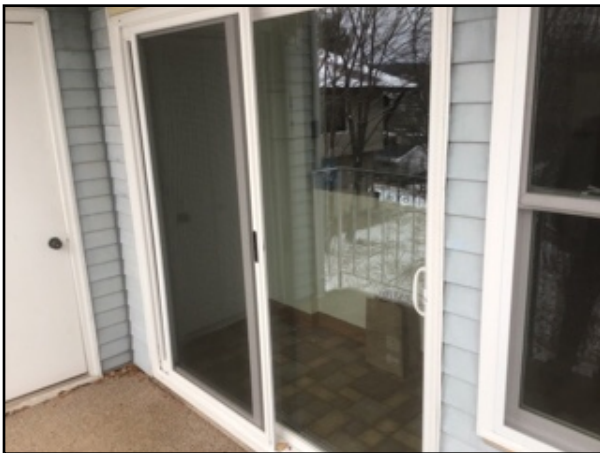
Figure 6-1

New vinyl patio door installed in unit number six, Note, all of the tenants mentioned that they were told replacement patio doors were scheduled .

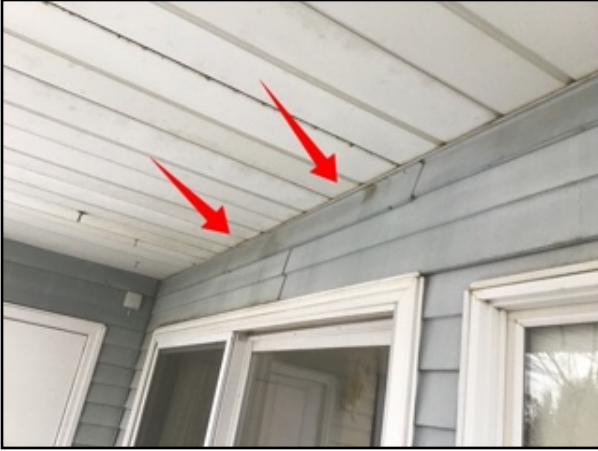
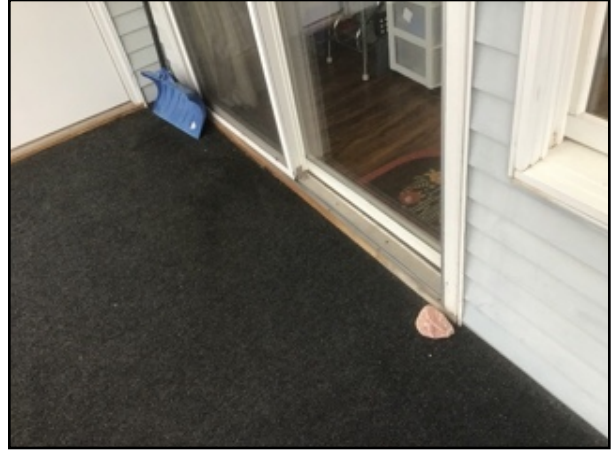
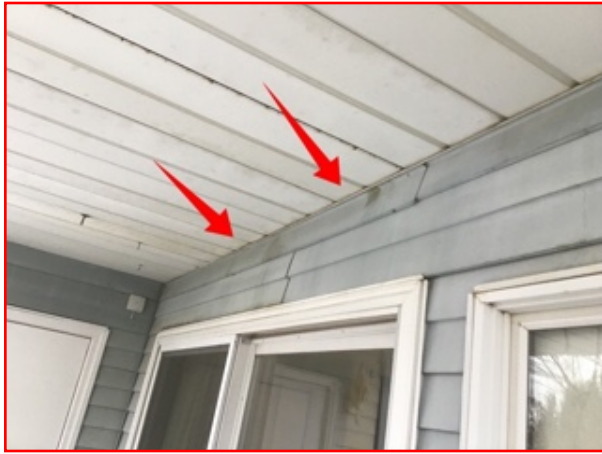
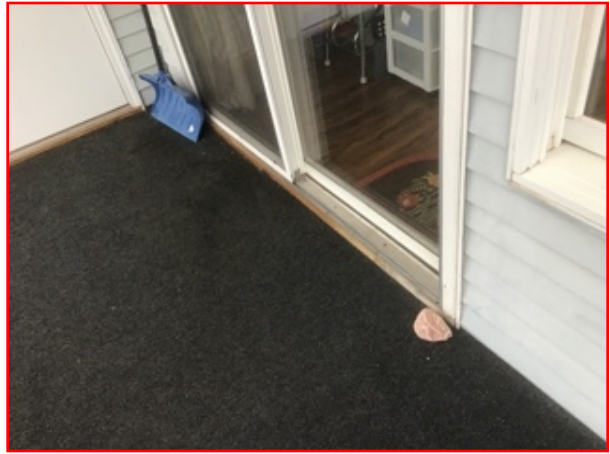
Comment 7:
Leaking from balcony above example.

2) Leaking from balcony above example.

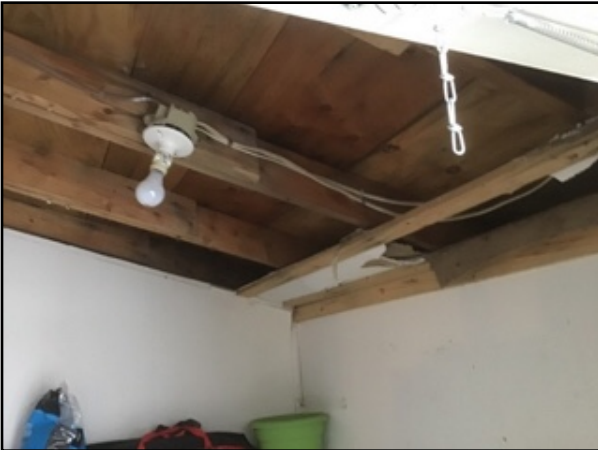
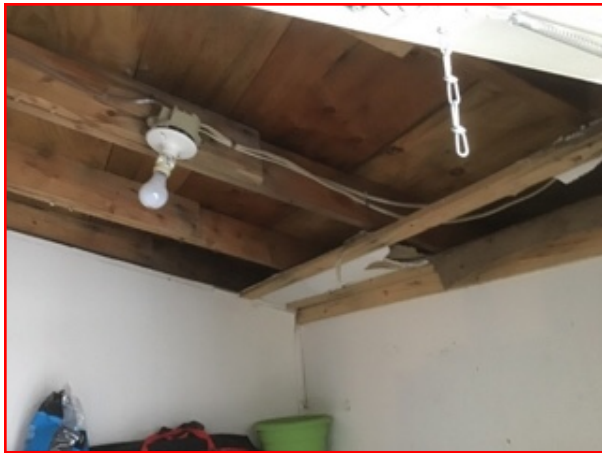
Figure 8-1

Comment 8:
Storage shed on unit three is missing ceiling.

3) Storage shed on unit three is missing ceiling.

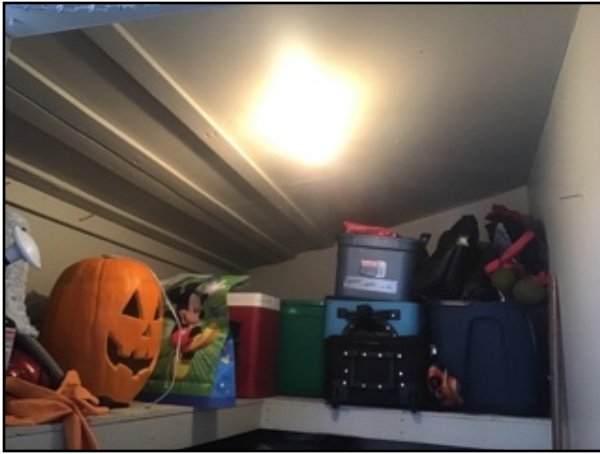
Figure 9-1

Unit four ceiling in shed for example of properly installed storage shed ceiling.

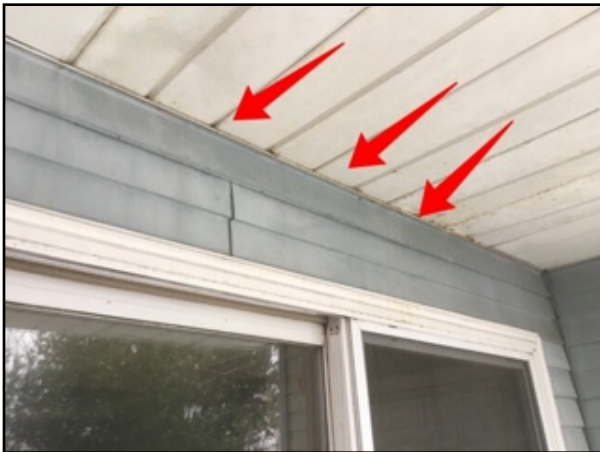
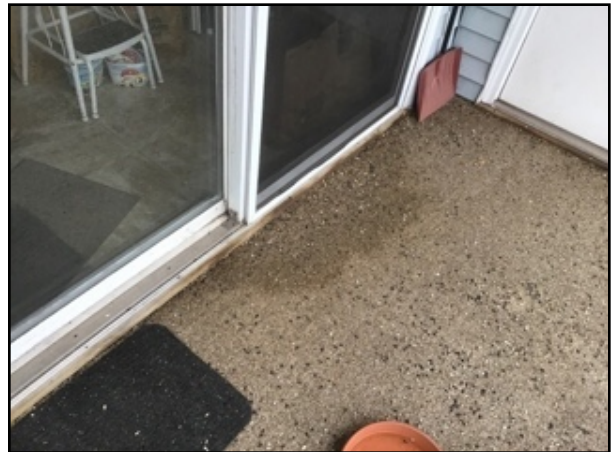
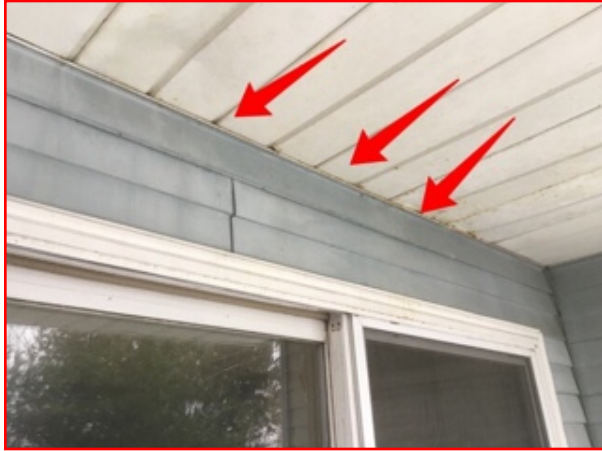
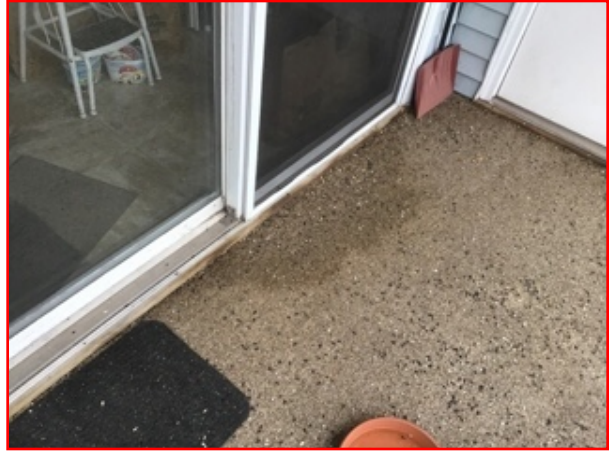
Unit five has leaking from balcony above.

4) Unit five has leaking from balcony above.

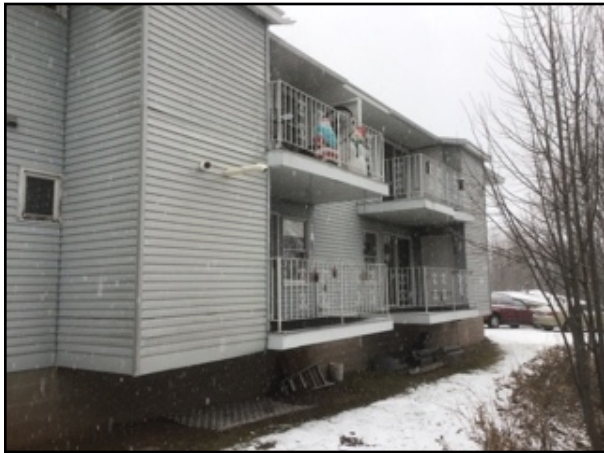
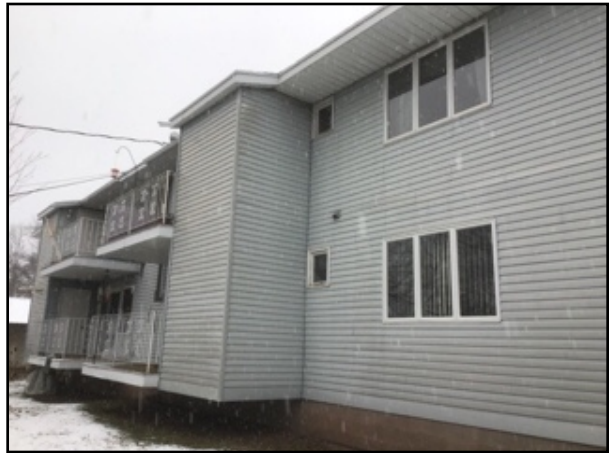
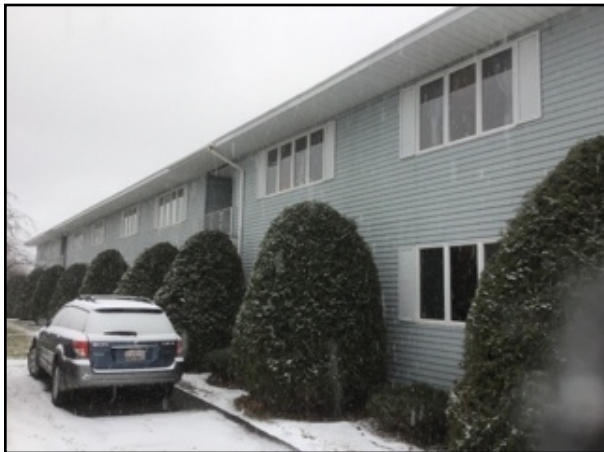
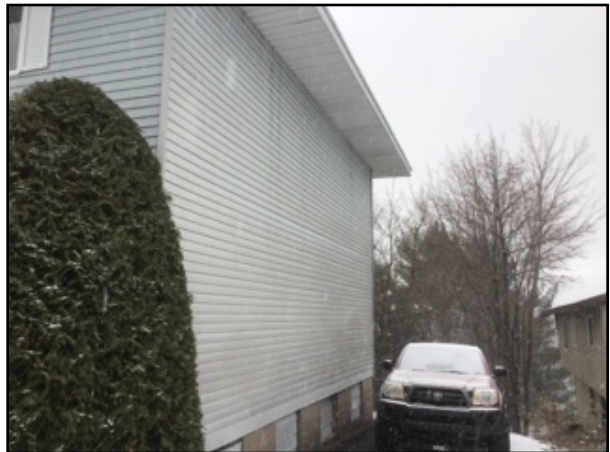
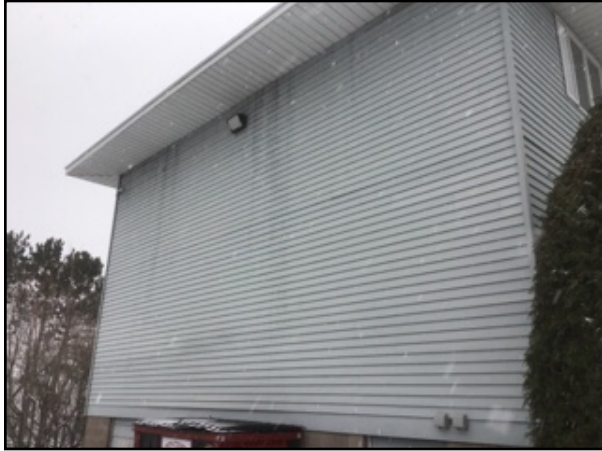
Exterior aluminum siding views. The exterior of the complex inspected well and no major deficiencies were found at the time of inspection.

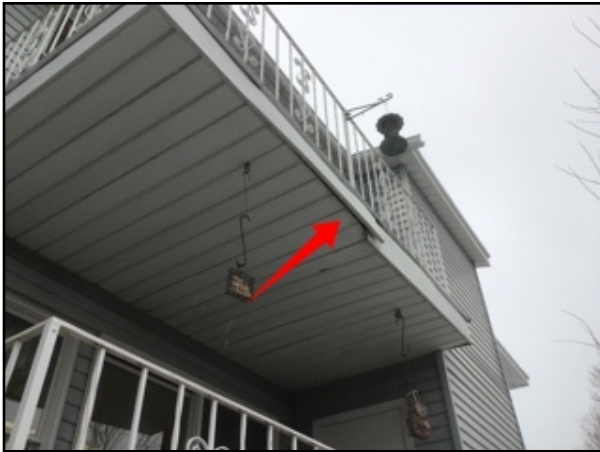
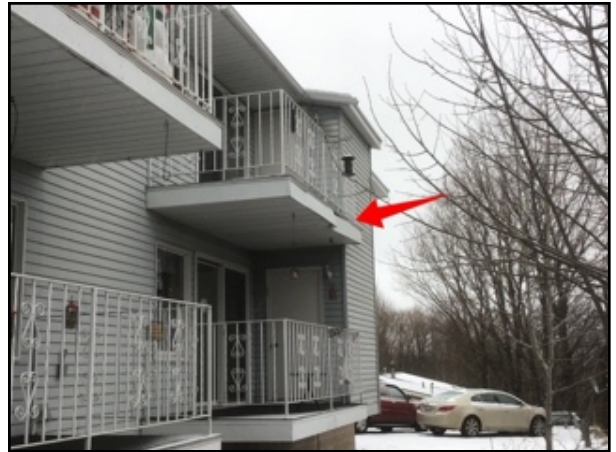
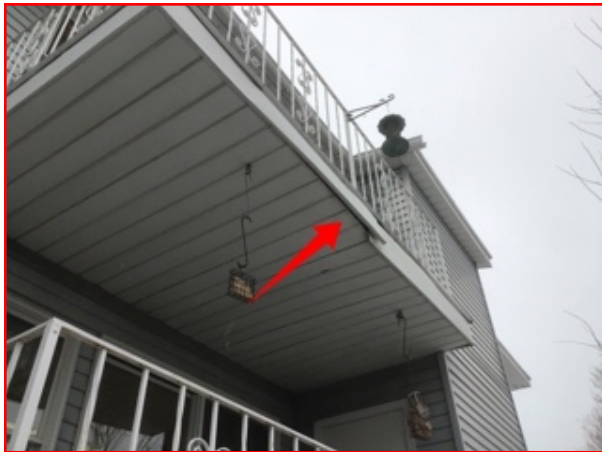
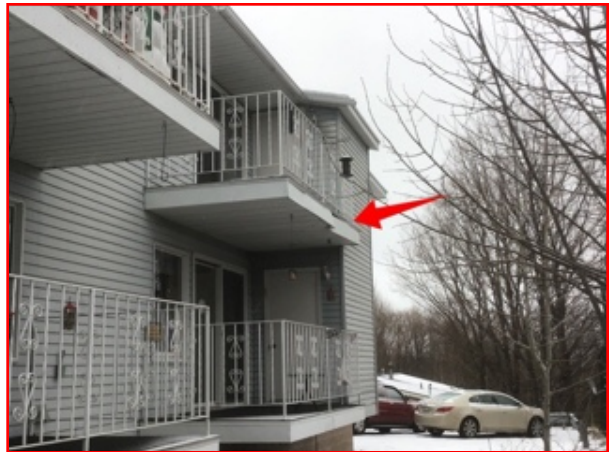
Fascia board damaged on unit three balcony .

5) Fascia board damaged on unit three balcony .

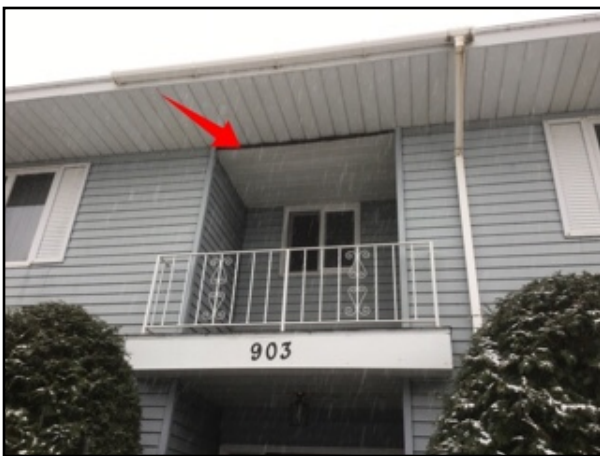
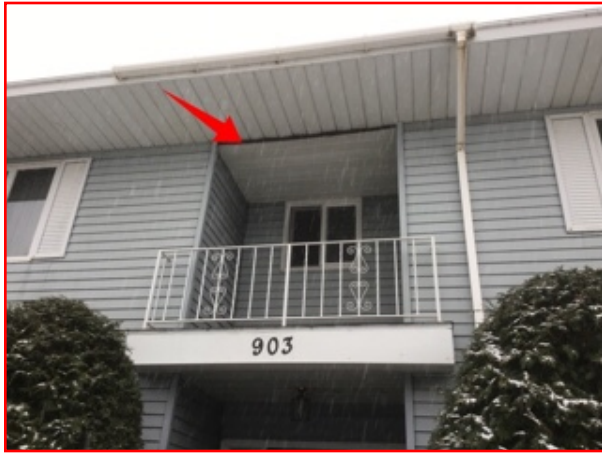
Figure 14-1

Missing trim under entrance balcony.

6) Missing trim under entrance balcony.

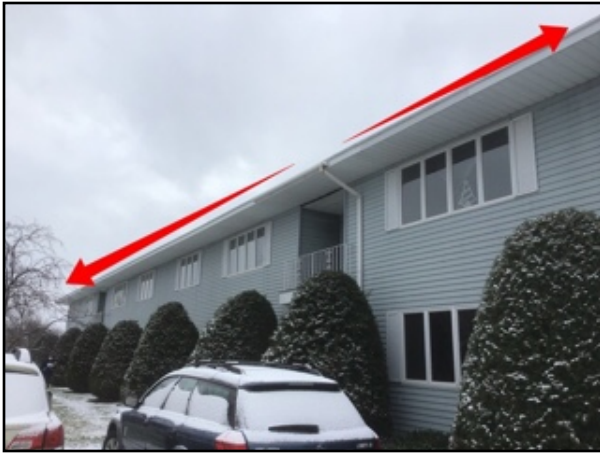
Figure 15-1

I always recommend full gutters systems on all homes. A proper system will take roof runoff away from the building, protect the base materials of the home, and keep the basement and crawl space areas dryer.

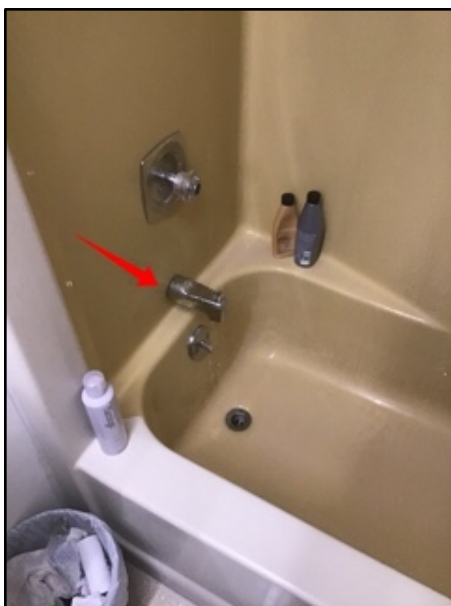
Figure 18-1

Unit three tub faucet is loose, this will need to be caulked to prevent water intrusion to the wall cavity .

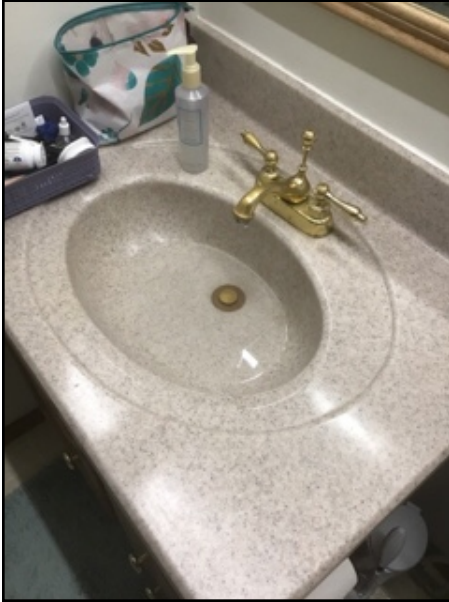
Figure 19-1

Slow drain in hallway bath in unit 3, also missing aerator on end of faucet , trap will need to be cleaned and recommend an aerator be installed .

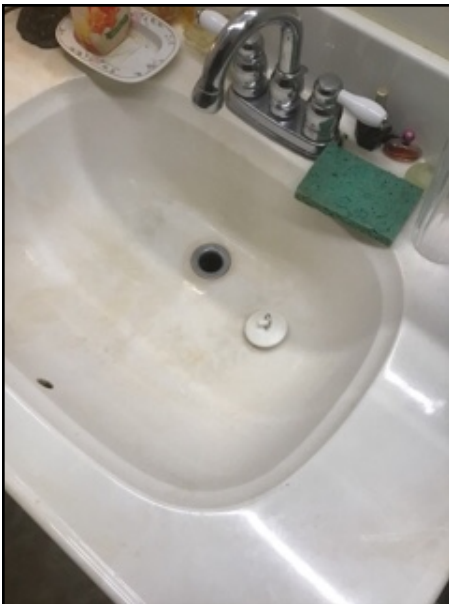
Figure 20-1

Unit five hallway bathroom sink is missing drain stopper.

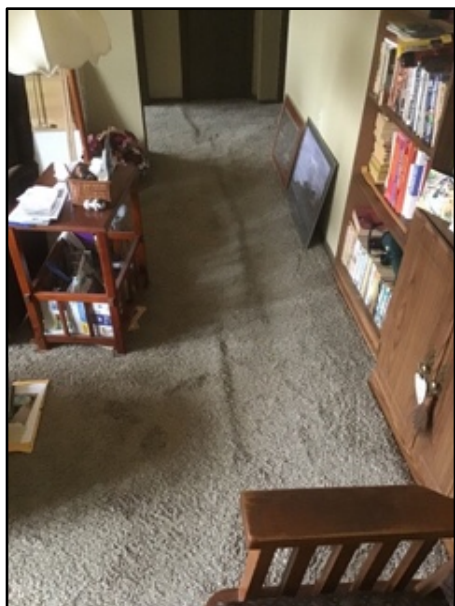
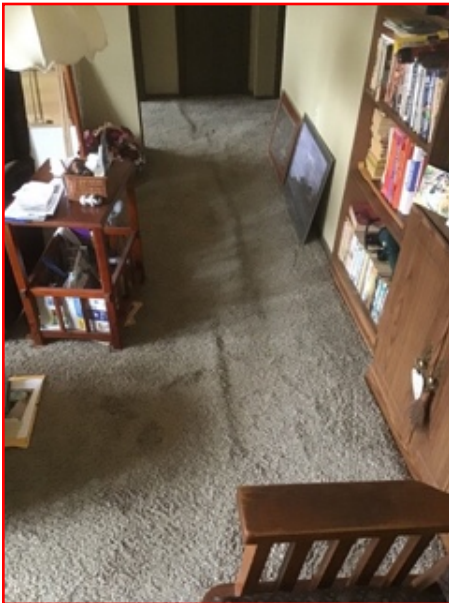
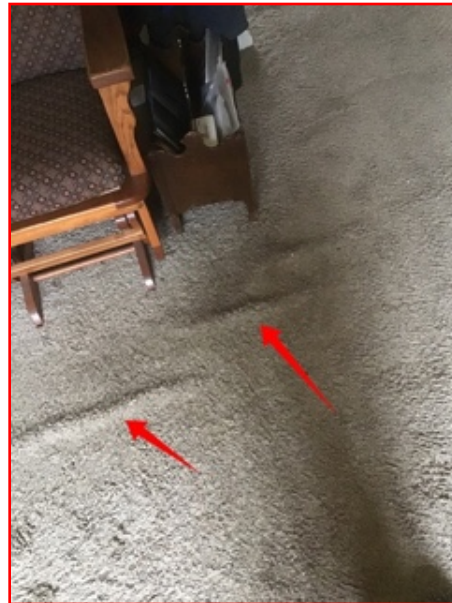
Carpet in unit five is in need of replacement. It is bunched up in multiple locations throughout the unit. Tenant complained of this being a trip hazard,

7) Carpet in unit five is in need of replacement. It is bunched up in multiple locations throughout the unit. Tenant complained of this being a trip hazard,

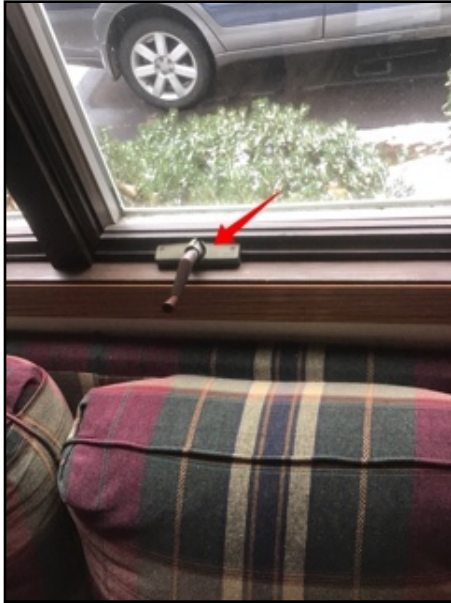
Figure 24-1

Comment 24:
Crank stripped in unit five on living room window.

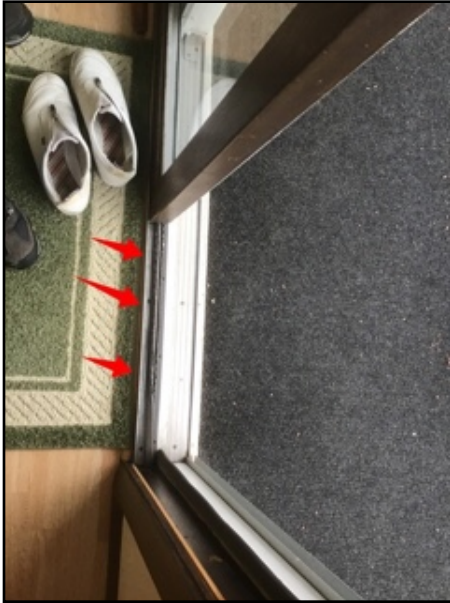
Figure 27-1

Weather stripping needs replacement on unit one sliding door.

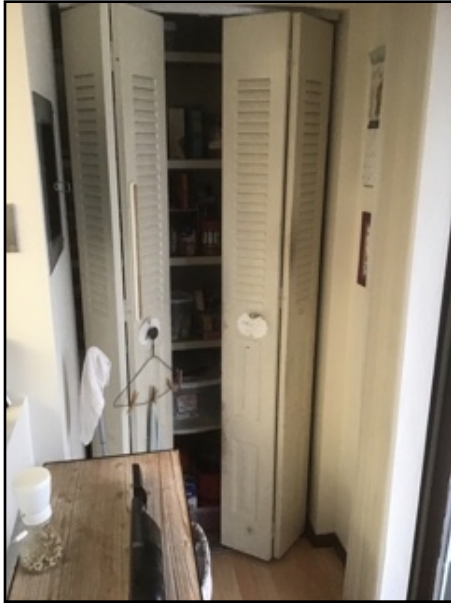
Figure 28-1

Steel pantry doors in some units are hard to close and open.

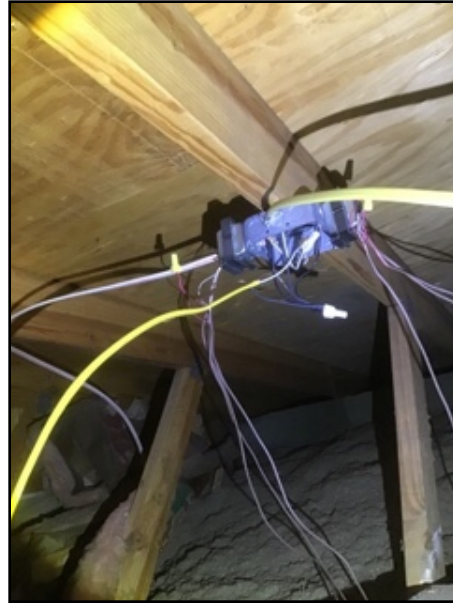
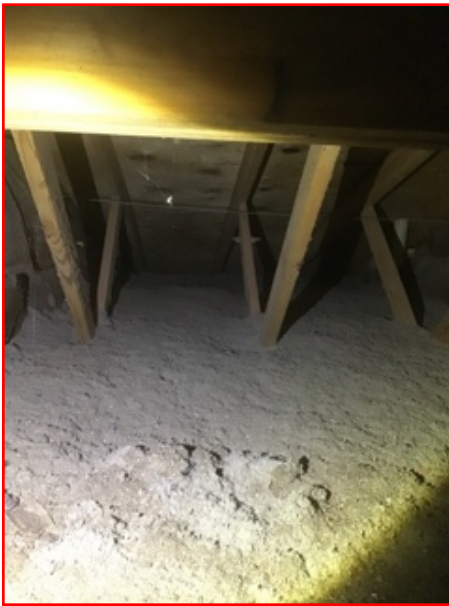
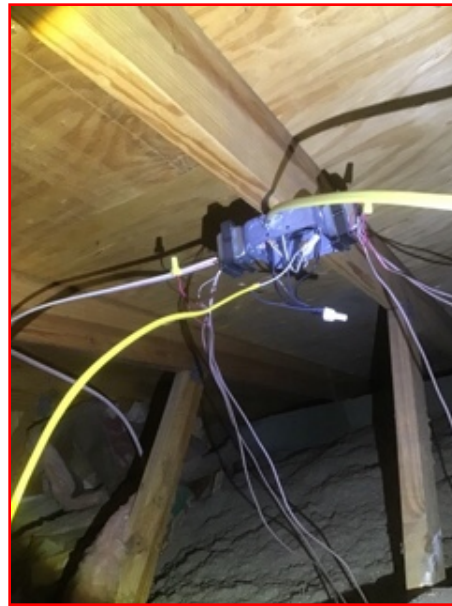
Attic east end of complex, has one open junction box .

10) Attic east end of complex, has one open junction box .

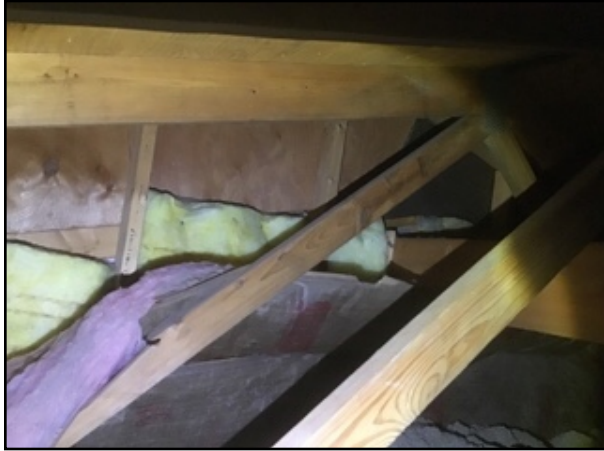
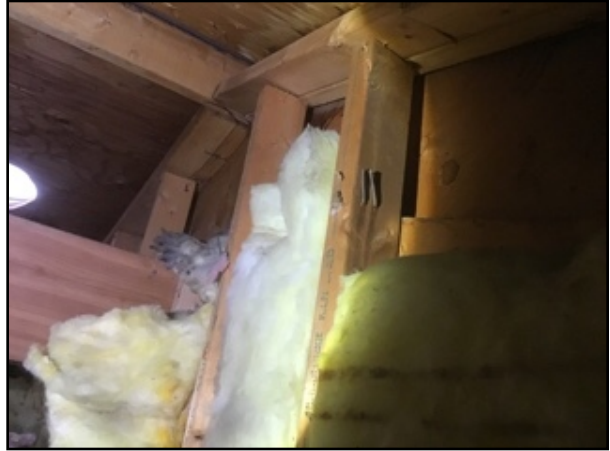
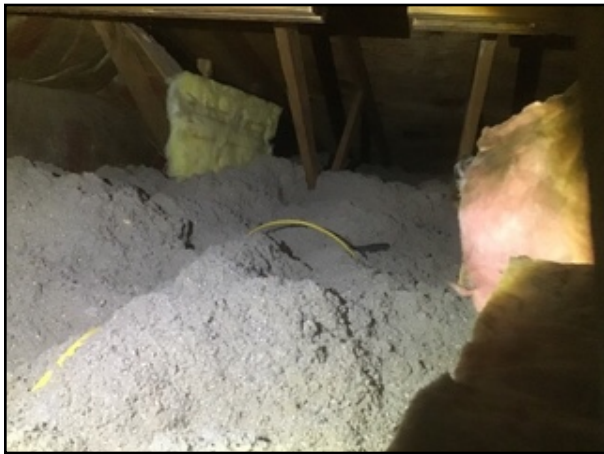
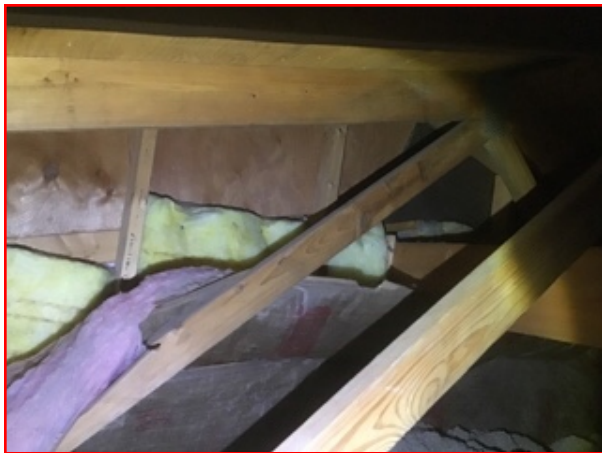
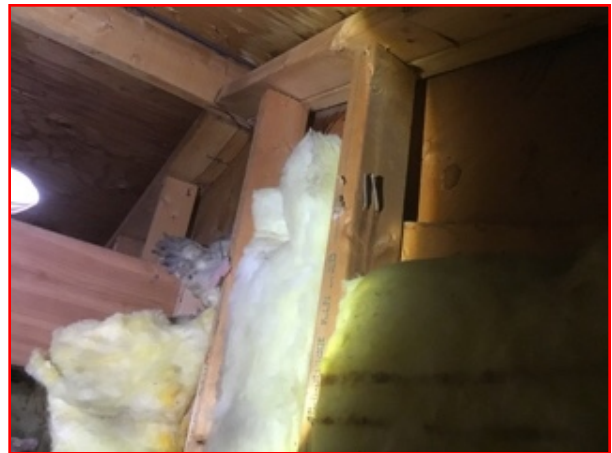
Attic on west end of complex. Fiberglass batting has fallen down from interior gable wall to attic area causing heat loss from apartments as well as cold spots in the apartments on both sides, this insulation needs to be properly put back into place,

11) Attic on west end of complex. Fiberglass batting has fallen down from interior gable wall to attic area causing heat loss from apartments as well as cold spots in the apartments on both sides, this insulation needs to be properly put back into place,

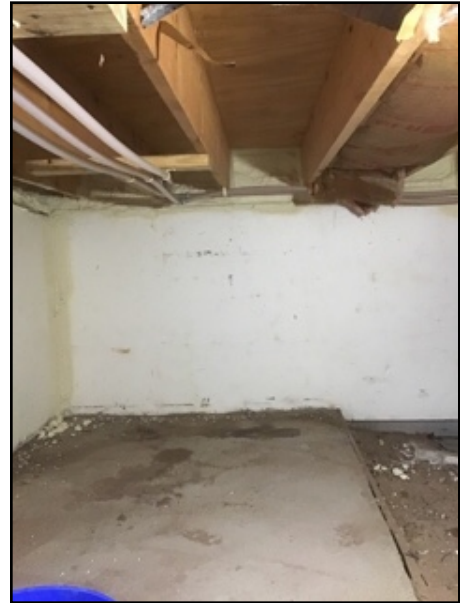
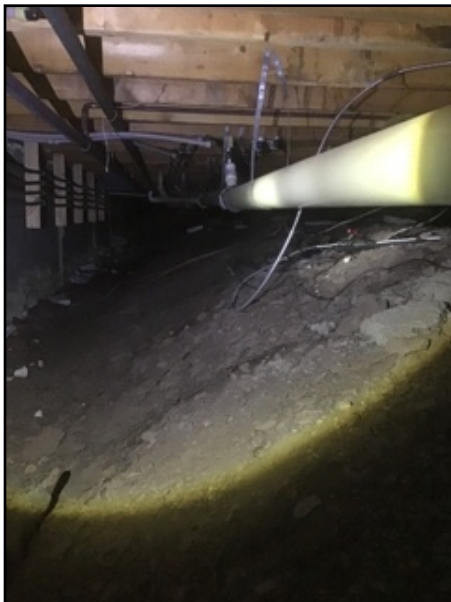
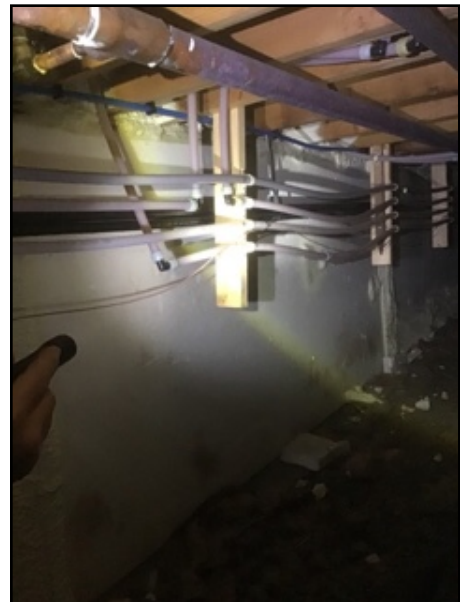
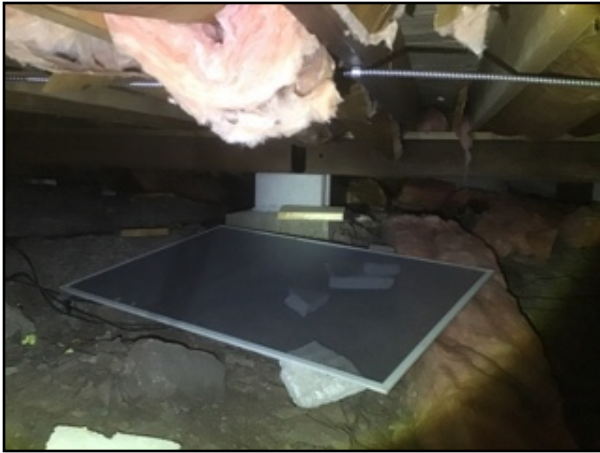
Crawl space has foam board walls and spray foamed floor joists. This is very good for plumbing and keeping the space tempered. It was very dry with no signs of water penetration.

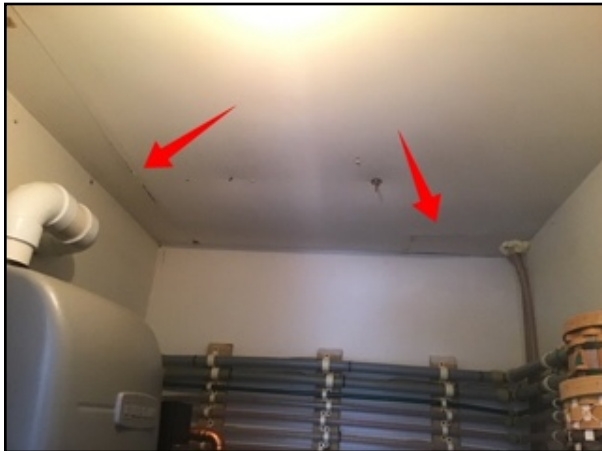
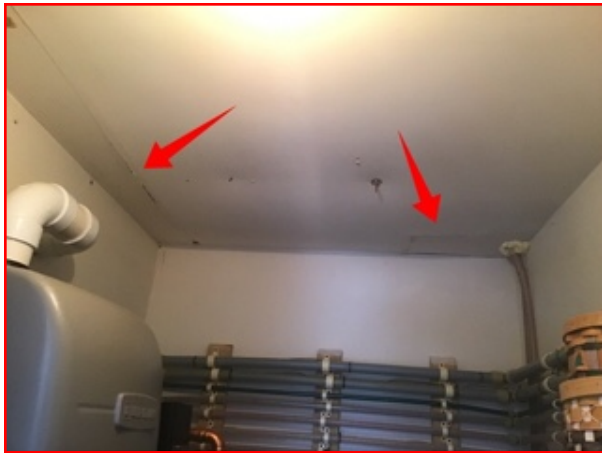
Figure 46-1

Boiler room number one off unit number two has some moisture damage, however it was dry at the time of inspection and should be monitored.

12) Boiler room number one off unit number two has some moisture damage, however it was dry at the time of inspection and should be monitored.

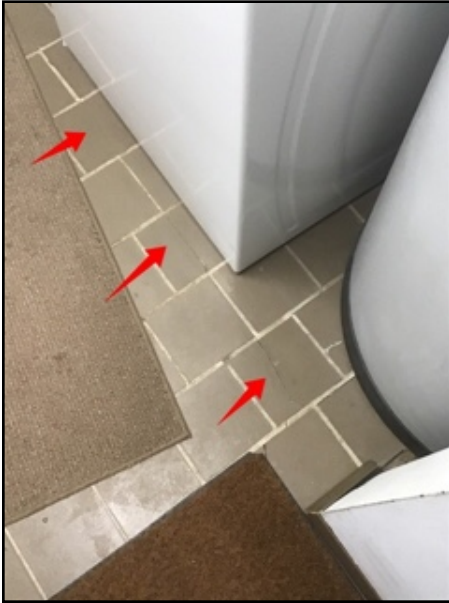
Figure 56-1

Comment 56:
Some cracks in East laundry center floor tile.
