Home Evaluation Services

Commercial Inspection

Sample Report

Inspected on Wed, Jan 13 2021 at 8:50 PM

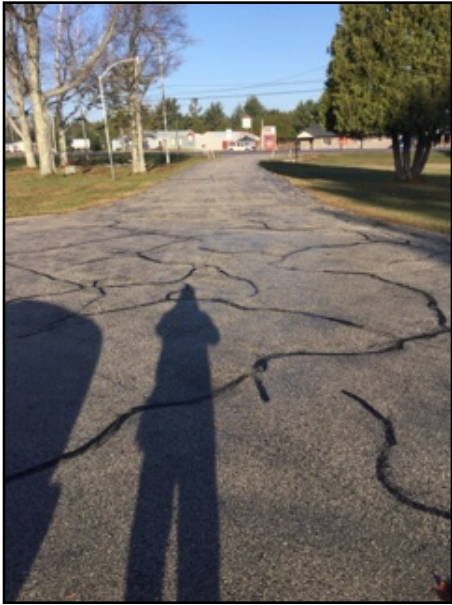
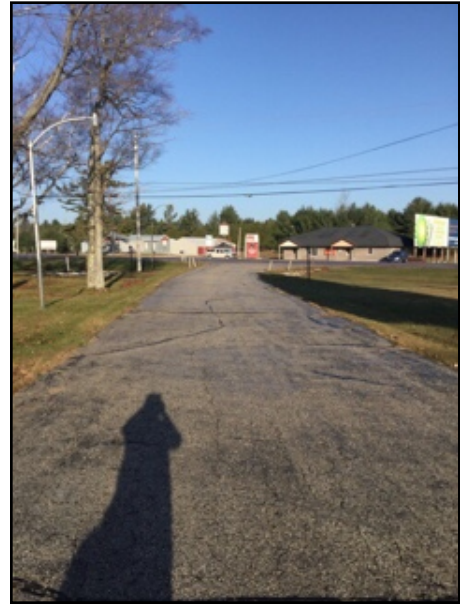
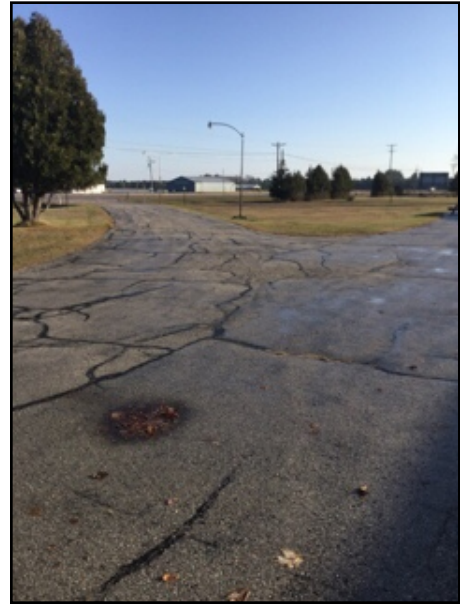
The asphalt parking lot has seen better days. There has been some repair work done to the parking lot at sometime. I suggest contacting a asphalt sealing contractor for recommendations.

1) The asphalt parking lot has seen better days. There has been some repair work done to the parking lot at sometime. I suggest contacting a asphalt sealing contractor for recommendations.

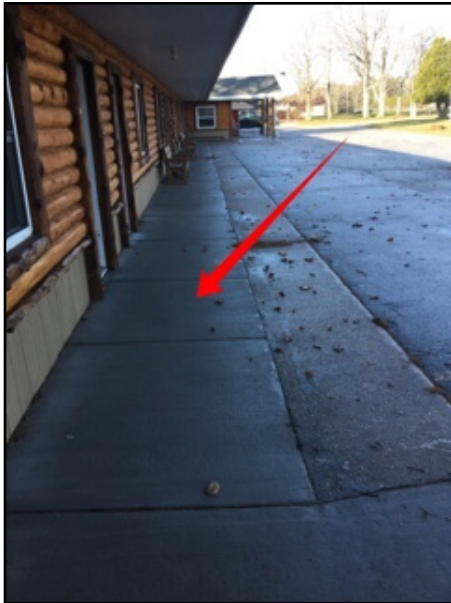
Figure 2-1

Some of the motels sidewalks have been replaced at some point .

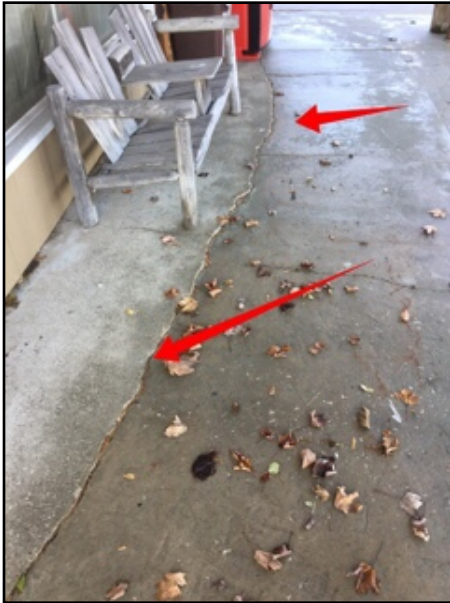
Figure 3-1

The sidewalk in front of the motel has seem settlement cracks and settling at various locations. If possible, the cracks should be sealed to keep out moisture and to prevent further deterioration.

2) The sidewalk in front of the motel has seem settlement cracks and settling at various locations. If possible, the cracks should be sealed to keep out moisture and to prevent further deterioration.

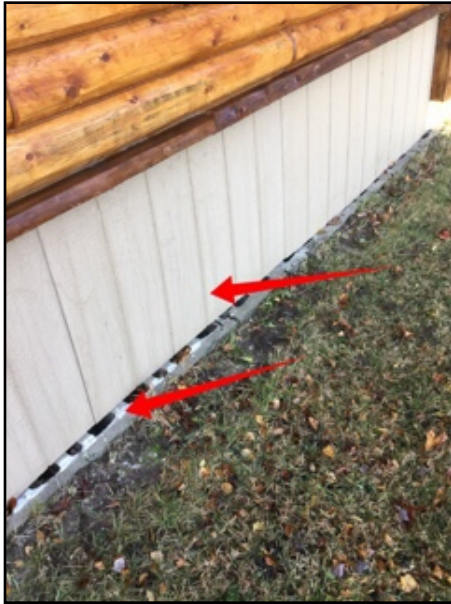
Figure 4-1

This end of the hotel is covered with t111 wood siding. It shouldn't be touching the block foundation since it will get damaged from water absorption. Also, the foundation block is open at the top exposing it to water. This is the same condition on both ends of the motel.

3) This end of the hotel is covered with t111 wood siding. It shouldn't be touching the block foundation since it will get damaged from water absorption. Also, the foundation block is open at the top exposing it to water. This is the same condition on both ends of the motel.

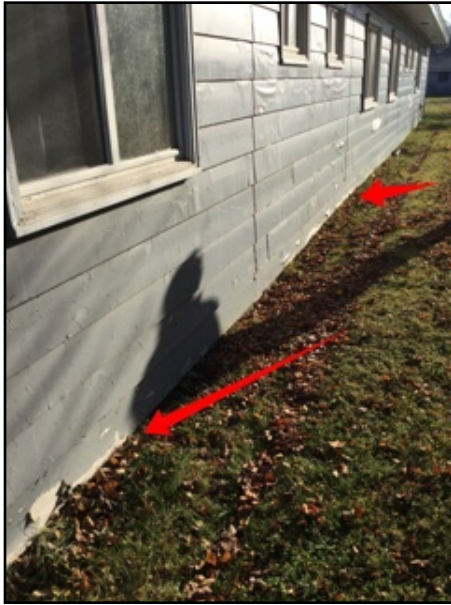
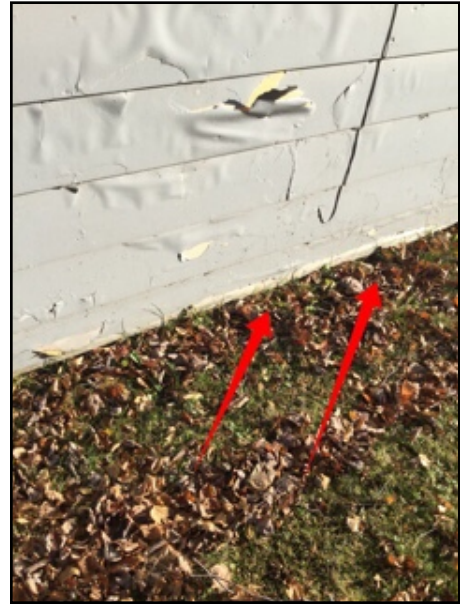
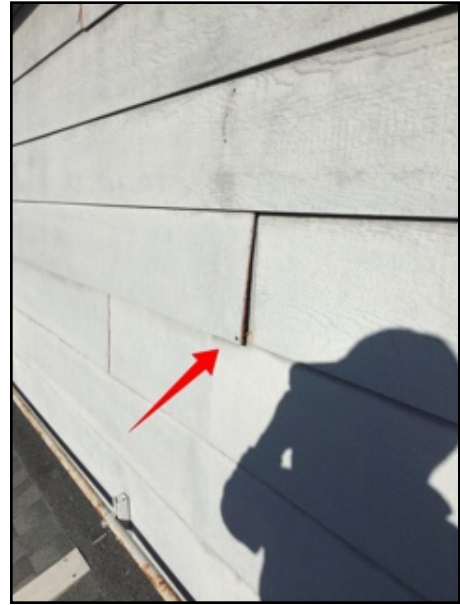
The wood lap siding is in need of painting and it's touching the ground causing water damage to start on the siding. There is also some locations that need some repair because of slight water damage and from the siding pulling away from the building.

4) The wood lap siding is in need of painting and it's touching the ground causing water damage to start on the siding. There is also some locations that need some repair because of slight water damage and from the siding pulling away from the building.

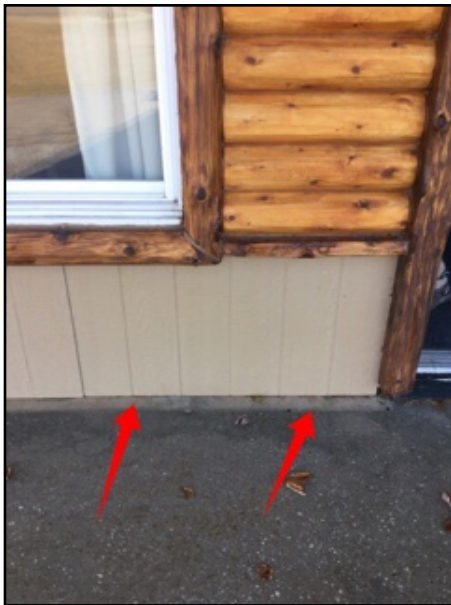
Figure 7-1

The wood t111 siding is touching the cement sidewalk. This could cause water damage over time.

6) The wood t111 siding is touching the cement sidewalk. This could cause water damage over time.

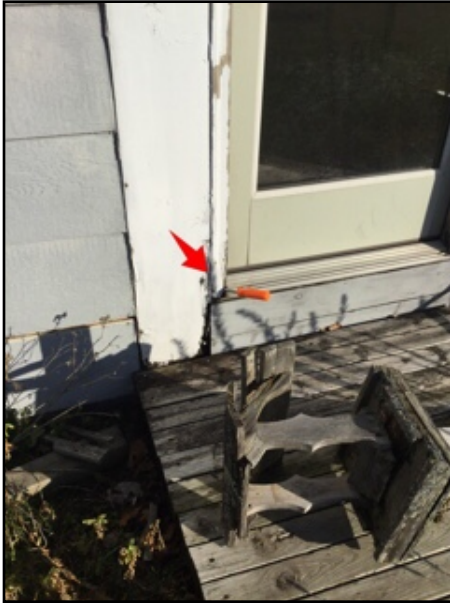
Figure 8-1

The wood trim is water damaged by the main living quarters back door.

7) The wood trim is water damaged by the main living quarters back door.

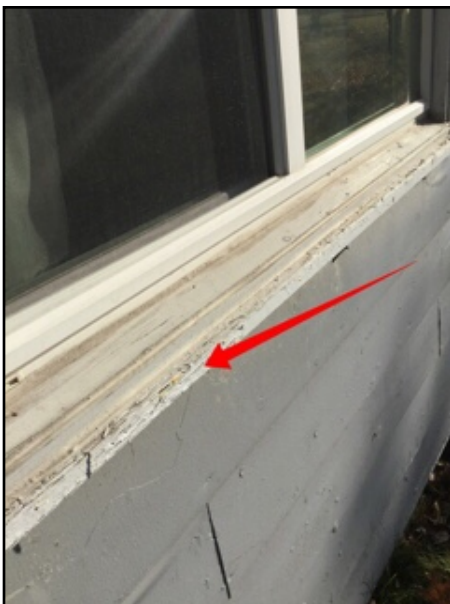
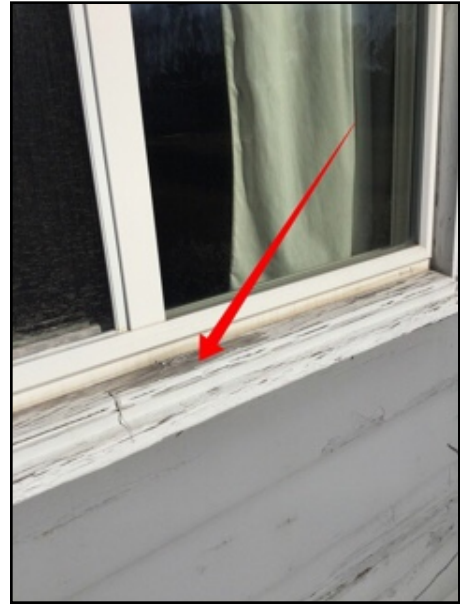
The window trim on the motel could use repainting in the near future. There is some locations that have a little water damage.

8) The window trim on the motel could use repainting in the near future. There is some locations that have a little water damage.

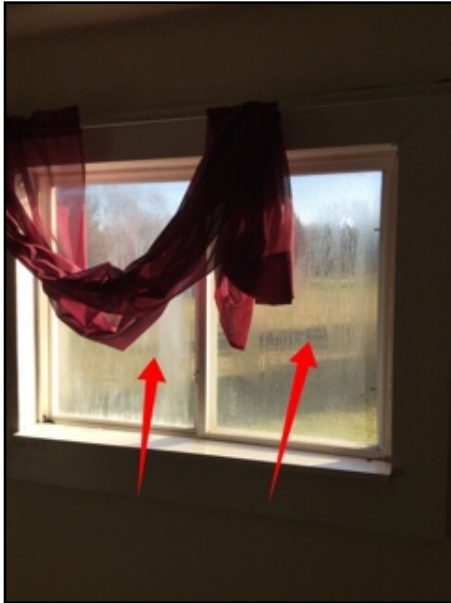
Figure 10-1

The window has lost it's seal causing a fog like appearance between the panes of glass. Replacement of the window or pane needs to be done to repair this situation.

9) The window has lost it's seal causing a fog like appearance between the panes of glass. Replacement of the window or pane needs to be done to repair this situation.

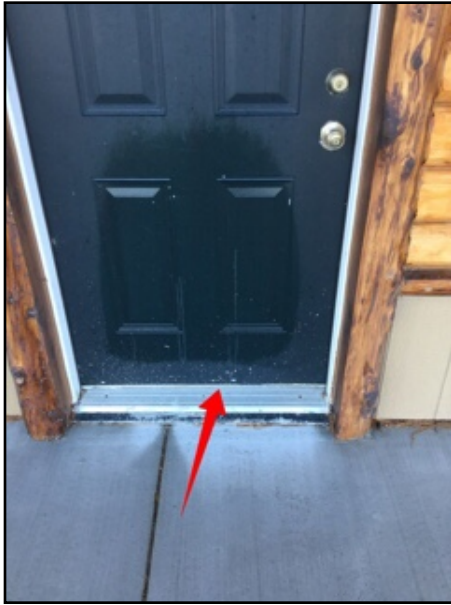
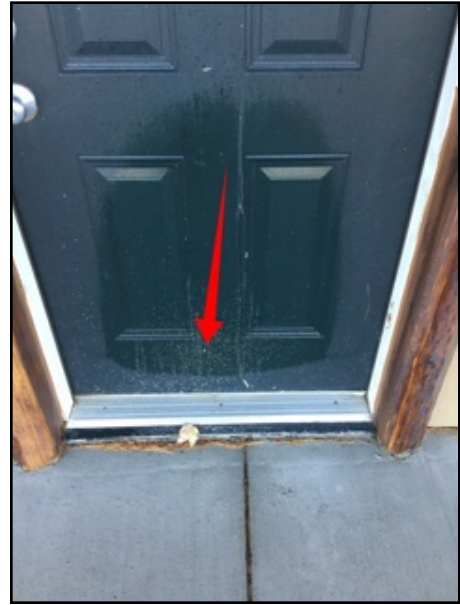
Cement splatter has stained the doors on the east end of the motel where the new sidewalk has been put in.

10) Cement splatter has stained the doors on the east end of the motel where the new sidewalk has been put in.

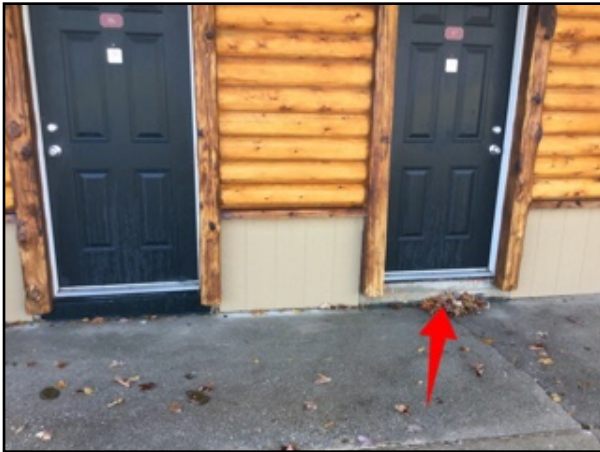
Figure 12-1

Room 17 is missing its kick plate beneath the door.

11) Room 17 is missing its kick plate beneath the door.

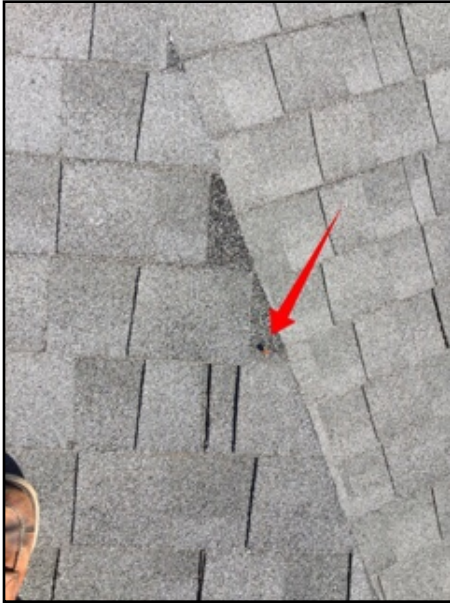
Figure 14-1

The roof had some nail pops that should be repaired with a sealer.

13) The roof had some nail pops that should be repaired with a sealer.

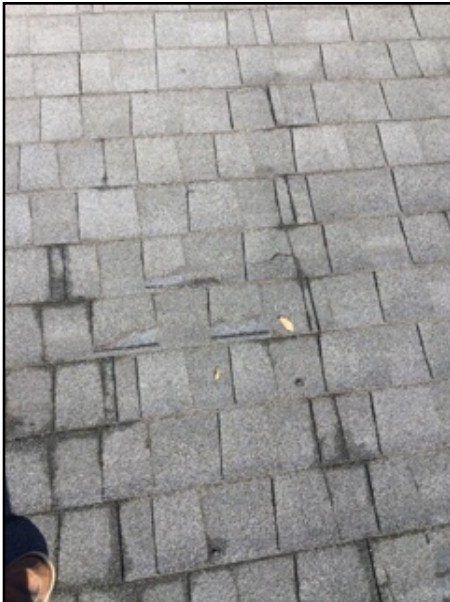
Figure 15-1

The roof over the main kitchen area has some damage from snow shoveling. We did not see any water intrusion at the time of the inspection.

14) The roof over the main kitchen area has some damage from snow shoveling. We did not see any water intrusion at the time of the inspection.

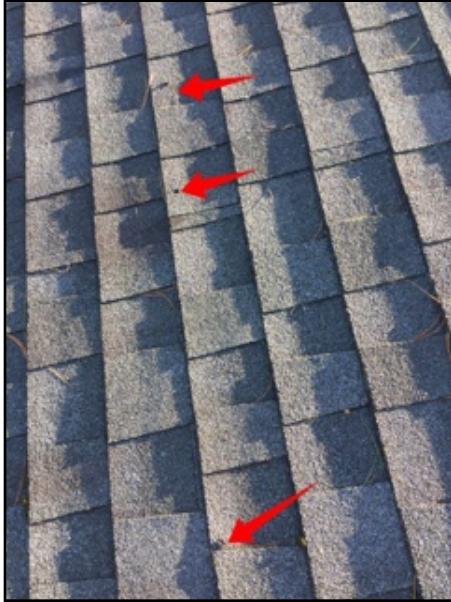
Figure 17-1

The roof covering was found to be in good general condition, with no major damage or deterioration but there were some blemishes.

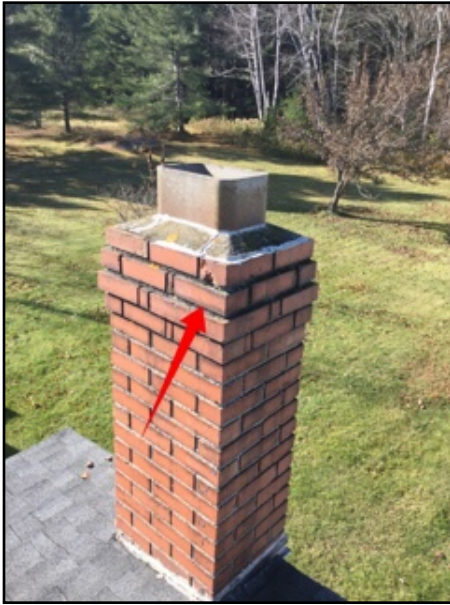
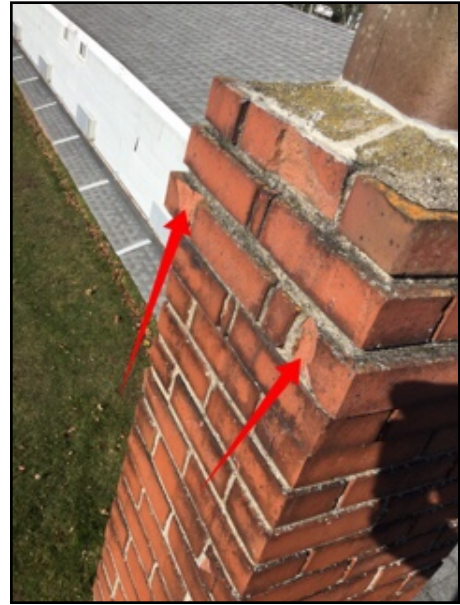
The chimney's brick has some Spauling that has occurred that's damaged the bricks. This occurs when water gets into cracks and then freezes causing the bricks to come apart. The cracks in the chimney and cap should be sealed to prevent moisture from seeping in.

16) The chimney's brick has some Spauling that has occurred that's damaged the bricks. This occurs when water gets into cracks and then freezes causing the bricks to come apart. The cracks in the chimney and cap should be sealed to prevent moisture from seeping in.

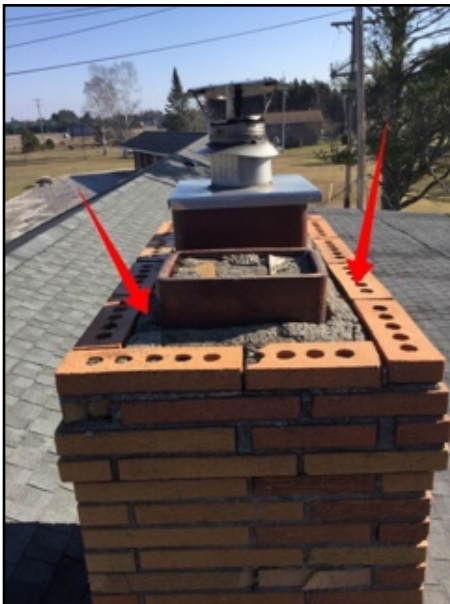
Figure 20-1

The chimney's brick has some Spauling that has occurred that's damaged the bricks. This occurs when water gets into cracks and then freezes causing the bricks to come apart. The cracks in the chimney and cap should be sealed to prevent moisture from seeping in.

17) The chimney's brick has some Spauling that has occurred that's damaged the bricks. This occurs when water gets into cracks and then freezes causing the bricks to come apart. The cracks in the chimney and cap should be sealed to prevent moisture from seeping in.

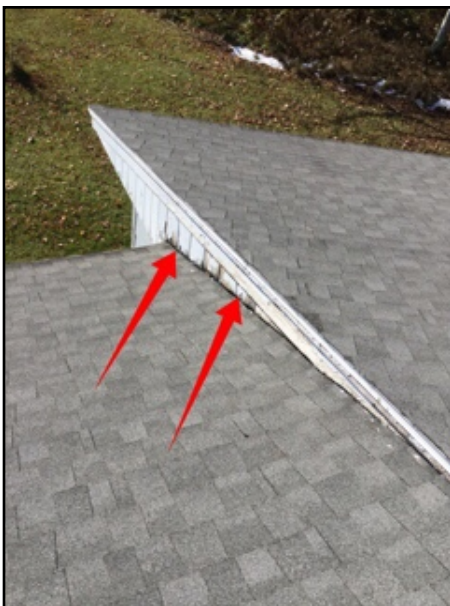
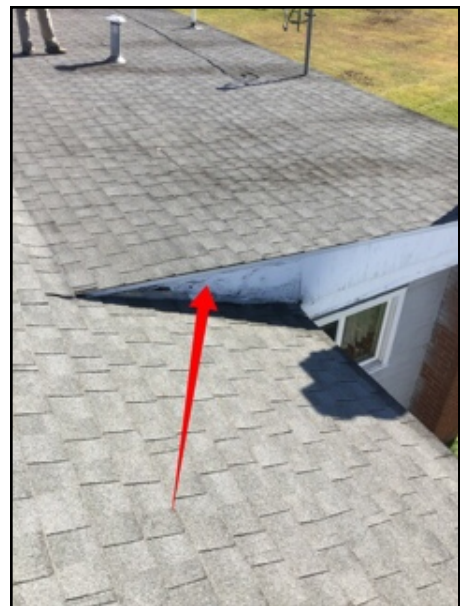
These areas on the roof are water damaged and should be metal flashed.

18) These areas on the roof are water damaged and should be metal flashed.

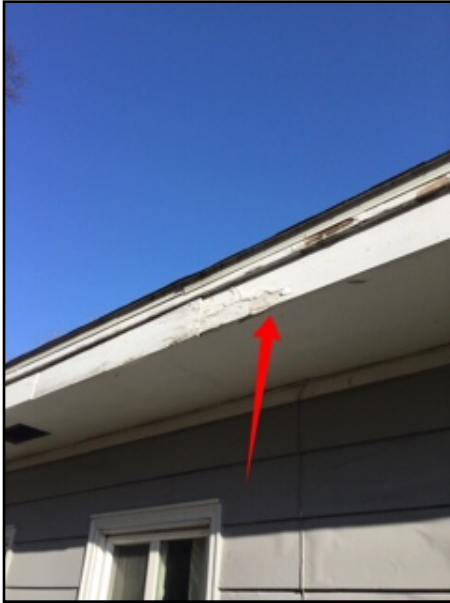
Figure 23-1

The wood soffit and fascia is in need of paint and repair.

19) The wood soffit and fascia is in need of paint and repair.

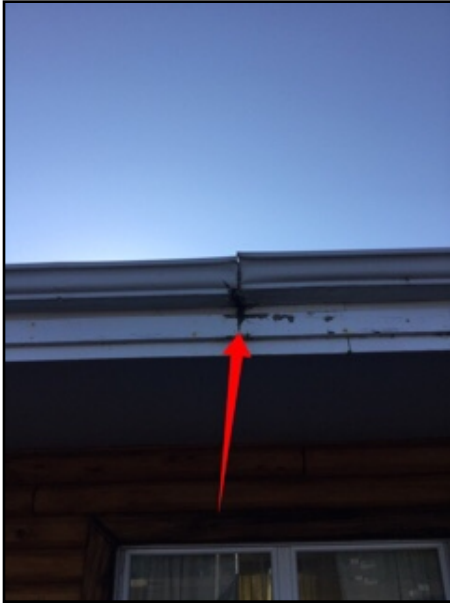
Figure 25-1

Gutter joints are leaking and rotting the fascia board at various locations.

21) Gutter joints are leaking and rotting the fascia board at various locations.

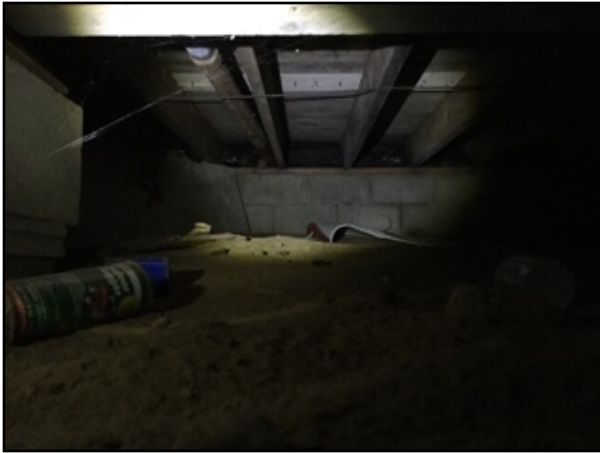
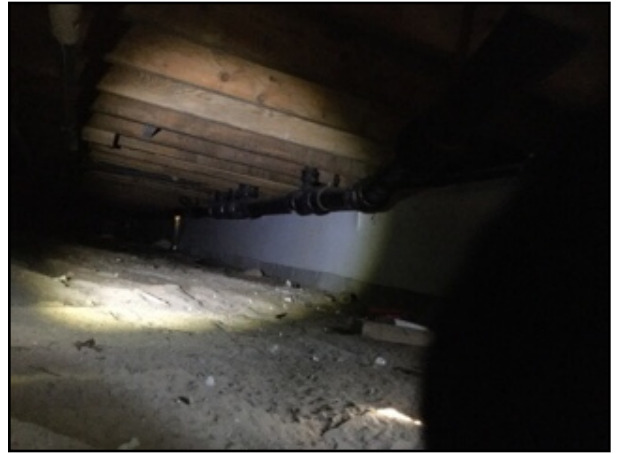
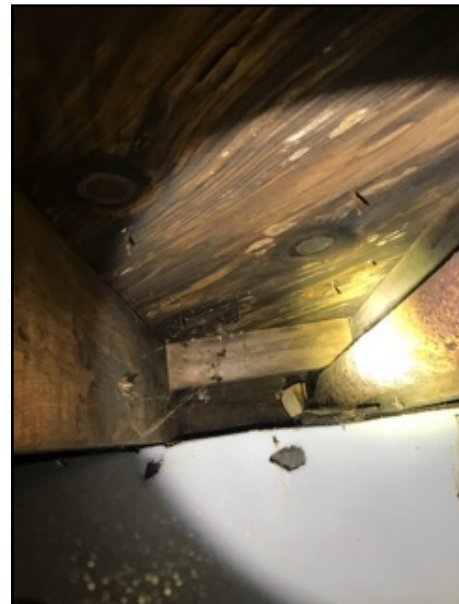
The sill plate is damaged from water intrusion at the east end/front of the building where an old drain pipe is located. This pipe is rusted through and no longer in use. Both ends of the building have a pipe like this with similar problems except the west ends sill plate is not damaged as bad the red arrows show the area where the sill plate is damaged.

23) The sill plate is damaged from water intrusion at the east end/front of the building where an old drain pipe is located. This pipe is rusted through and no longer in use. Both ends of the building have a pipe like this with similar problems except the west end's sill plate is not damaged as bad the red arrows show the area where the sill plate is damaged.

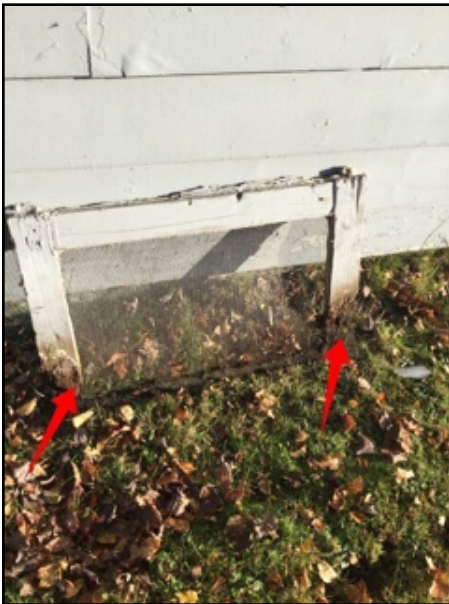
Figure 29-1

This crawl space screen framing has severe water damage.

24) This crawl space screen framing has severe water damage.

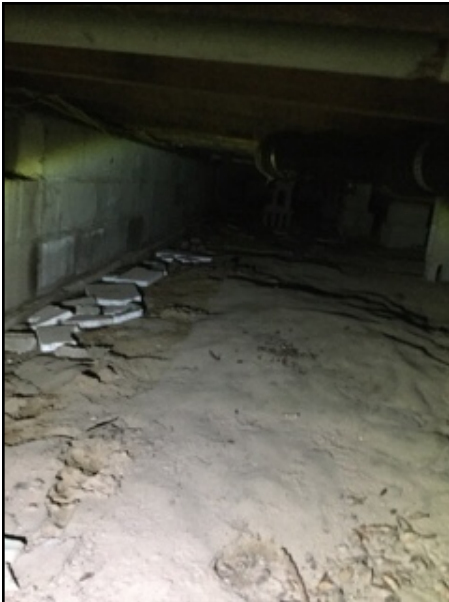
Figure 32-1

East end crawl space area was in good dry condition at the time of inspection.

26) East end crawl space area was in good dry condition at the time of inspection.

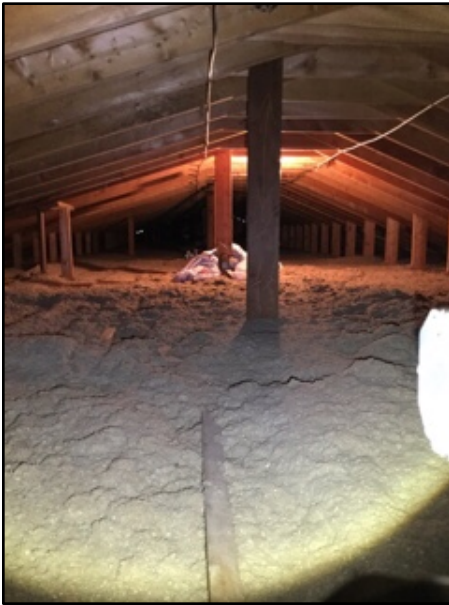
Figure 33-1

No visible issues found in the attic areas, venting and insulation was present. The blown cellulose insulation could be added too.

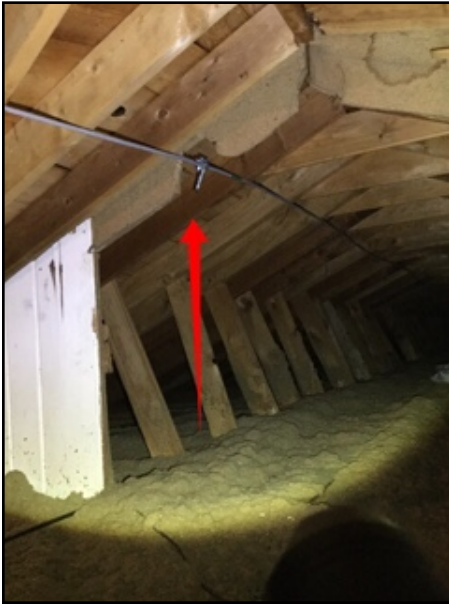
Figure 34-1

It appears the attic area may have a sprinkler system in place. The condition of this system was not tested.

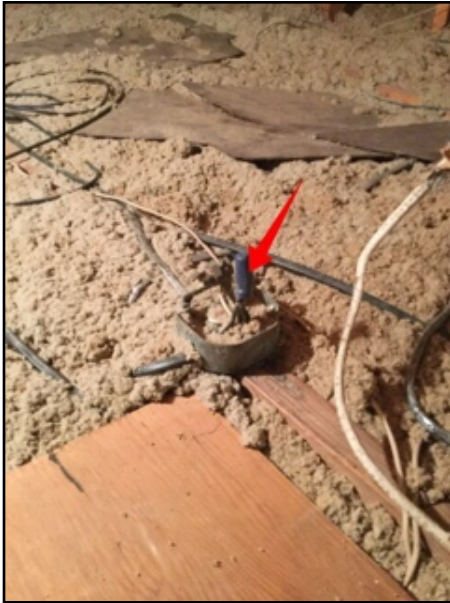
Figure 39-1

There were wires in the attic that are terminated but not in a sealed junction box. An electrician could review and make repairs.

29) There were wires in the attic that are terminated but not in a sealed junction box. An electrician could review and make repairs.

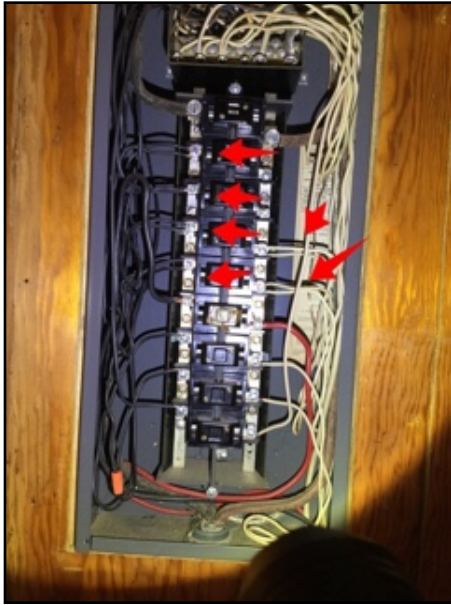
Figure 41-1

The branch circuits are double tapped at a breaker. This is done when no room is available in an electrical panel to add a line so a breaker is double tapped to avoid having a sub panel or new panel installed to accommodate additional breakers. An electrician could review and make recommendations.

30) The branch circuits are double tapped at a breaker. This is done when no room is available in an electrical panel to add a line so a breaker is double tapped to avoid having a sub panel or new panel installed to accommodate additional breakers. An electrician could review and make recommendations.

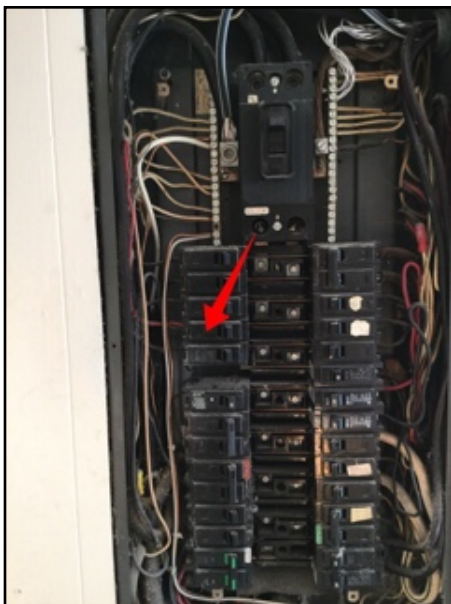
Figure 42-1

The branch circuits are double tapped at a breaker. This is done when no room is available in an electrical panel to add a line so a breaker is double tapped to avoid having a sub panel or new panel installed to accommodate additional breakers. An electrician could review and make recommendations. Laundry room area breaker

31) The branch circuits are double tapped at a breaker. This is done when no room is available in an electrical panel to add a line so a breaker is double tapped to avoid having a sub panel or new panel installed to accommodate additional breakers. An electrician could review and make recommendations. Laundry room area breaker

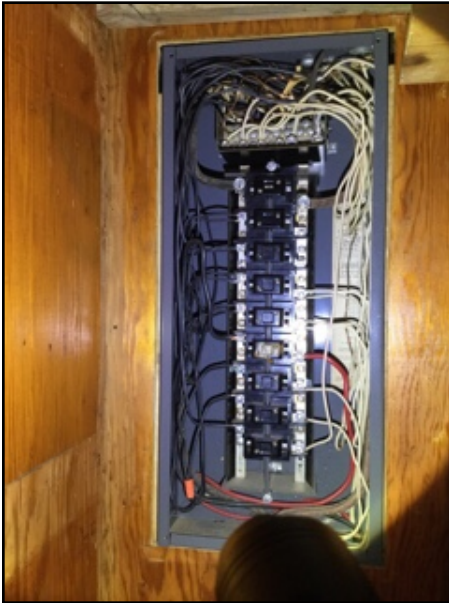
Figure 45-1

Main house electrical panel was in good condition except for some double tapped breakers. I'm not sure why the motel has so many non-grounded outlets in the motel and an electrician could review and make recommendations.

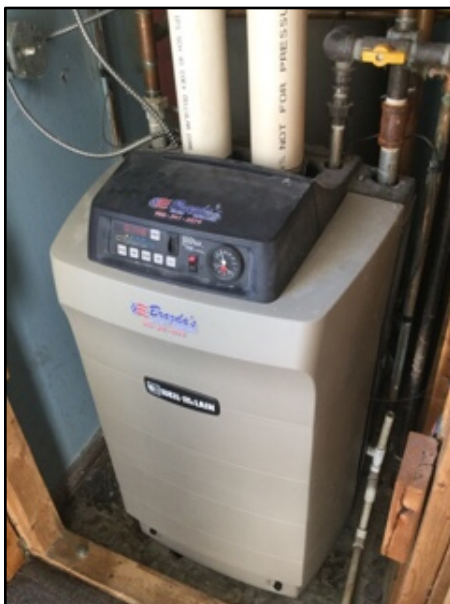
Figure 47-1

I always recommend an HVAC technician come and perform a clean and tune on all furnace units and boilers, This will allow for a complete inspection of heat exchanger and other internal components of the heater I am not able to inspect. Sometimes there are rebates from your gas company for this service which almost covers the cost of the inspection. This function should be performed regularly on your homes heating system. The unit was operating as designed at the time of the inspection and appears to be in good general condition.

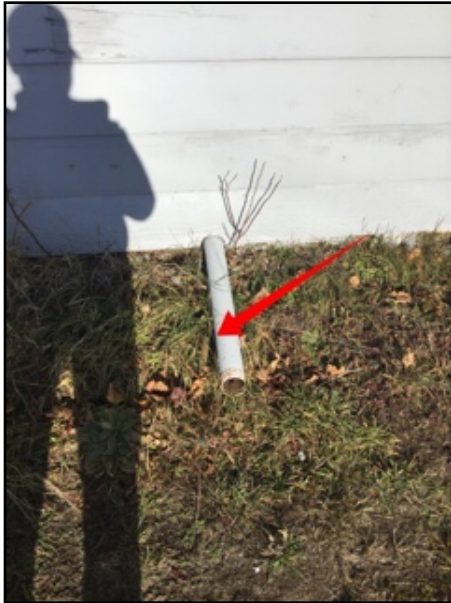
Figure 48-1

These two pipes are drains from the front of the building. There is water damage on the North side of the building where this pipe come through the sill plate.

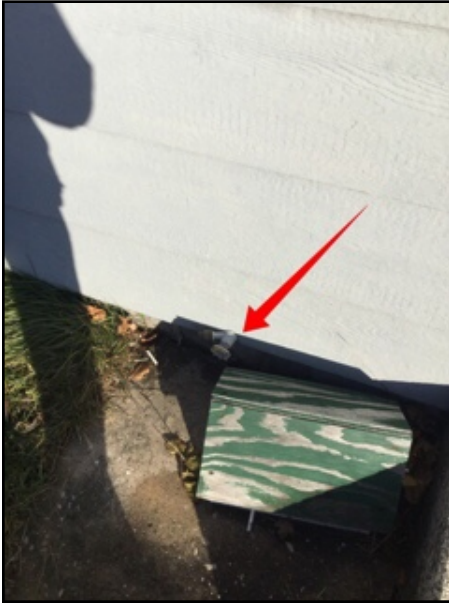
Figure 49-1

This water valve is leaking behind the wall.

33) This water valve is leaking behind the wall.

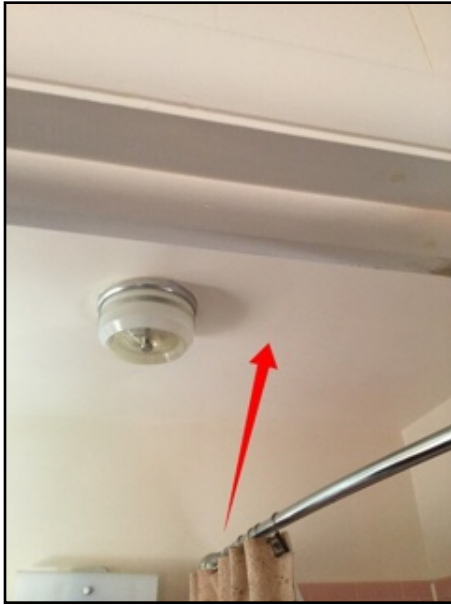
Figure 53-1

A bathroom venting fan is recommend in a shower equipped bathroom. This is missing in this bathroom. The window will work but the a ceiling or wall fan is recommended.

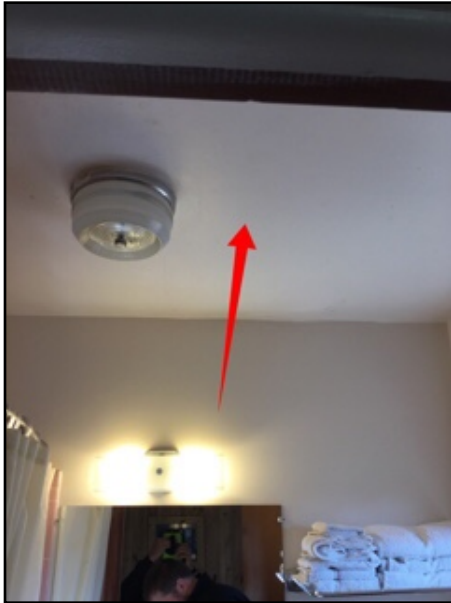
Figure 55-1

A bathroom venting fan is recommend in a shower equipped bathroom. This is missing in this bathroom. The window will work but the a ceiling or wall fan is recommended.

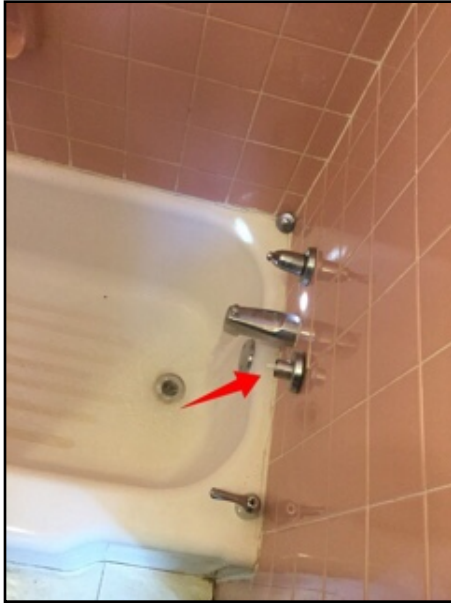
Figure 58-1

Comment 58:
Missing faucet handle.

38) Missing faucet handle.

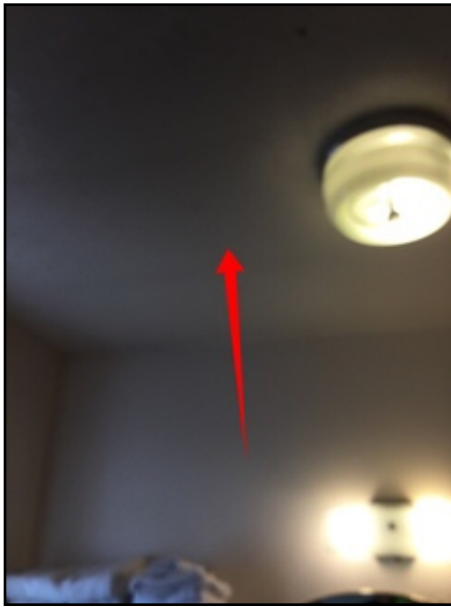
Figure 59-1

Comment 59:
A bathroom venting fan is recommend in a shower equipped bathroom. This is missing in this bathroom. The window will work but the a ceiling or wall fan is recommended.

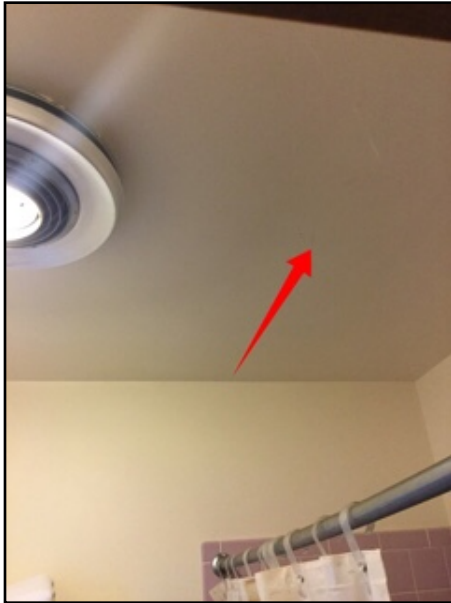
Figure 62-1

A bathroom venting fan is recommend in a shower equipped bathroom. This is missing in this bathroom. The window will work but the a ceiling or wall fan is recommended.

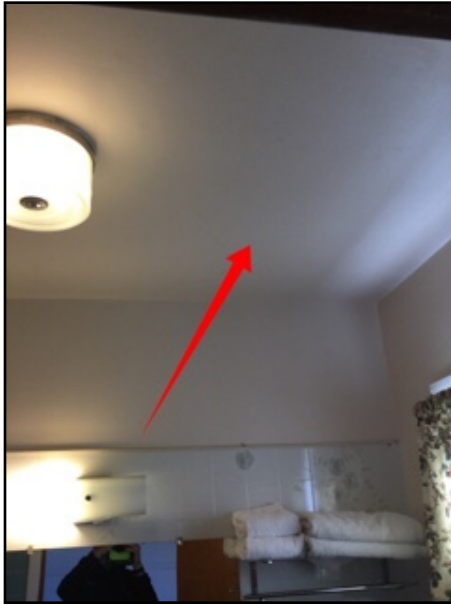
Figure 64-1

A bathroom venting fan is recommend in a shower equipped bathroom. This is missing in this bathroom. The window will work but the a ceiling or wall fan is recommended.

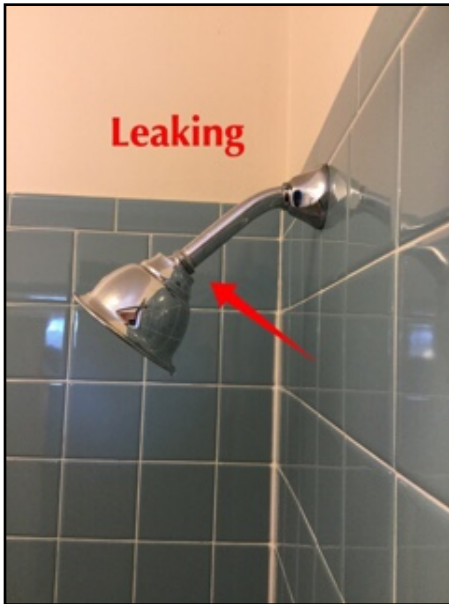
Figure 66-1

Comment 66:
The faucet head was leaking.

43) The faucet head was leaking.

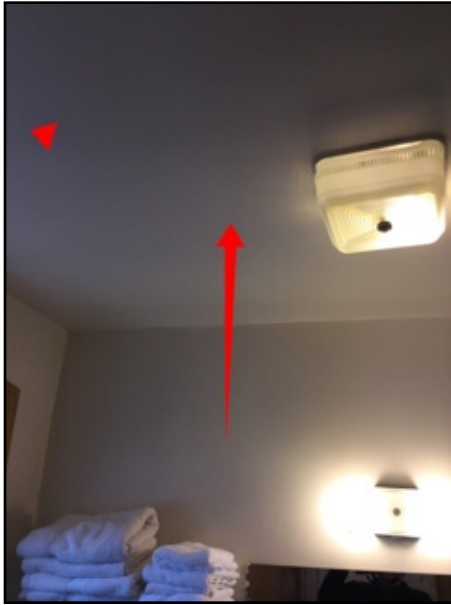
Figure 67-1

Comment 67:
A bathroom venting fan is recommend in a shower equipped bathroom. This is missing in this bathroom. The window will work but the a ceiling or wall fan is recommended.

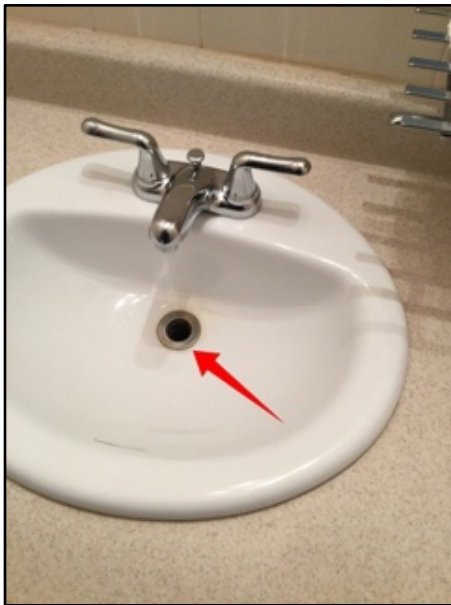
Figure 71-1

Comment 71:
The drain stop is missing from the sink.

47) The drain stop is missing from the sink.

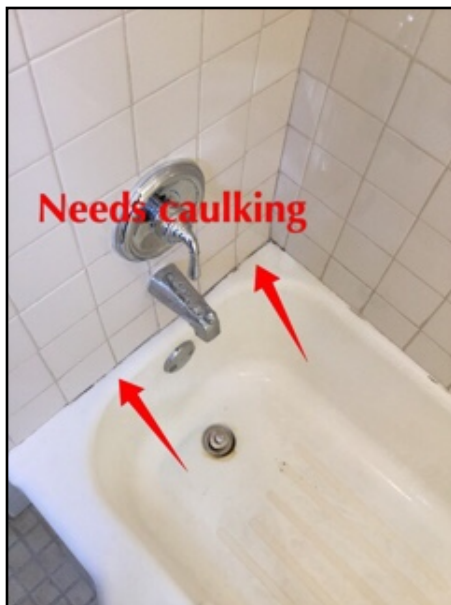
Figure 72-1

The caulk around the tub could use some repair.

48) The caulk around the tub could use some repair.

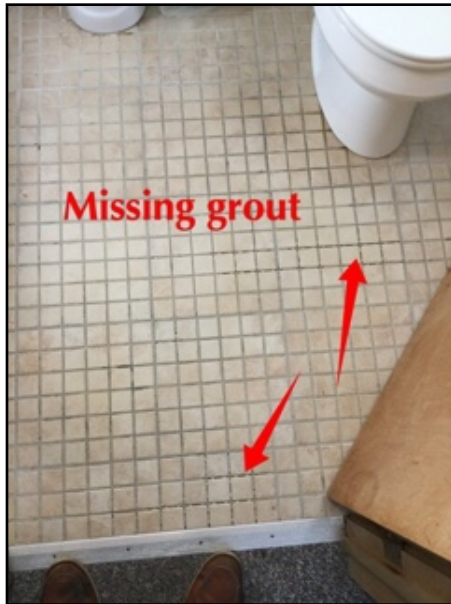
Figure 73-1

The grout in the floor was missing at several locations.

49) The grout in the floor was missing at several locations.

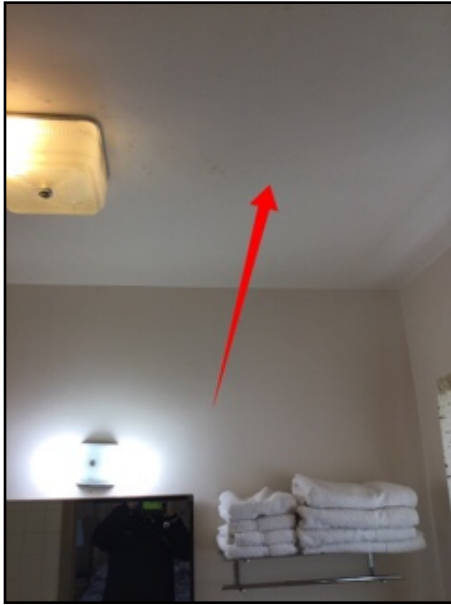
Figure 74-1

A bathroom venting fan is recommend in a shower equipped bathroom. This is missing in this bathroom. The window will work but the a ceiling or wall fan is recommended.

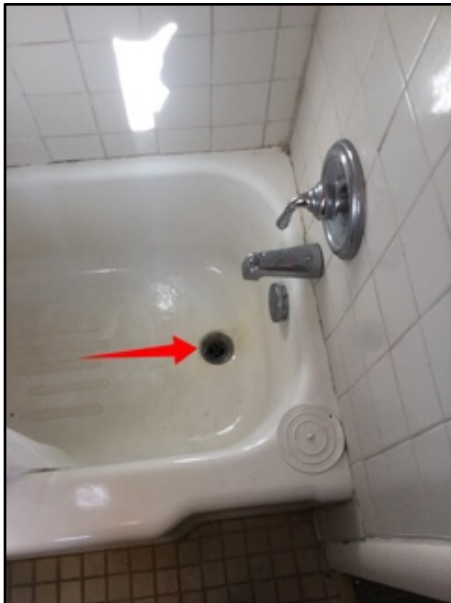
Figure 76-1

Comment 76:
The drain stop is missing from the tub.

51) The drain stop is missing from the tub.

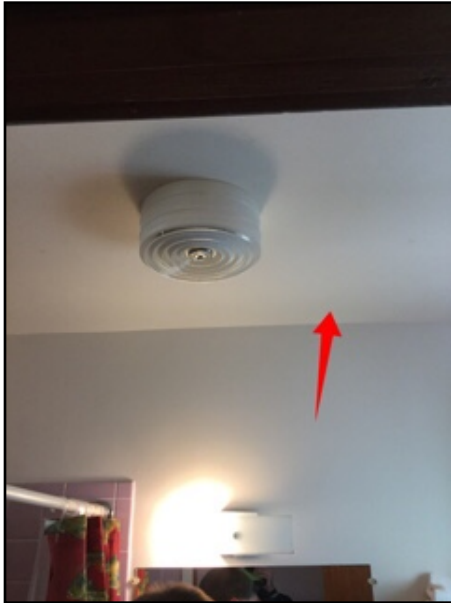
Figure 82-1

A bathroom venting fan is recommend in a shower equipped bathroom. This is missing in this bathroom. The window will work but the a ceiling or wall fan is recommended.

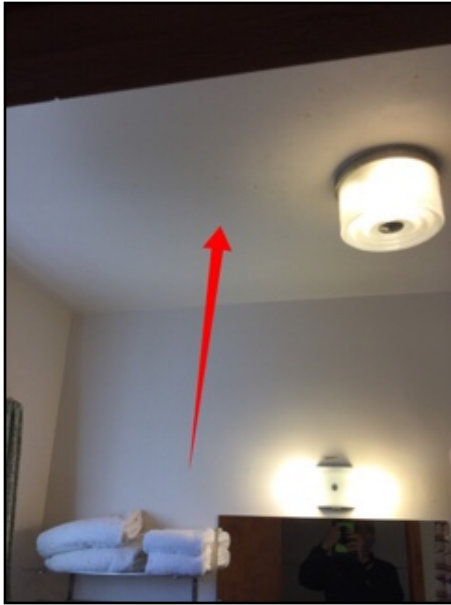
Figure 84-1

A bathroom venting fan is recommend in a shower equipped bathroom. This is missing in this bathroom. The window will work but the a ceiling or wall fan is recommended.

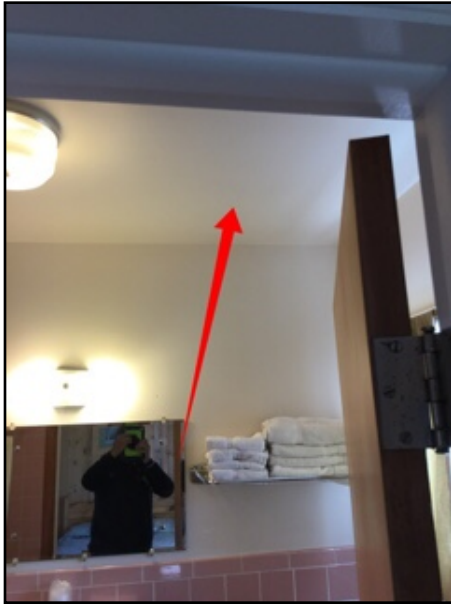
Figure 88-1

Comment 88:
A bathroom venting fan is recommend in a shower equipped bathroom. This is missing in this bathroom. The window will work but the a ceiling or wall fan is recommended.

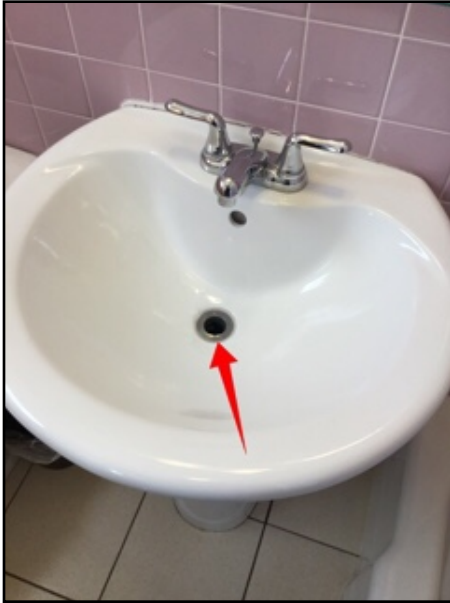
Figure 91-1

The drain stop is missing from the sink and the sink drains slowly.

62) The drain stop is missing from the sink and the sink drains slowly.

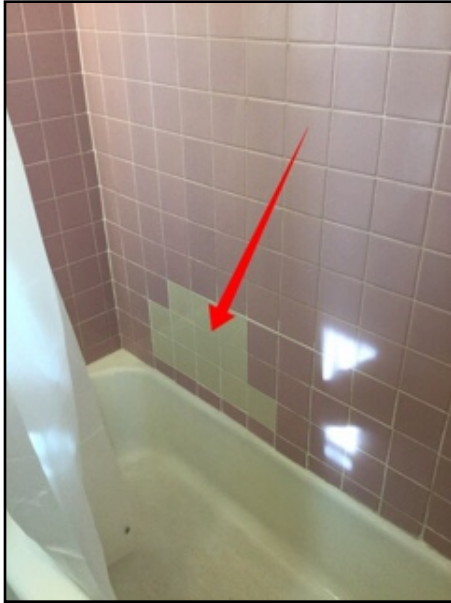
Figure 92-1

Some repair work was done to the shower wall.

63) Some repair work was done to the shower wall.

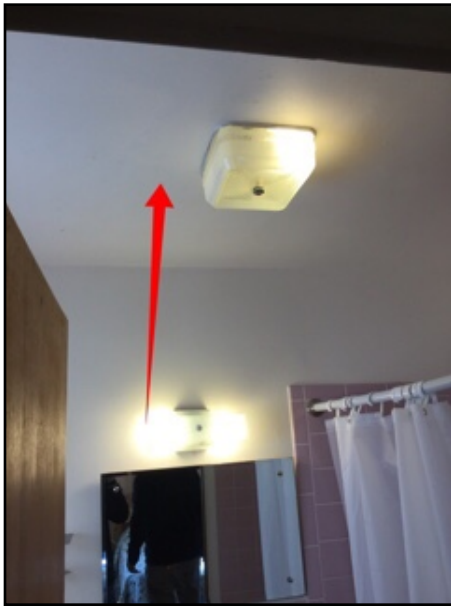
Figure 93-1

A bathroom venting fan is recommend in a shower equipped bathroom. This is missing in this bathroom. The window will work but the a ceiling or wall fan is recommended.

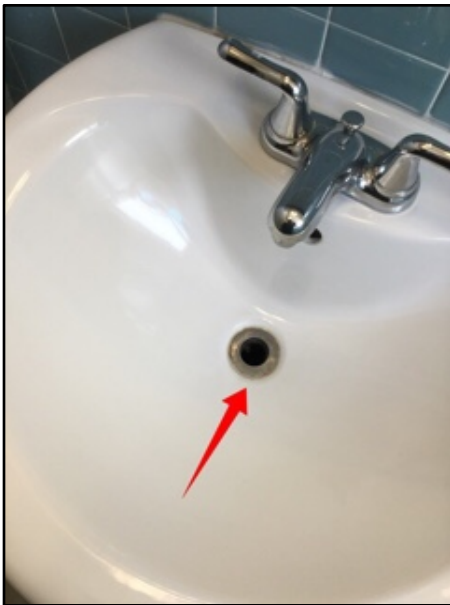
Figure 95-1

The drain stop is missing from the sink.

65) The drain stop is missing from the sink.

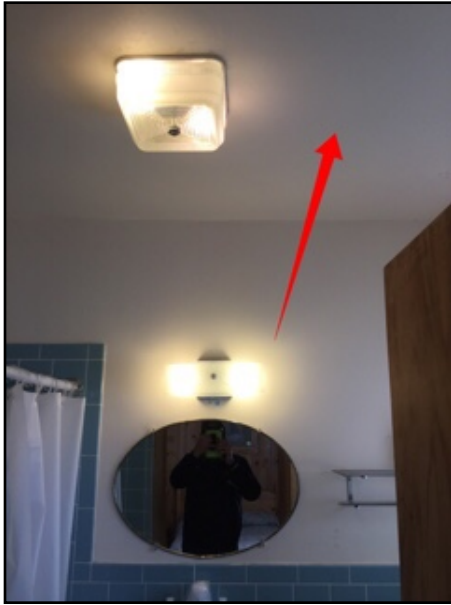
Figure 97-1

A bathroom venting fan is recommend in a shower equipped bathroom. This is missing in this bathroom. The window will work but the a ceiling or wall fan is recommended.

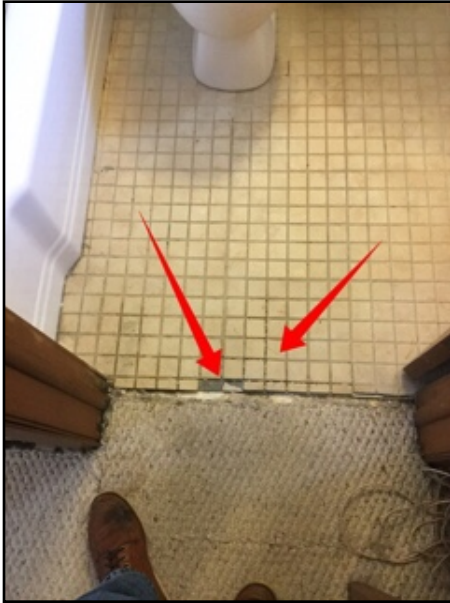
Figure 100-1

The tile floor had some damage at the time of inspection.

68) The tile floor had some damage at the time of inspection.

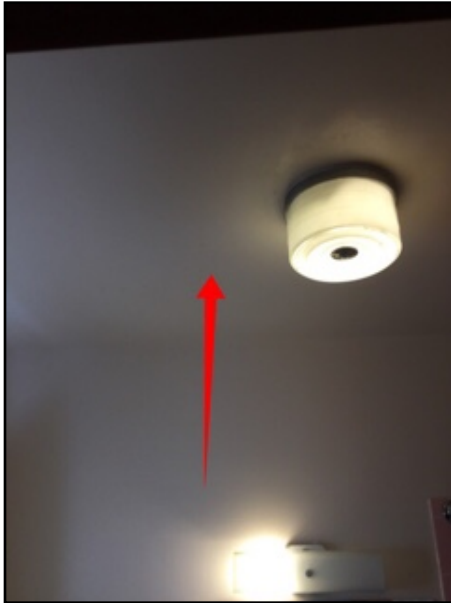
Figure 103-1

A bathroom venting fan is recommend in a shower equipped bathroom. This is missing in this bathroom. The window will work but the a ceiling or wall fan is recommended.

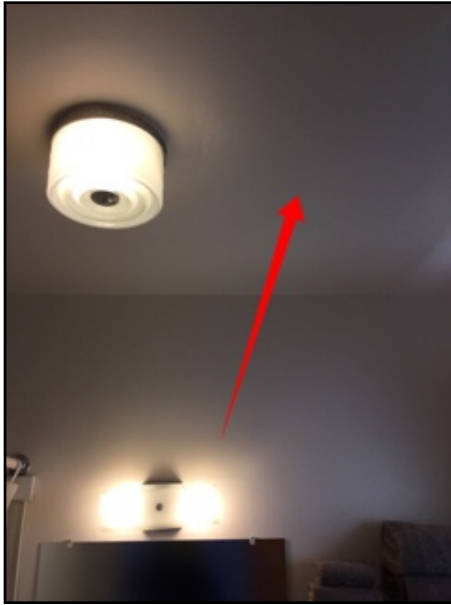
Figure 107-1

A bathroom venting fan is recommend in a shower equipped bathroom. This is missing in this bathroom. The window will work but the a ceiling or wall fan is recommended.

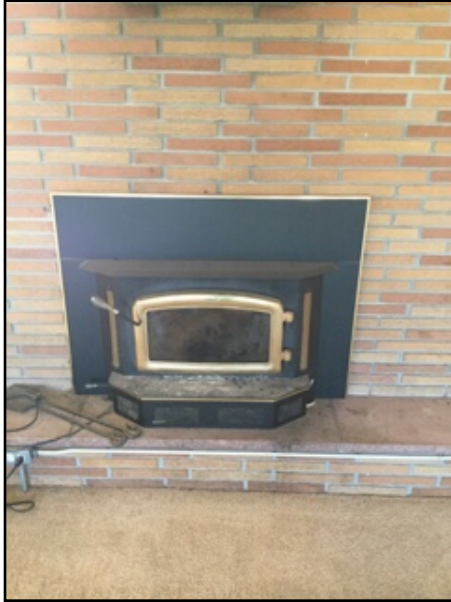
Figure 114-1

Wood stove chimneys need to be regularly cleaned due to creosote buildup, cleaning is always recommended before 1st. use,

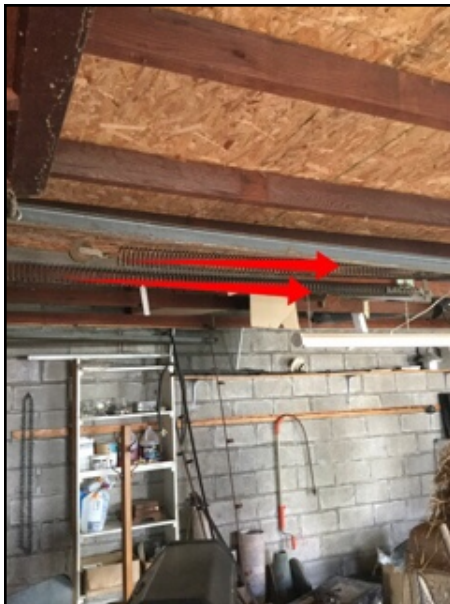
Figure 136-1

The springs for the overhead garage door do not have a safety cable running through them. This cable would prevent damage or injury should the springs ever break.

77) The springs for the overhead garage door do not have a safety cable running through them. This cable would prevent damage or injury should the springs ever break.
