# Home Evaluation Services

## Home Inspection Report

Sample Report 100+ Year Old Home

Inspected on Tue, Aug 4 2020 at 12:00 PM

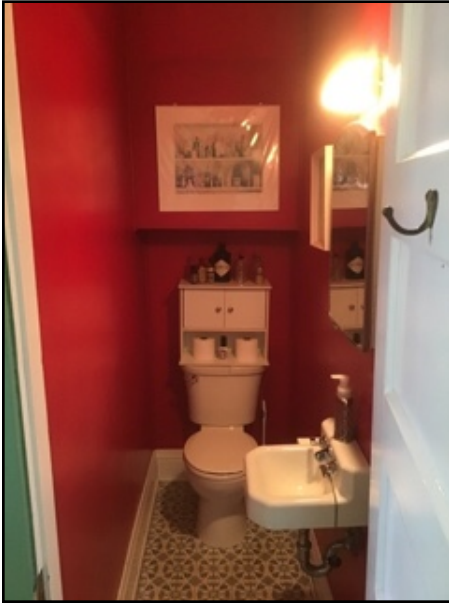
Figure 22-1

The main floor 1/2 bathroom is #1.

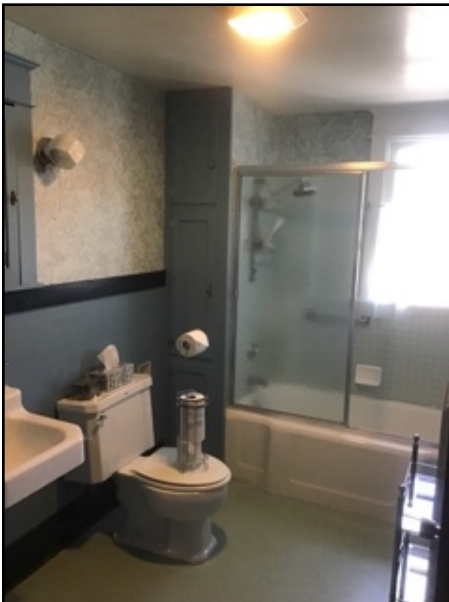
Figure 25-1

Comment 25:  
The upper hallway bathroom is #2.

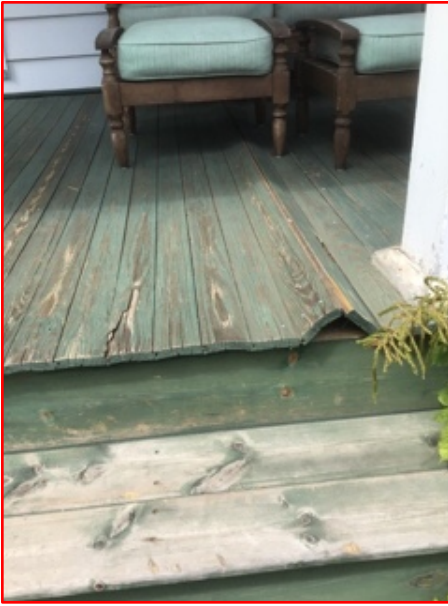
Figure 1-1

- 1) The front porch will need repair, lifting boards and loose peeling paint .

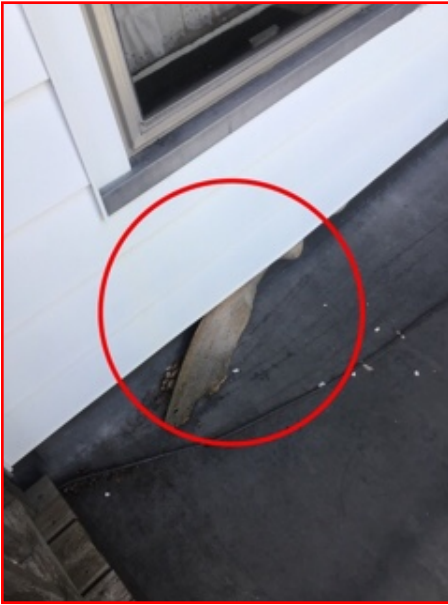
Figure 3-1

- 2) The loose hanging backing material at the siding by the upper back roof will need repair, ( sealing this area is also recommended .

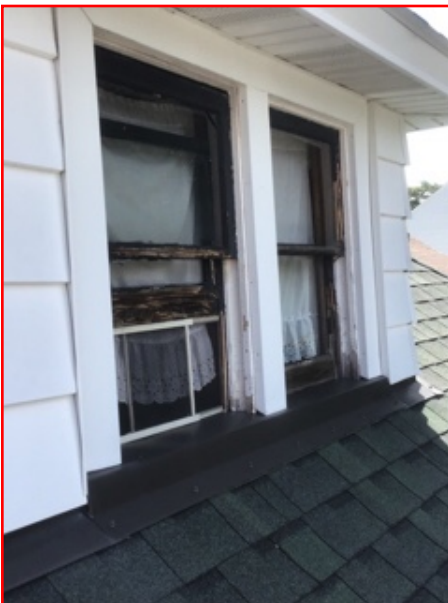
Figure 4-1

3) The back windows in the attic area are in poor condition, these will need repair or replacement .

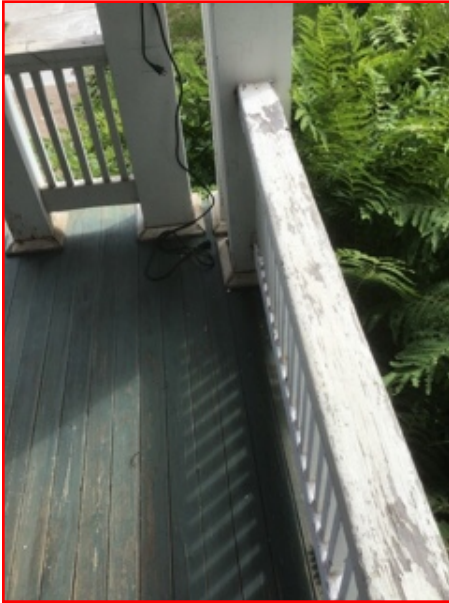
Figure 5-1

4) This photo shows a sample of the loose peeling paint .

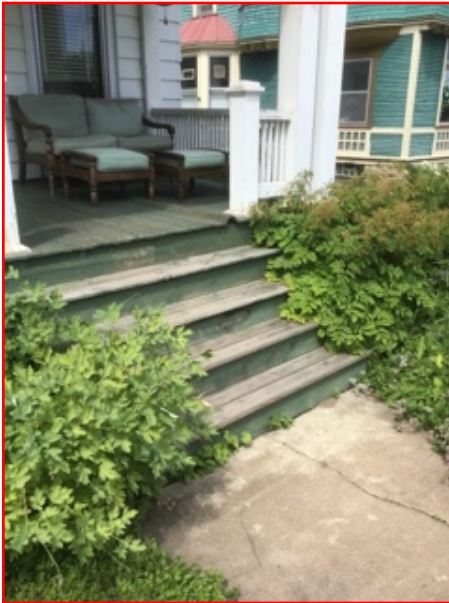
Figure 6-1

5) Safety hand railings are recommended at all stairways with 3 treads or more, also most insurance providers will require them. this safety item was missing at the front stairway,

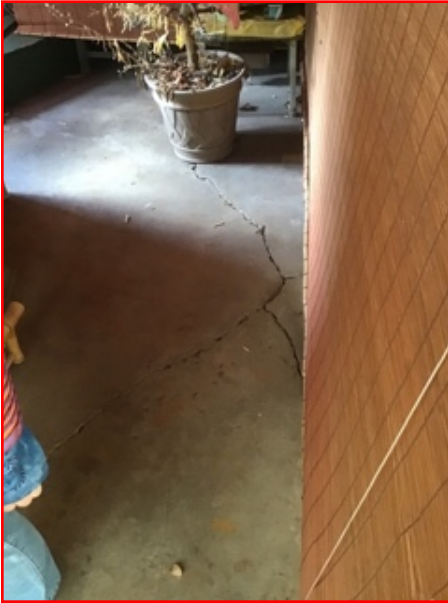
Figure 8-1

6) Some floor cracks are present, but the foundation was stable .

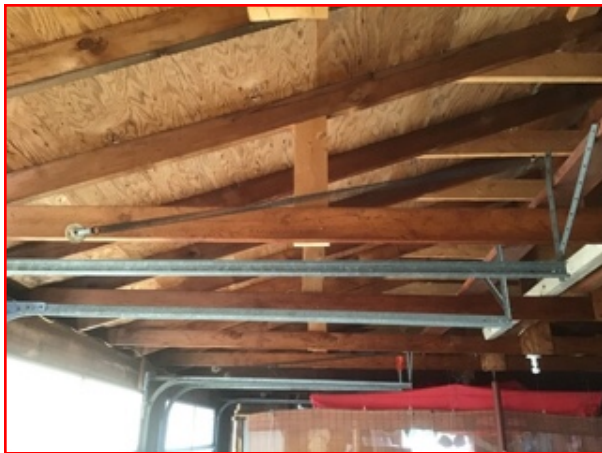
7) Garage door springs should have a safety cable running through them., also the spring system was broken on the center door,

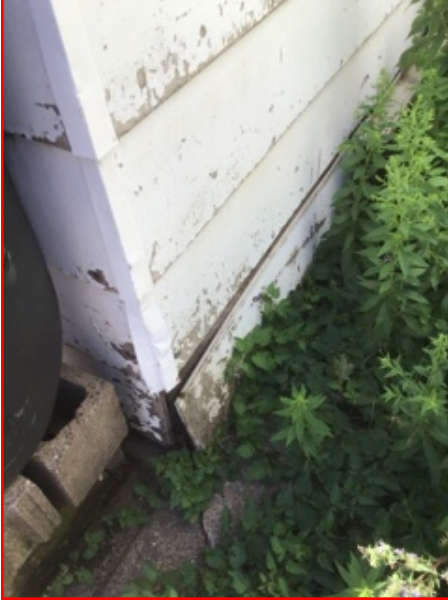
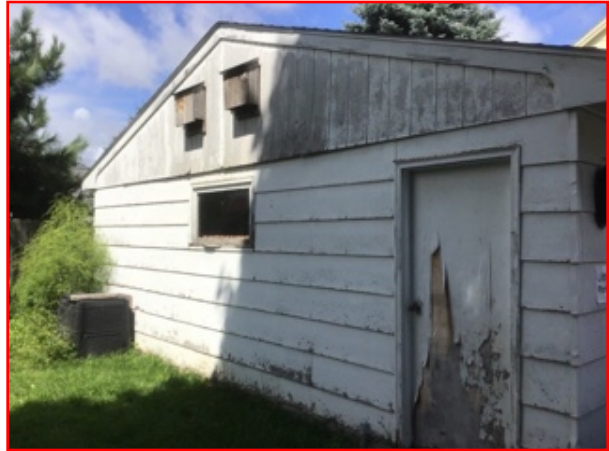
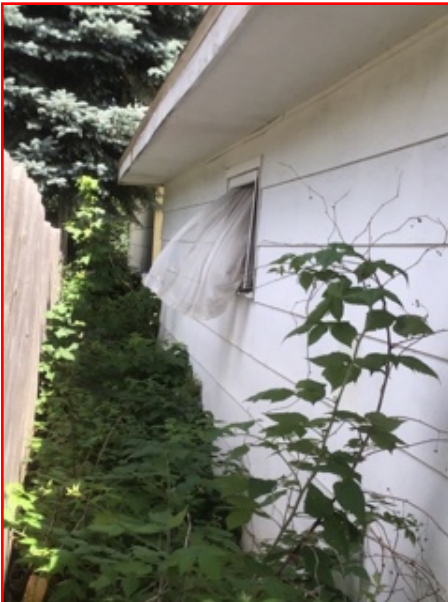
8) The siding on this building was in poor condition, also note the back window was broken .

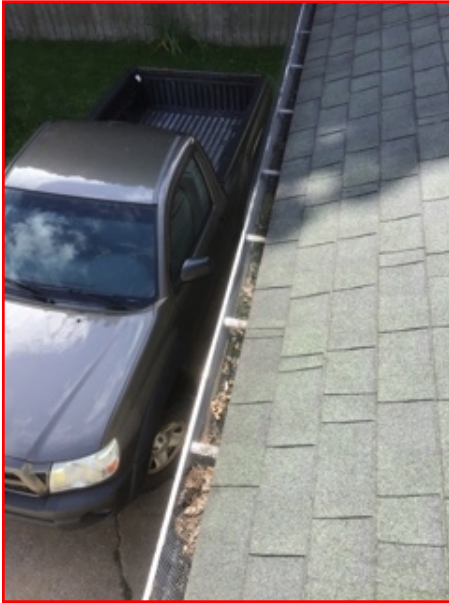
Figure 15-1

9) Only on the garage, these do need cleaning .

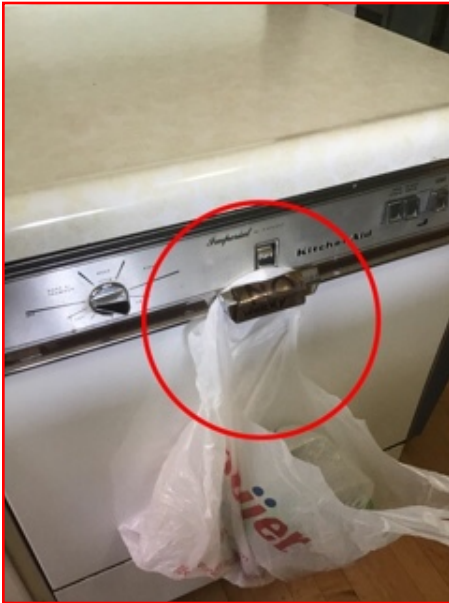
Figure 19-1

10) This unit was not working at time of inspection .

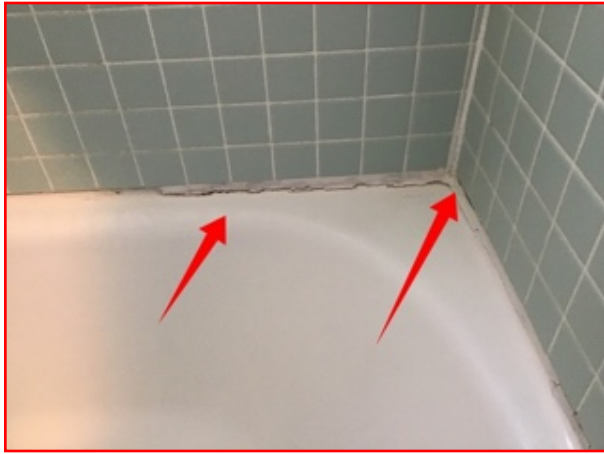
Figure 23-1

11) The tub shower was in good condition, but needs new sealing around the base.

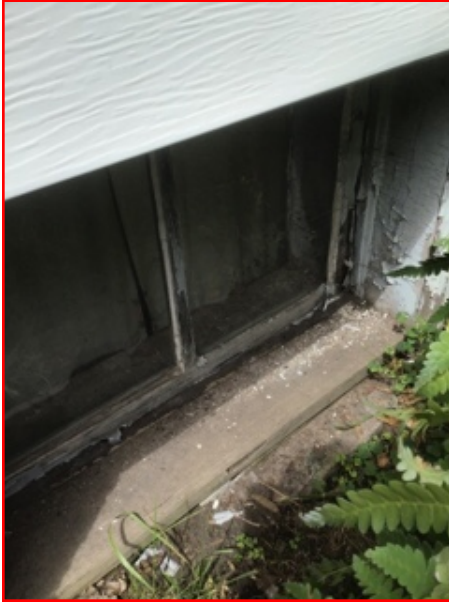
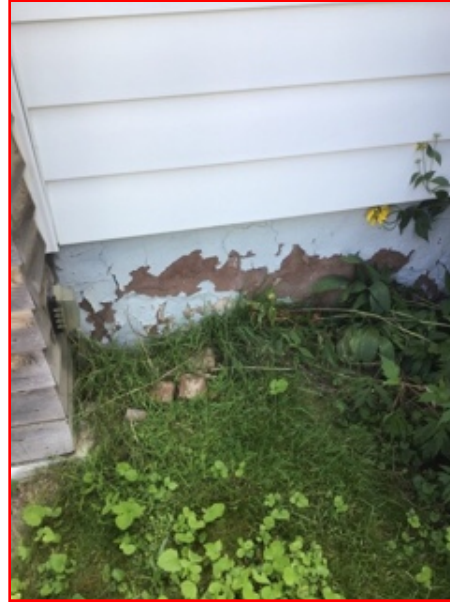
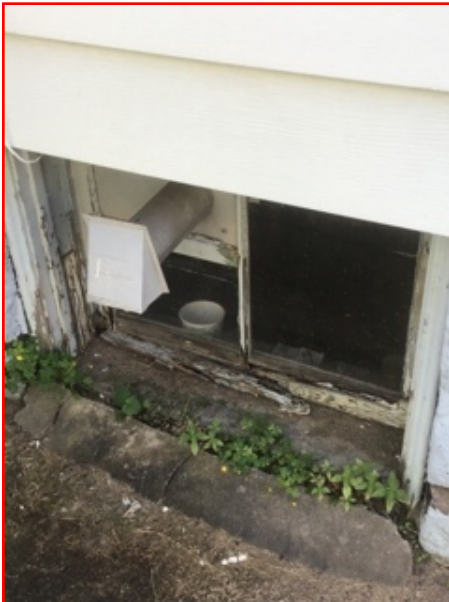
13) The basement wood window units are in poor condition, the exterior foundation paint was peeling, these items should be taken care of .

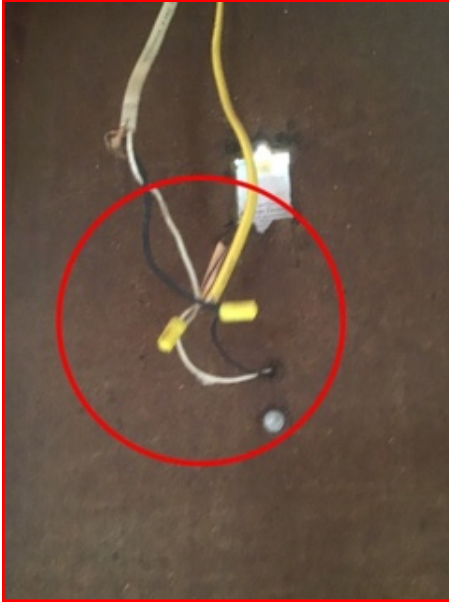
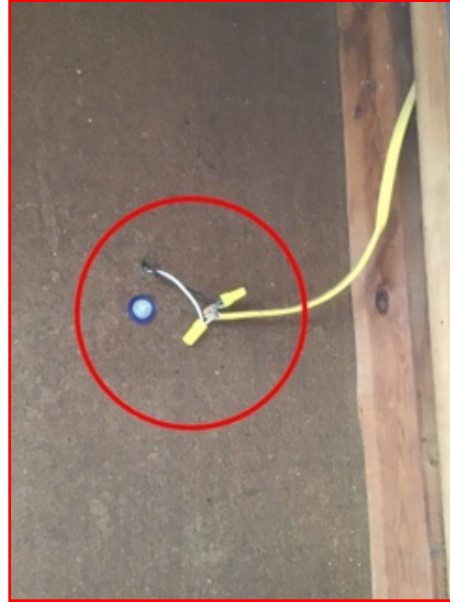
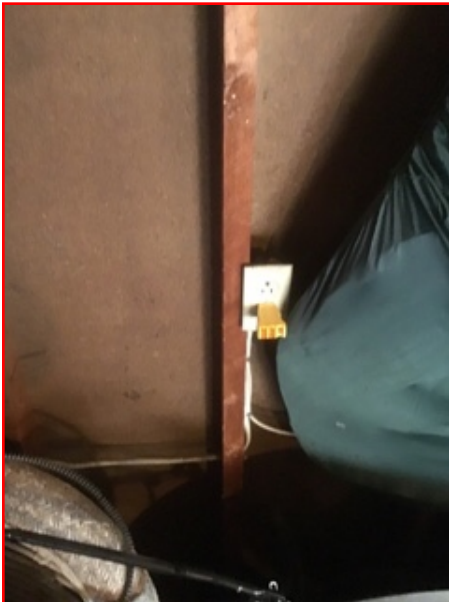
14) The wiring in the garage will also need to be repaired ( with proper junction box connections), Also, the back wall outlets were not energized .

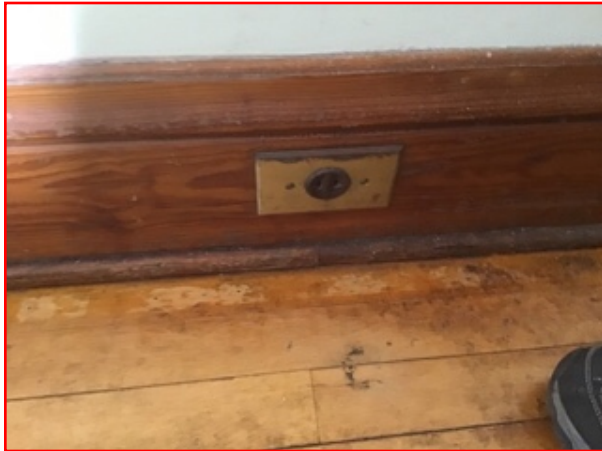
Figure 34-1

15) The home has a mix of two prong non-grounded outlets and three prong non-grounded outlets along with some grounded 3 prong outlets. Non grounded outlets will not protect three pronged appliances. Adding GFCI outlets to non grounded outlets will protect three pronged appliances. An electrician could review and make recommendations.

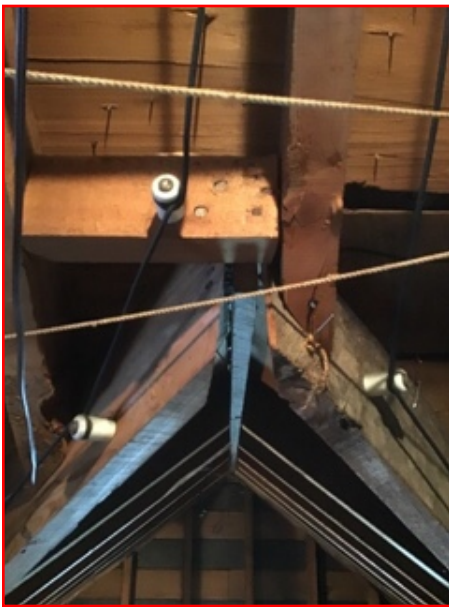
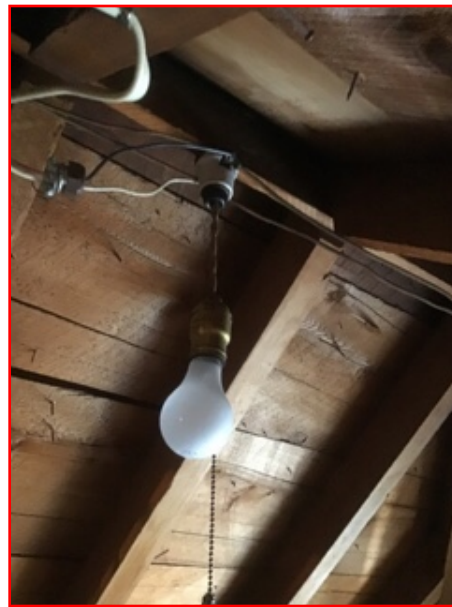
16) Knob and tube wiring is in attic and is charged.

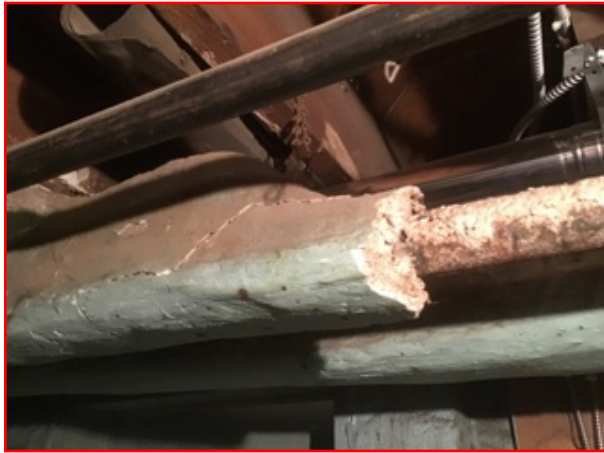
Figure 44-1

18) Some of the homes boiler piping has asbestos type insulation wrapped around it. Asbestos insulation is harmful if handled or removed without the proper safety equipment. If removal is desired, it should be handled by a licensed abatement contractor.
