Home Evaluation Services

Home Inspection Report

Inspected on Wed, Jan 13 2021 at 9:10 PM

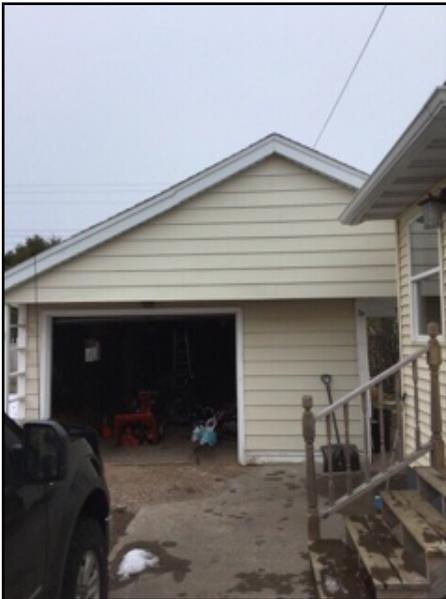
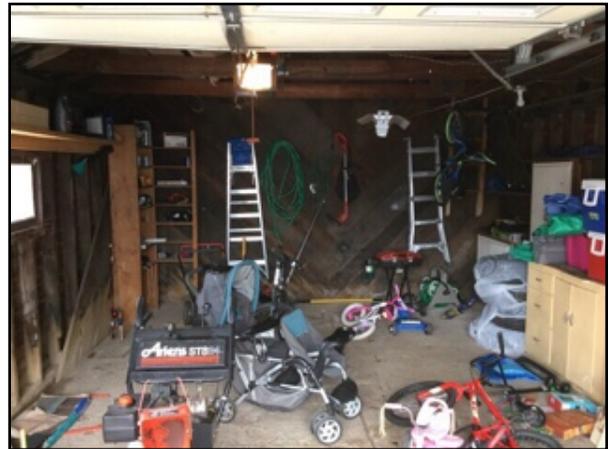
Comment 10:
Garage views.

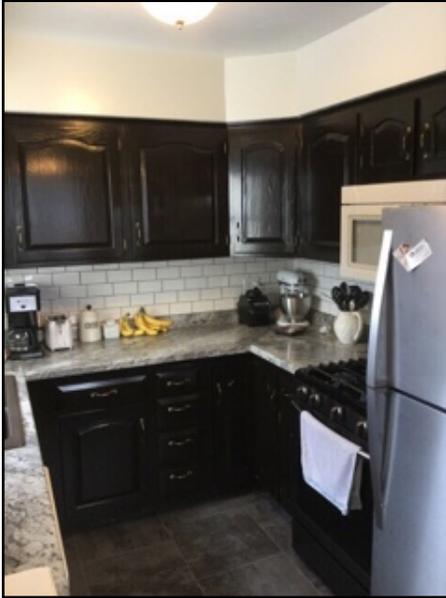
Figure 17-1

i Comment 17:
Kitchen area inspected well and no major deficiencies were uncovered.

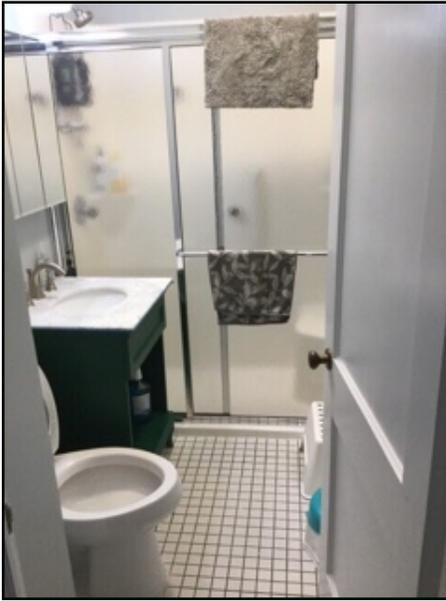
Figure 21-1

The main bathroom was in good condition with no major deficiencies found at the time of inspection.

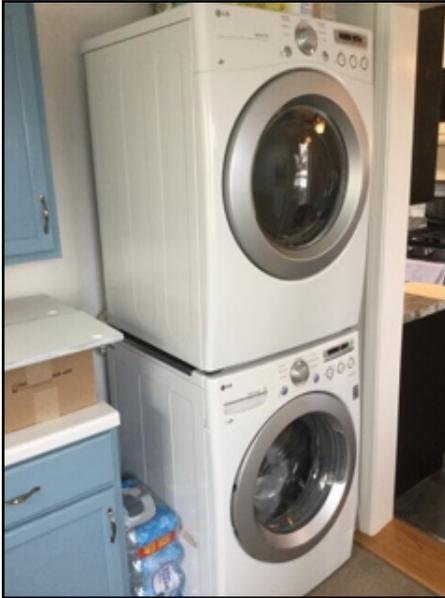
Figure 24-1

The laundry area of the home was in good condition.

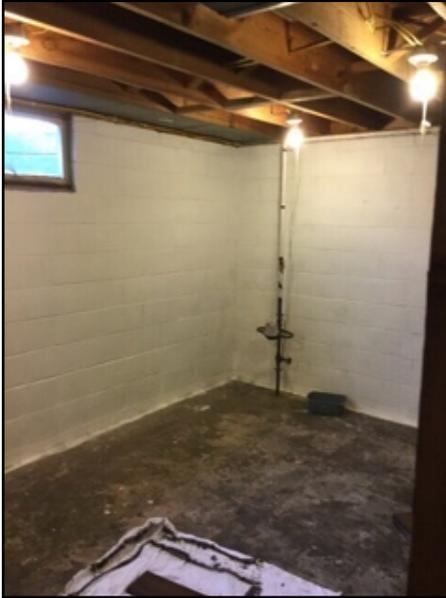
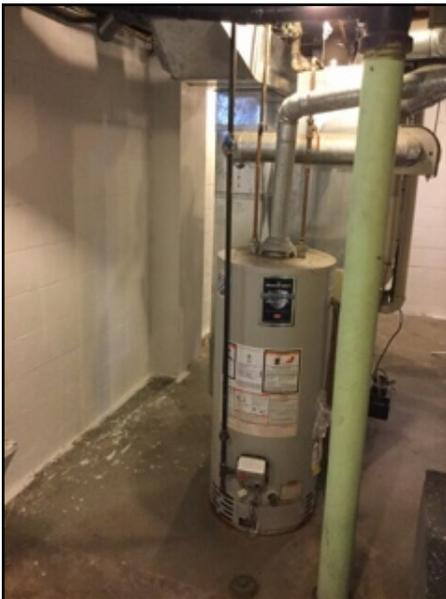
The foundation walls and floor structure was found to be in good general condition.

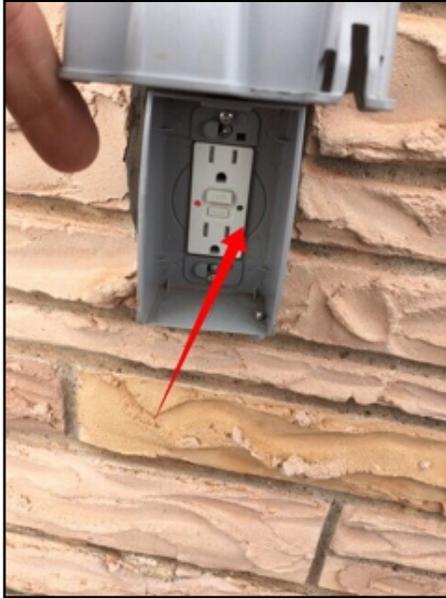
Figure 32-1

This gfci outlet would not reset at the time of the inspection.

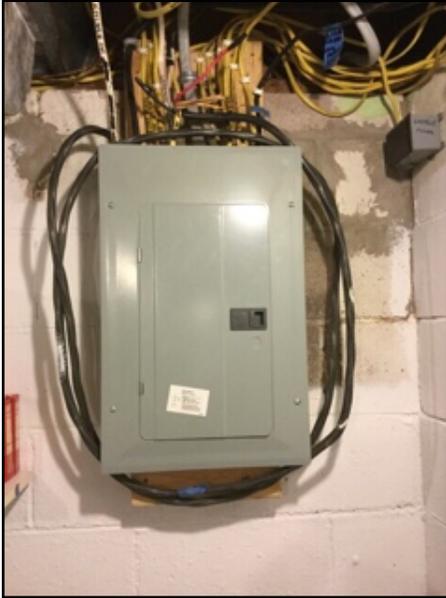
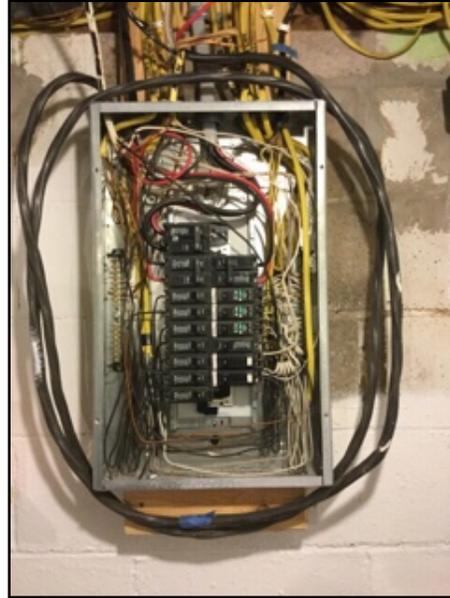
Comment 37:
Breaker panel was in good order.

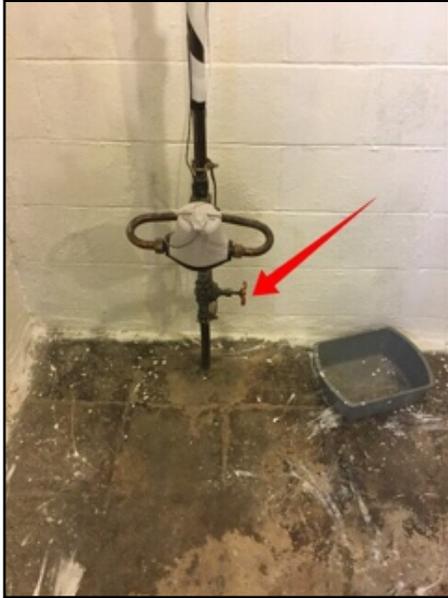
Figure 38-1

The red arrow marks the location of the water shutoff for the home.

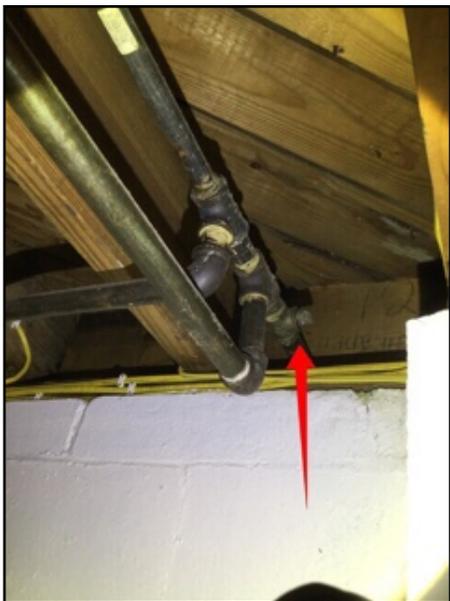
Figure 40-1

The red arrow marks the location for the gas shutoff to the whole house.

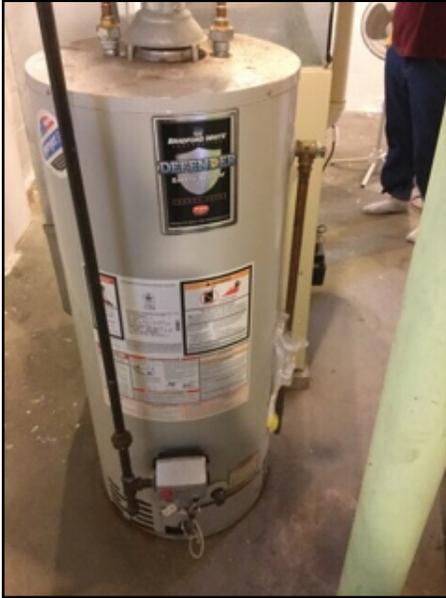
Figure 42-1

- i** Comment 42:
The 2006 electric water heater was operating as designed at inspection.

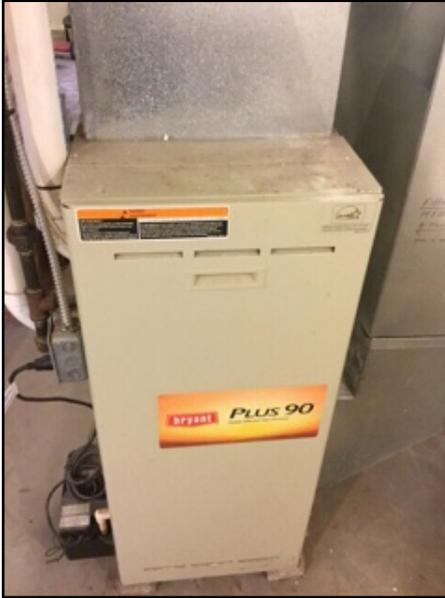
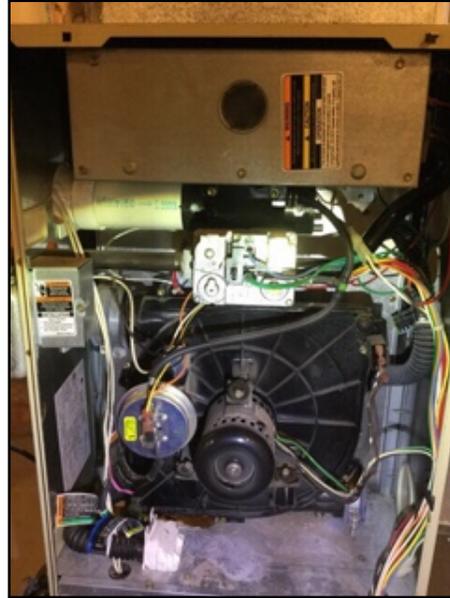
Comment 44:
1999 forced air furnace worked as designed at the time of the inspection.

Furnaces over 10 years old should be checked, cleaned and serviced yearly by a licensed contractor.

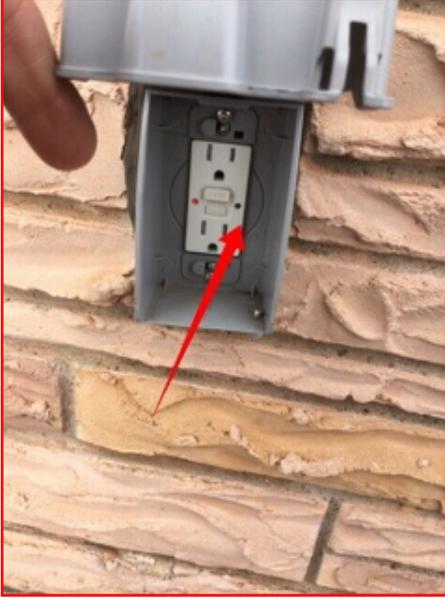
Figure 32-1

14) This gfci outlet would not reset at the time of the inspection.
