Home Evaluation Services

Home Inspection Report

Sample Report Multi Family

Inspected on Wed, Jan 13 2021 at 8:37 PM

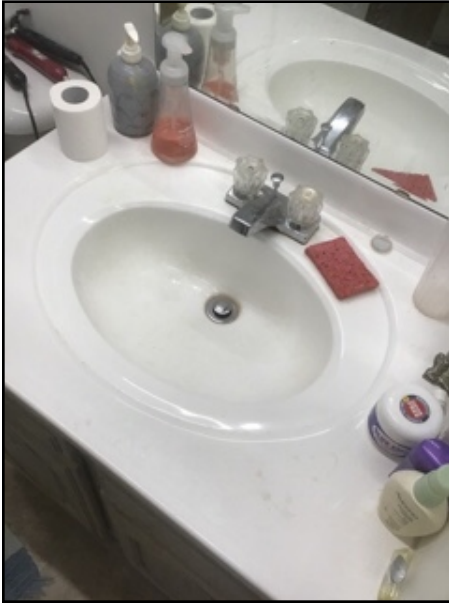
Figure 21-1

Comment 21:

Drain is also slow in unit five's master bathroom sink.

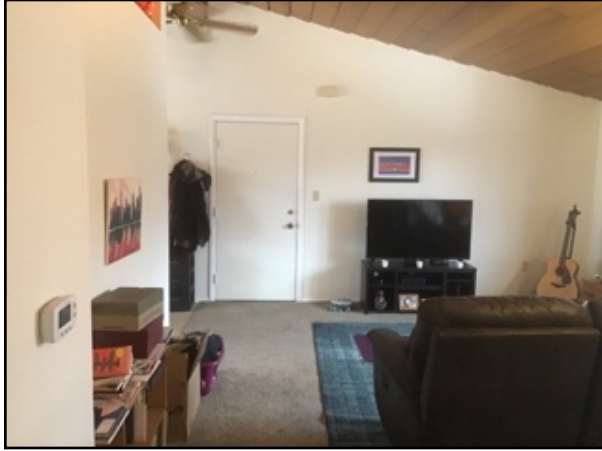
Figure 32-1

Comment 32:
Interior unit three.

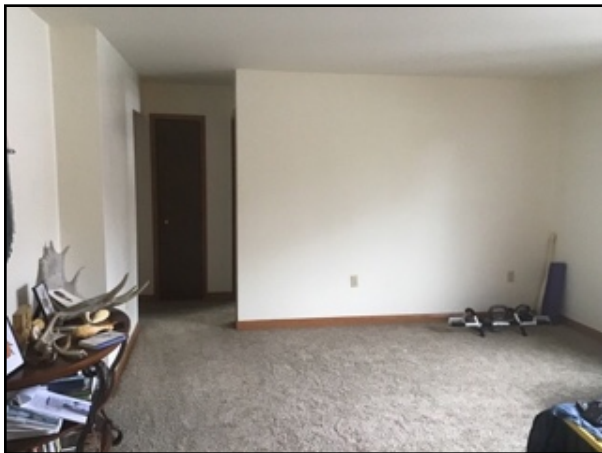
Figure 35-1

Comment 35:
Unit six interior .

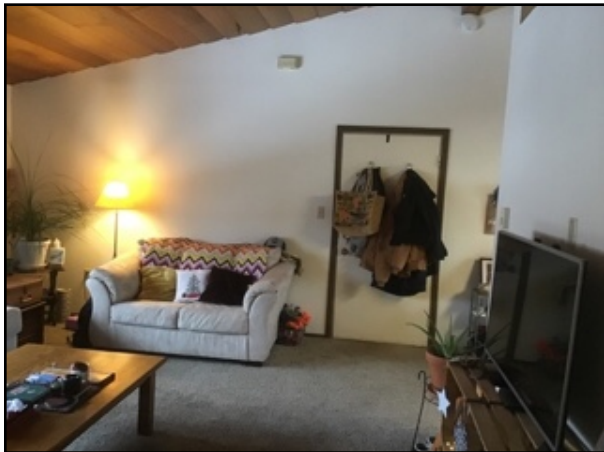
Figure 37-1

Comment 37:
Unit eight interior .

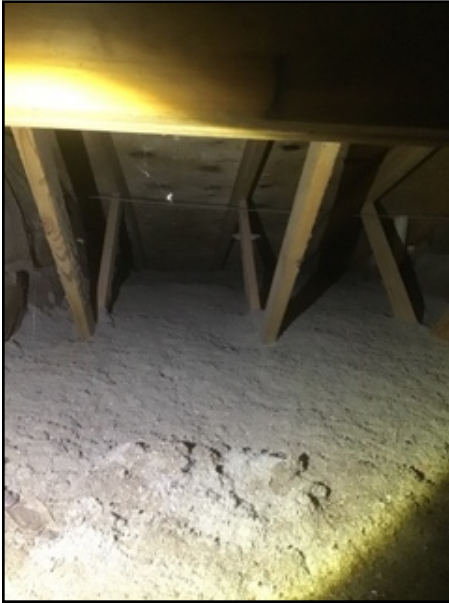
Figure 40-1

Comment 40:

Attic east end of complex, has one open junction box .

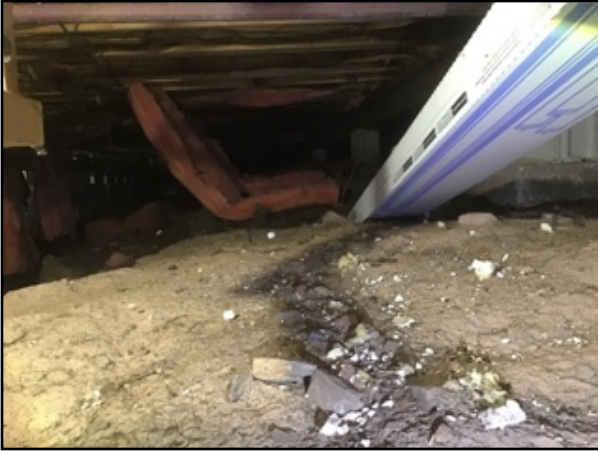
Figure 42-1

Comment 42:

Crawl space has foam board walls and spray foamed floor joists. This is very good for plumbing and keeping the space tempered. It was very dry with no signs of water penetration.

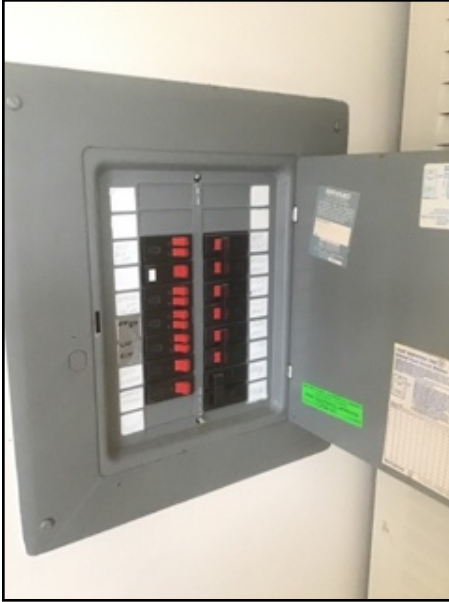
Figure 43-1

Unit one panel for example.

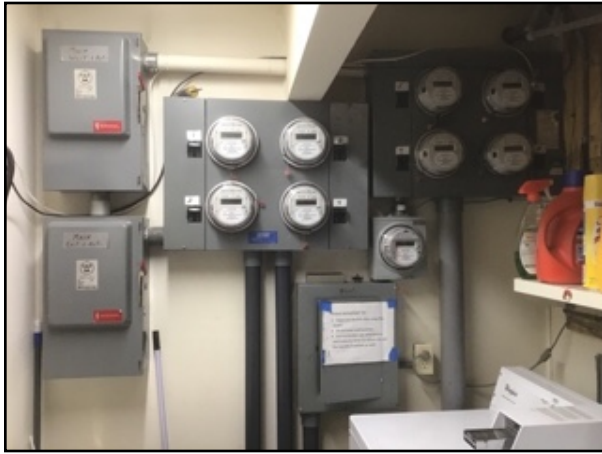
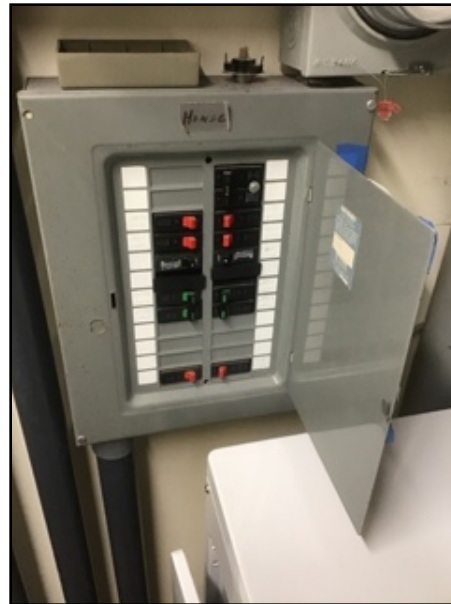
Comment 44:
Electrical panels for building in west laundry center.

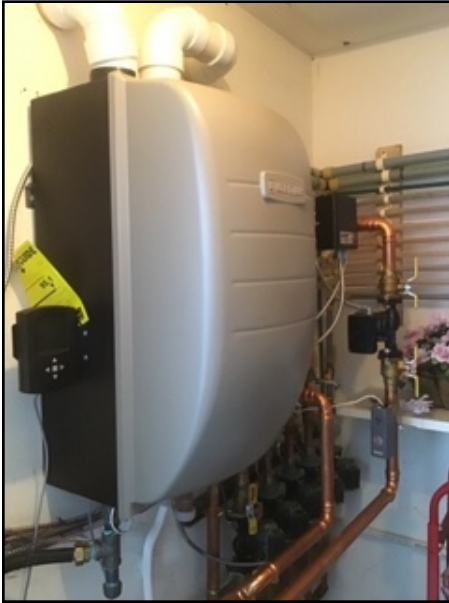
Figure 48-1

Boiler off unit two for units 1-4 .

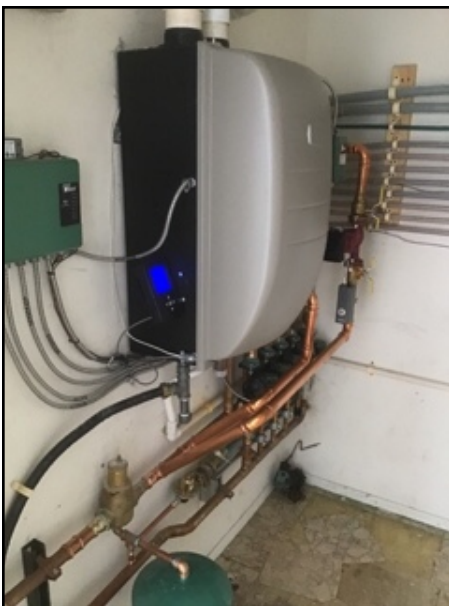
Figure 49-1

Boiler off unit six for units 5-8.

Furnaces over 10 years old should be checked, cleaned and serviced yearly

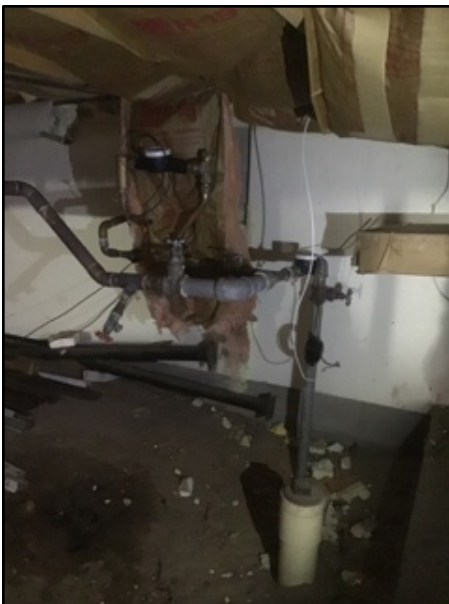
Figure 50-1

Comment 50:
Water main for complex in crawlspace.

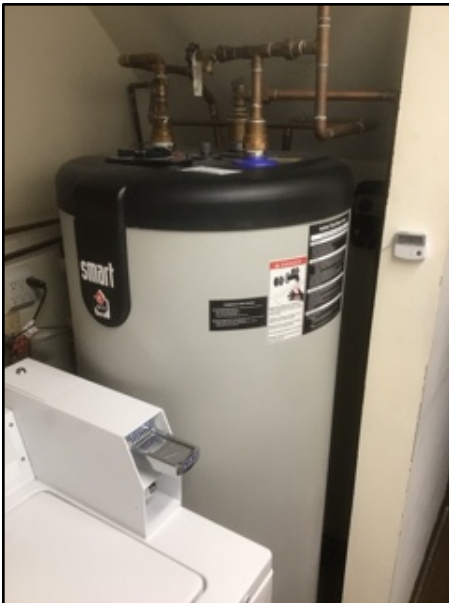
Figure 52-1

Water maker in East laundry center for hot water.

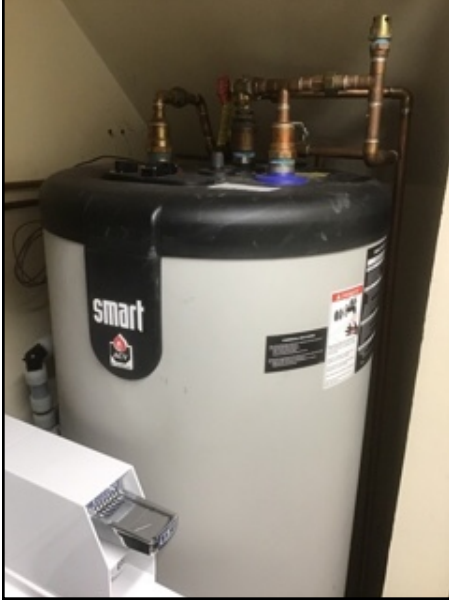
Figure 53-1

Comment 53:
West laundry center water maker. Both units were operating as designed at inspection,

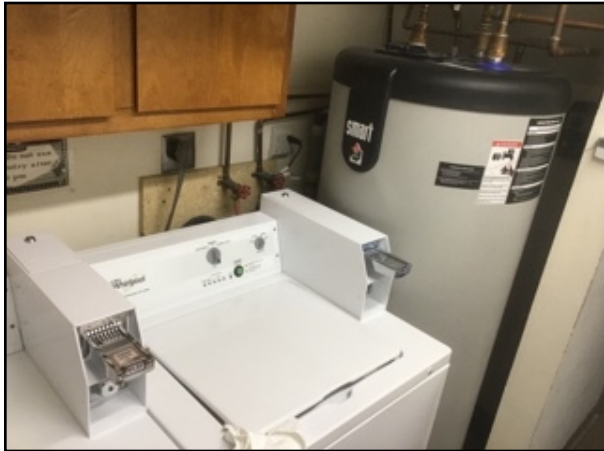
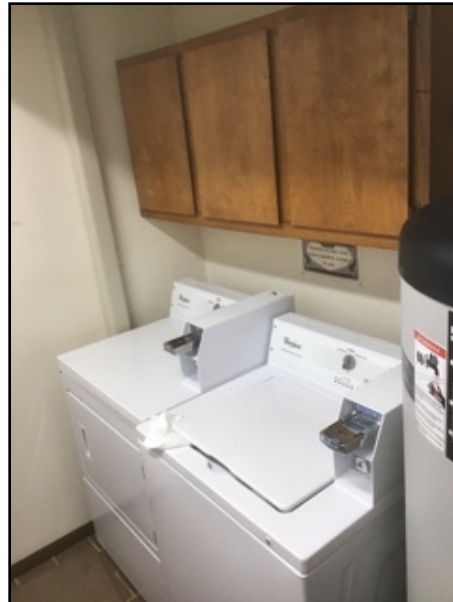
East laundry center .

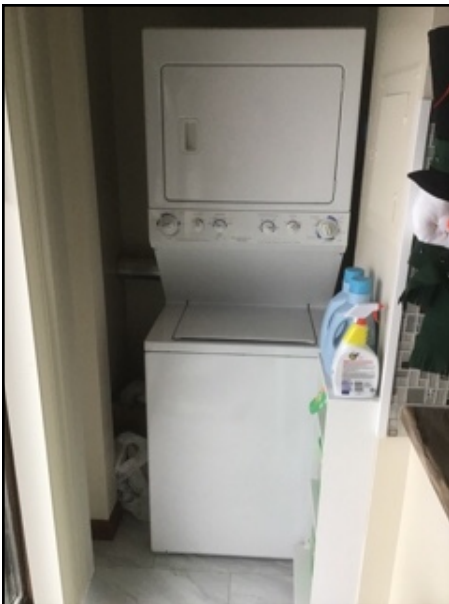
Figure 57-1

Comment 57:
Unit four has its own laundry.

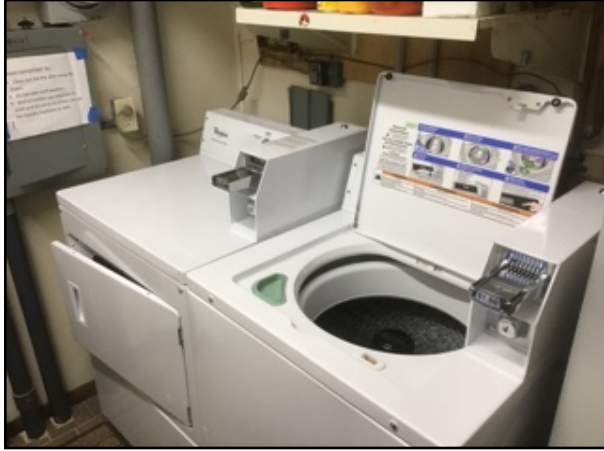
Figure 58-1

Comment 58:
West laundry center.

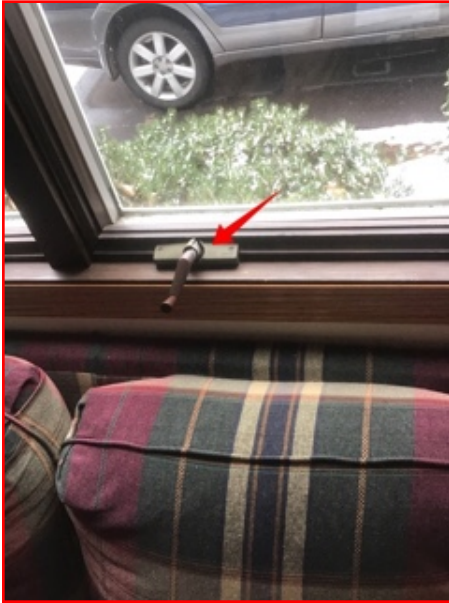
Figure 24-1

8) Crank stripped in unit five on living room window.
