Home Evaluation Services

Commercial Inspection

Sample Report

Inspected on Wed, Jan 13 2021 at 8:50 PM

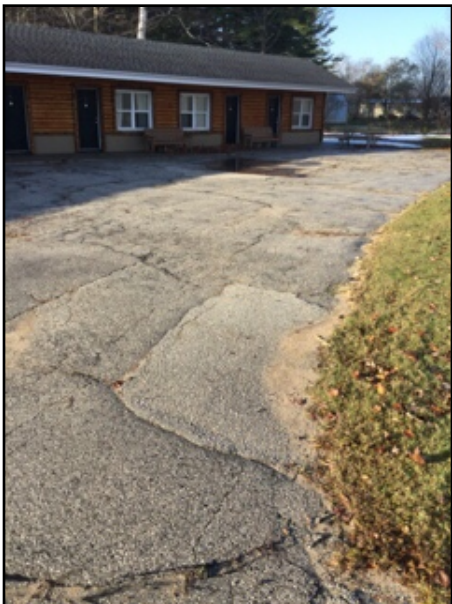
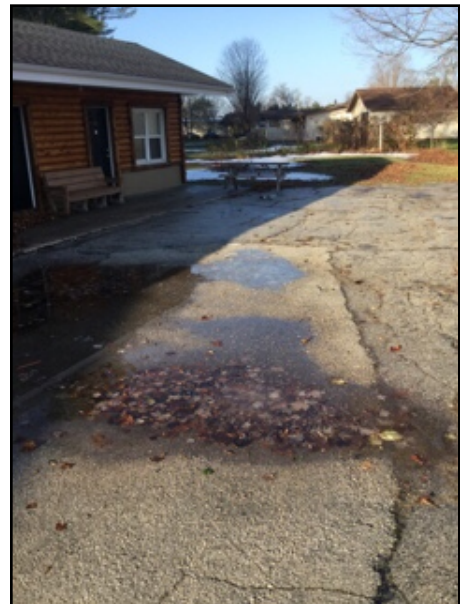
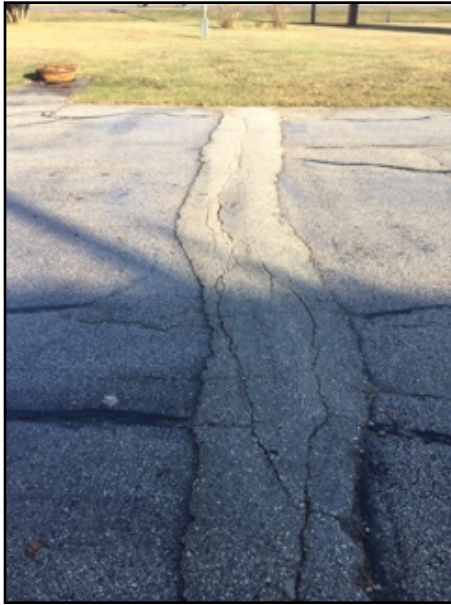
The asphalt parking lot has seen better days. There has been some repair work done to the parking lot at sometime. I suggest contacting a asphalt sealing contractor for recommendations.

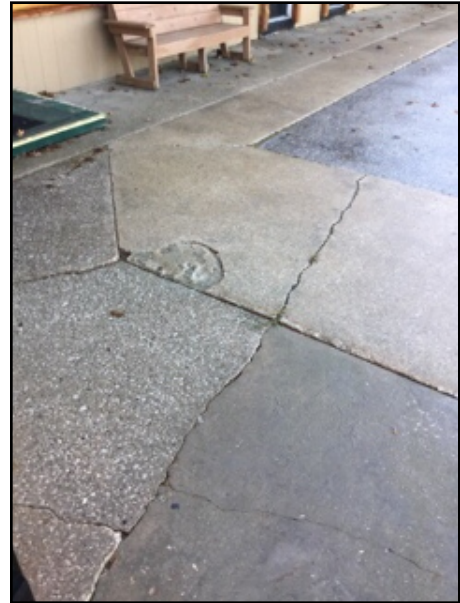
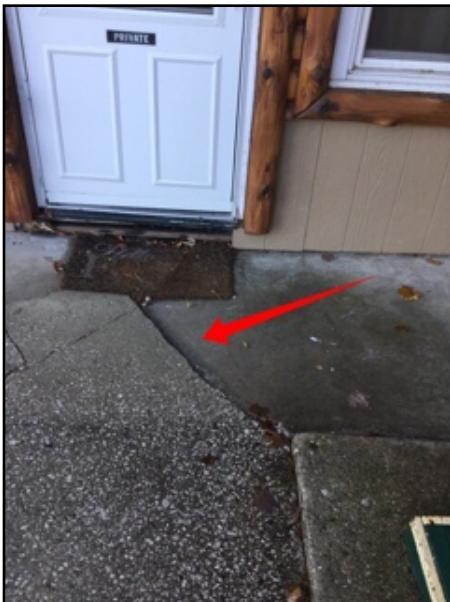
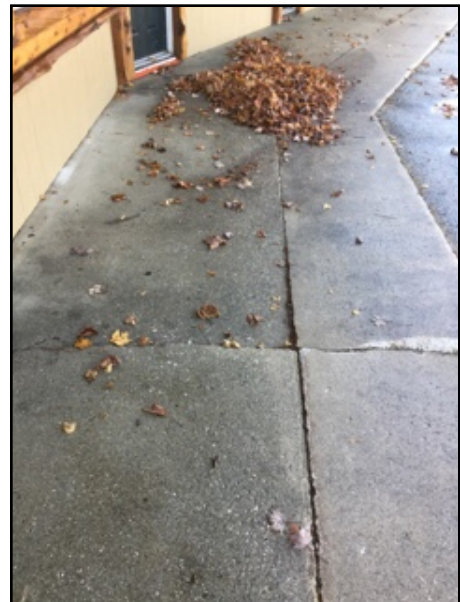
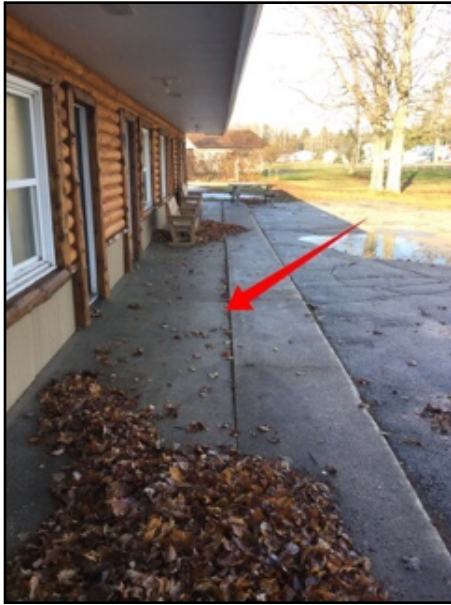
The sidewalk in front of the motel has seem settlement cracks and settling at various locations. If possible, the cracks should be sealed to keep out moisture and to prevent further deterioration.

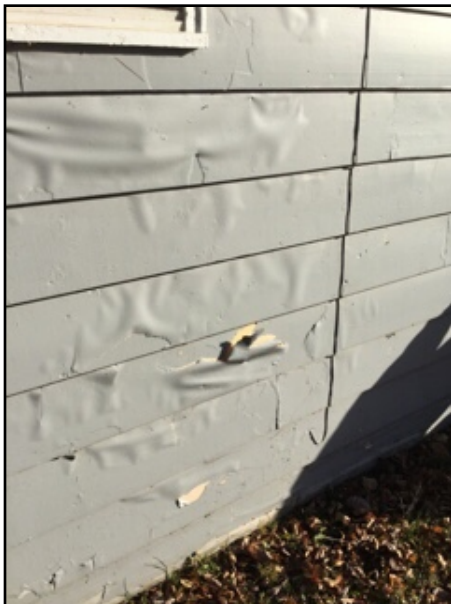
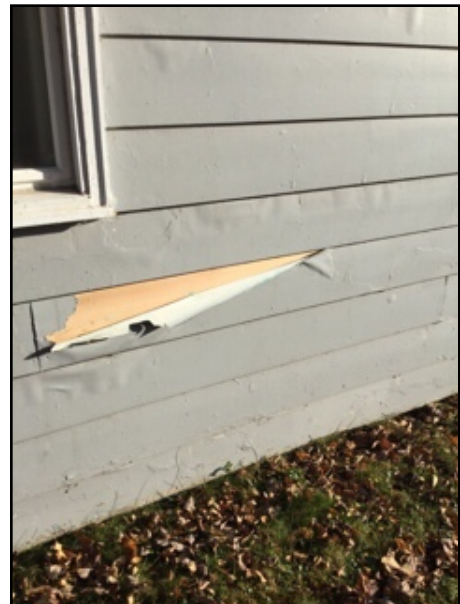
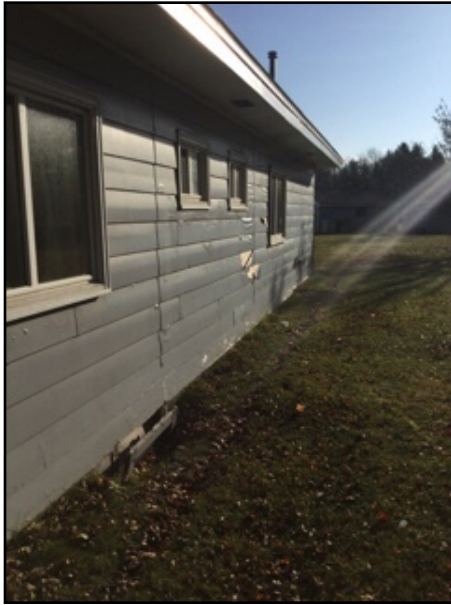
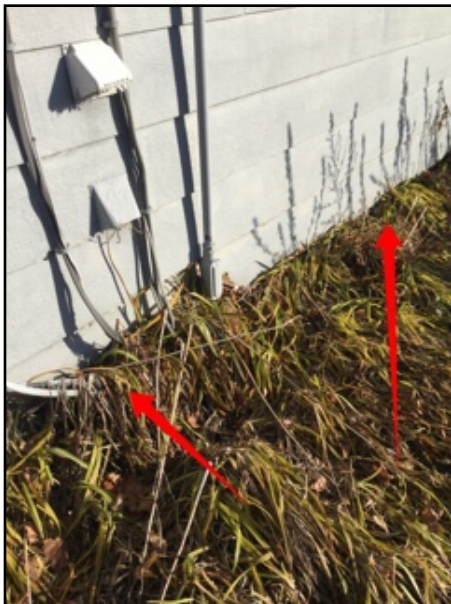
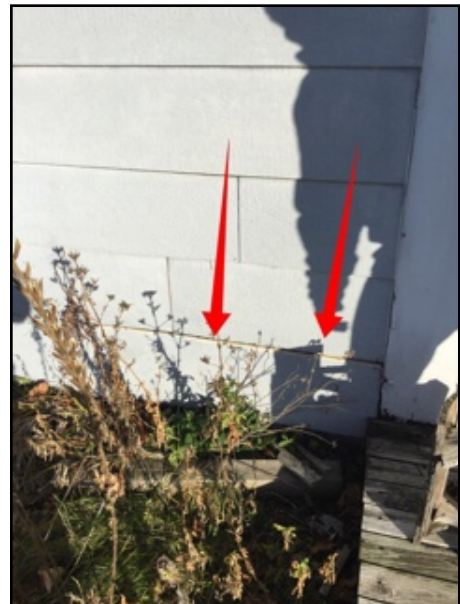
The wood lap siding is in need of painting and it's touching the ground causing water damage to start on the siding. There is also some locations that need some repair because of slight water damage and from the siding pulling away from the building.

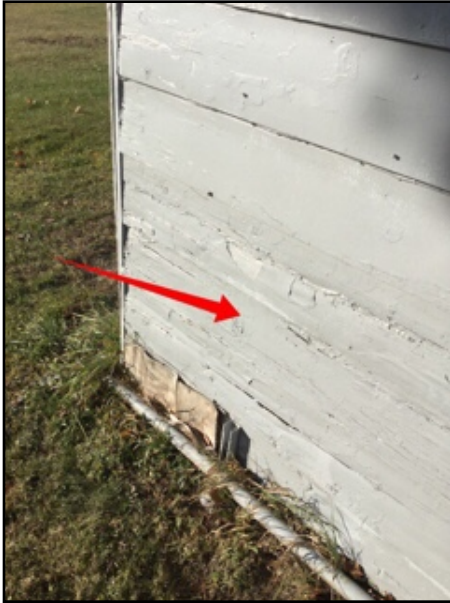
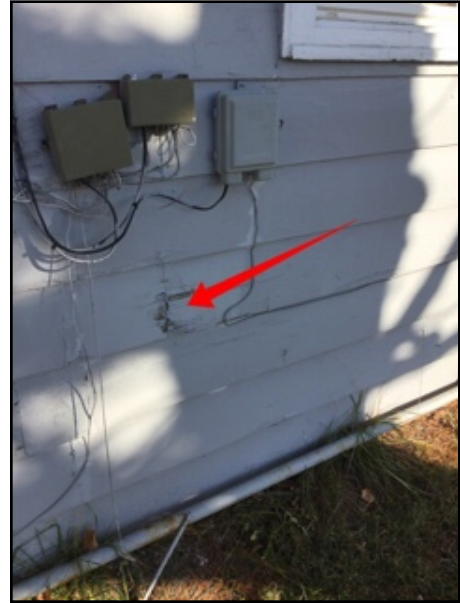
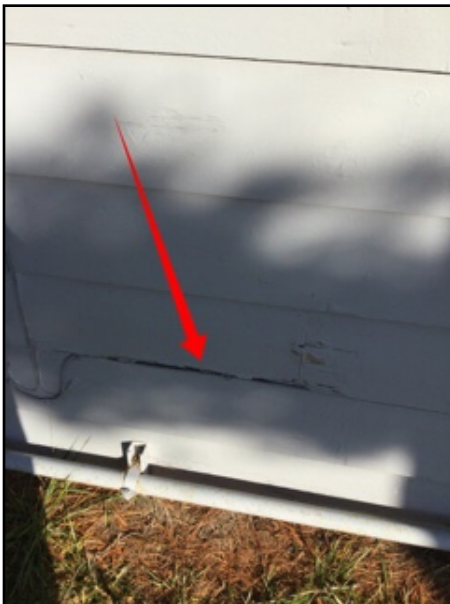
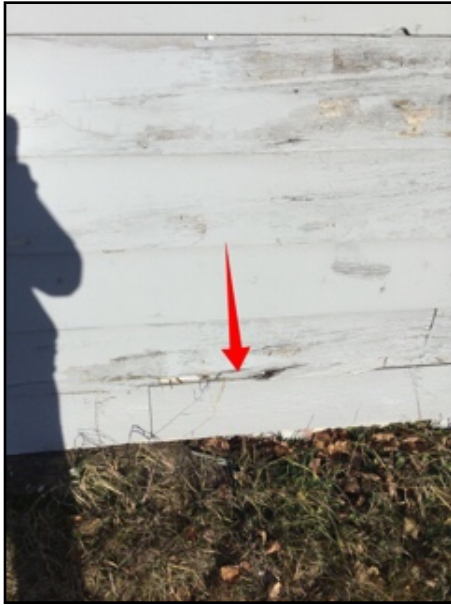
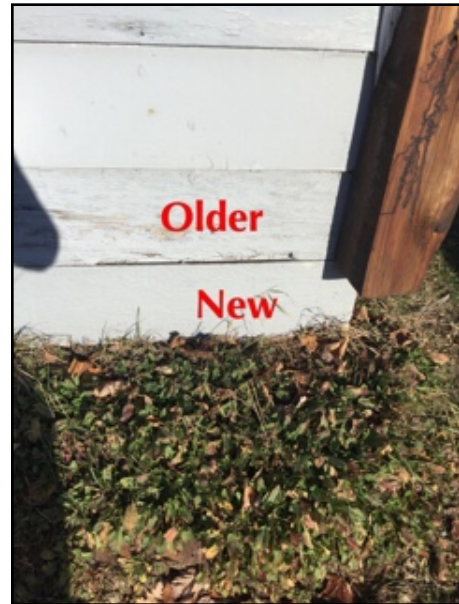
Comment 6:
Additional siding examples.

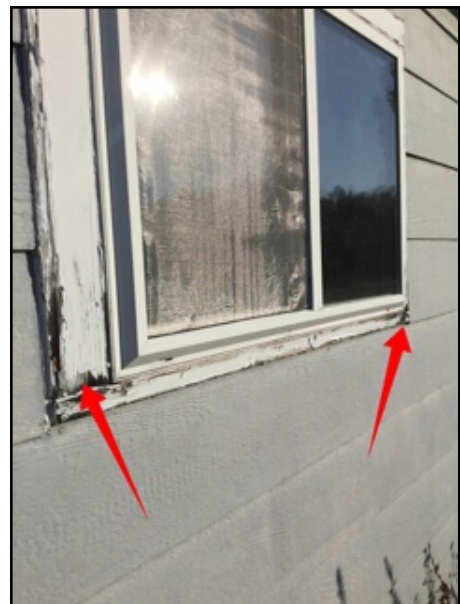
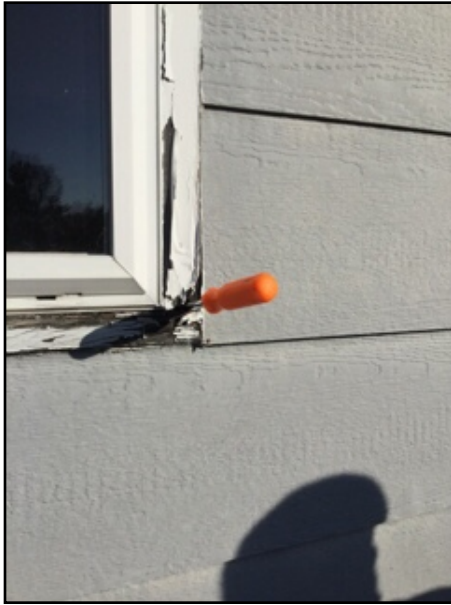
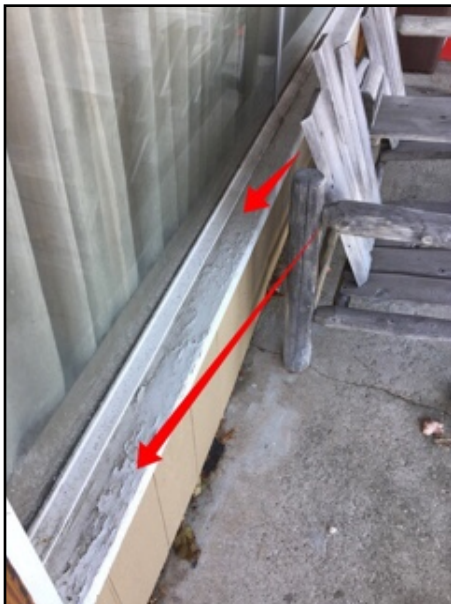
The window trim on the motel could use repainting in the near future. There is some locations that have a little water damage.

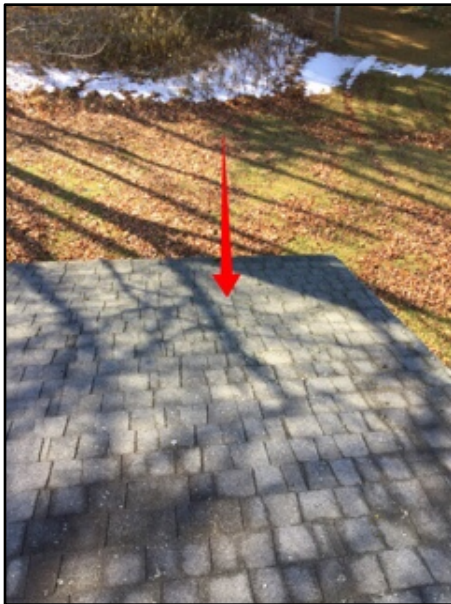
Figure 13-1

The roof has some moss growth occurring in areas. This kind of growth can shorten shingle life and should be removed. There are products available to treat the moss and then it can be gently rinsed off the roof. This was on the back southwest corner of the roof.

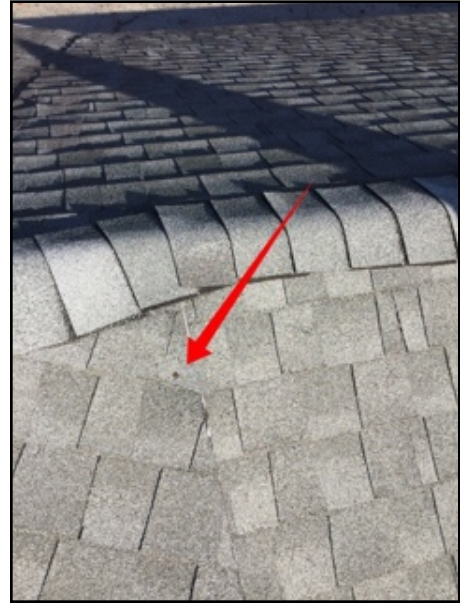
Figure 14-2

The roof had some nail pops that should be repaired with a sealer.

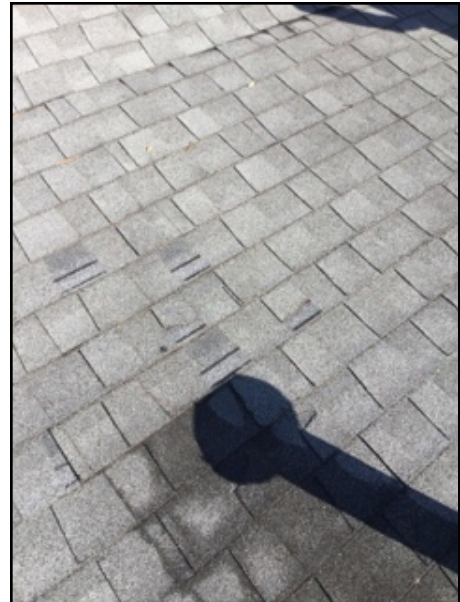
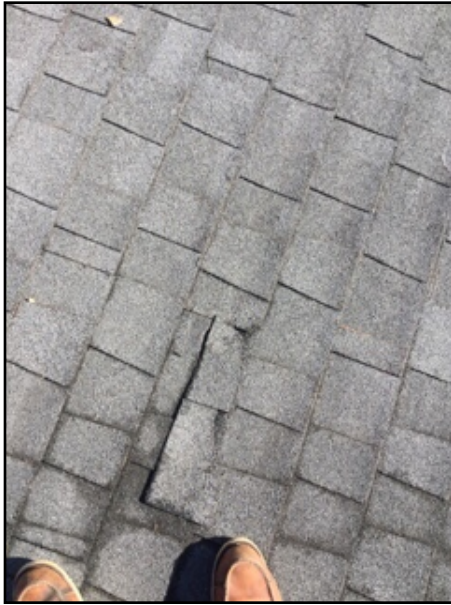
The roof over the main kitchen area has some damage from snow shoveling. We did not see any water intrusion at the time of the inspection.

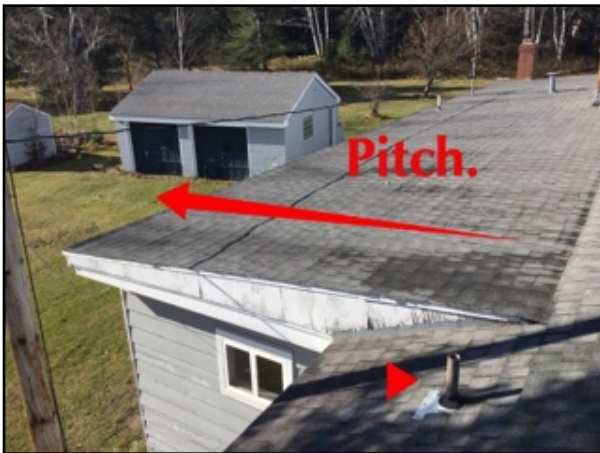
Figure 16-1

The roof over the kitchen was shingled. Usually, this type of roof with a low pitch would be covered in roll roofing or rubber roofing. Keep monitoring this area for water intrusion.

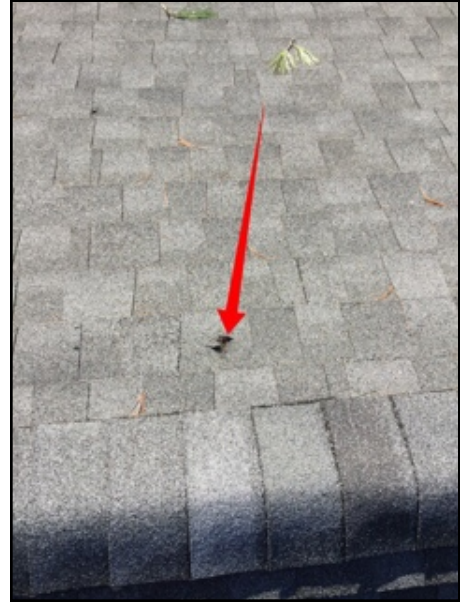
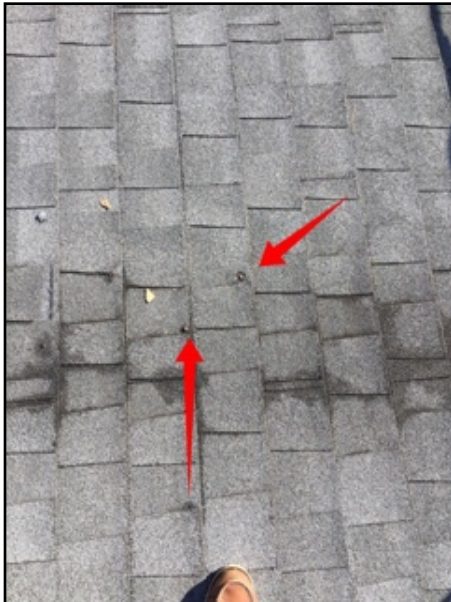
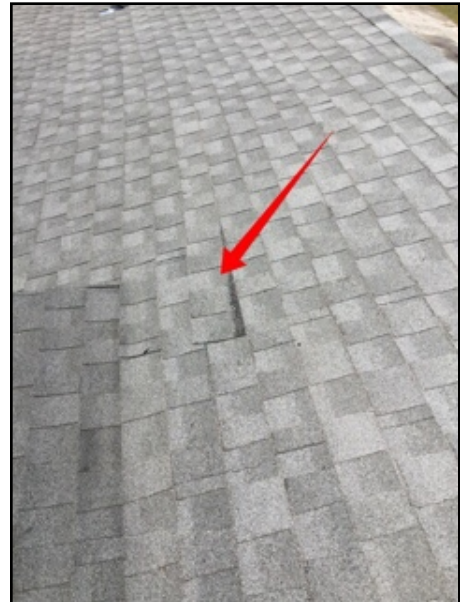
The roof covering was found to be in good general condition, with no major damage or deterioration but there were some blemishes.

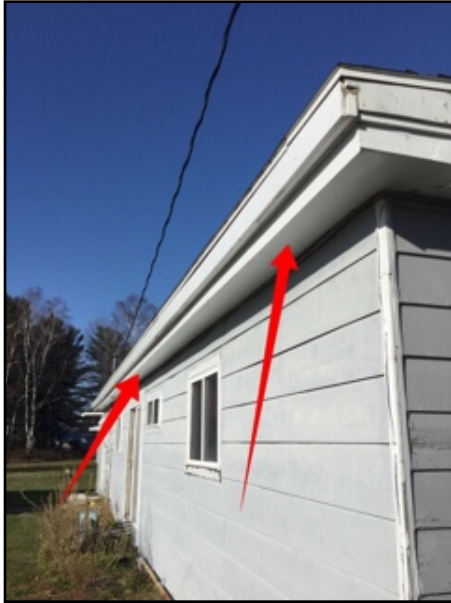
Figure 18-1

There is no soffit ventilation for the roof over the main living quarters.

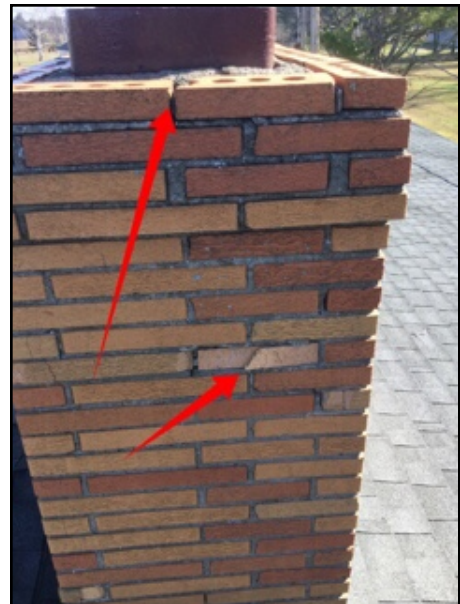
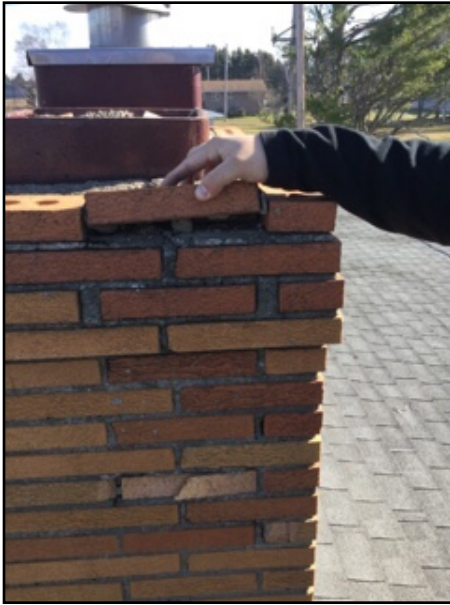
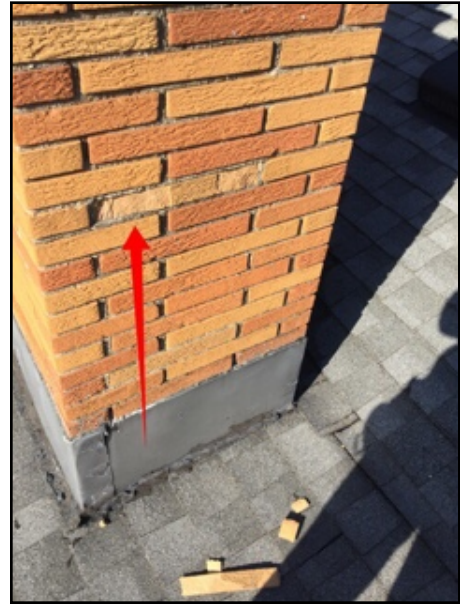
The chimney's brick has some Spauling that has occurred that's damaged the bricks. This occurs when water gets into cracks and then freezes causing the bricks to come apart. The cracks in the chimney and cap should be sealed to prevent moisture from seeping in.

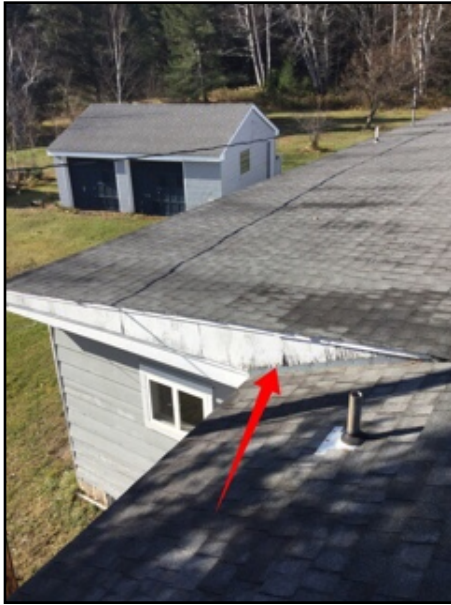
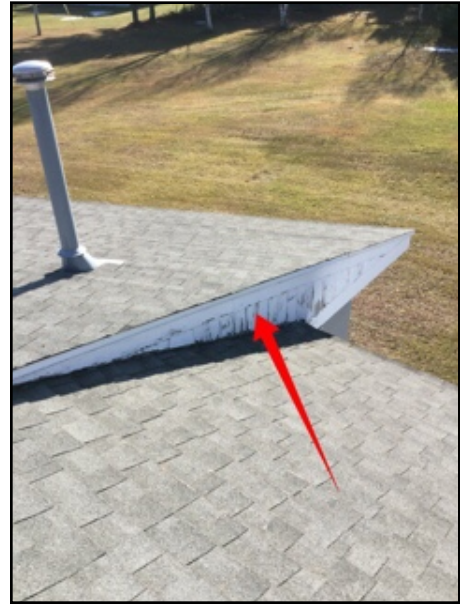
These areas on the roof are water damaged and should be metal flashed.

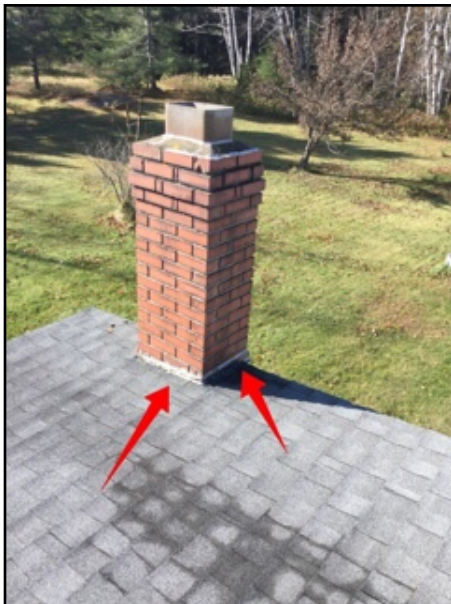
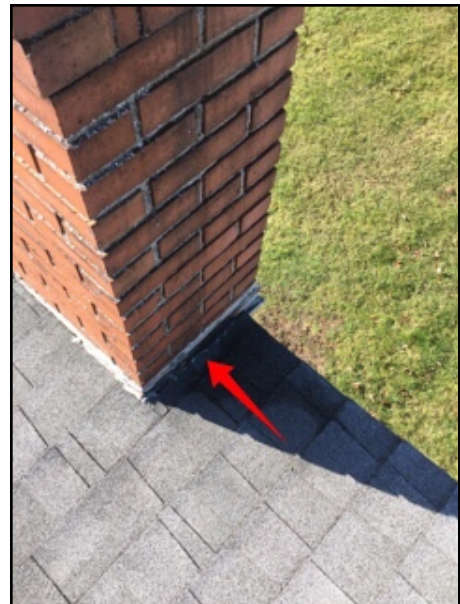
This area could use some recaulking in the future.

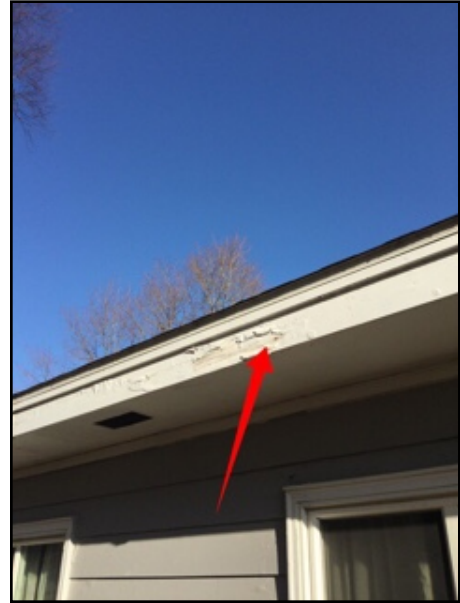
Figure 23-2

The wood soffit and fascia is in need of paint and repair.

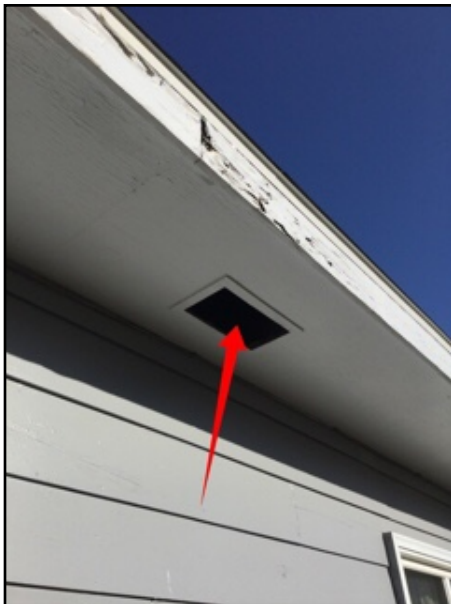
Figure 24-1

Comment 24:
This roof vent has lost its screen.

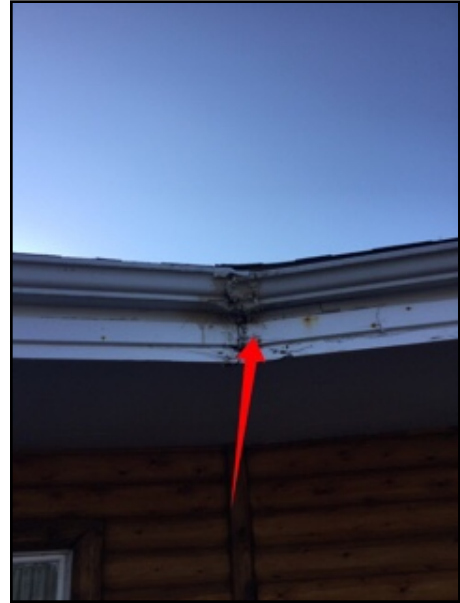
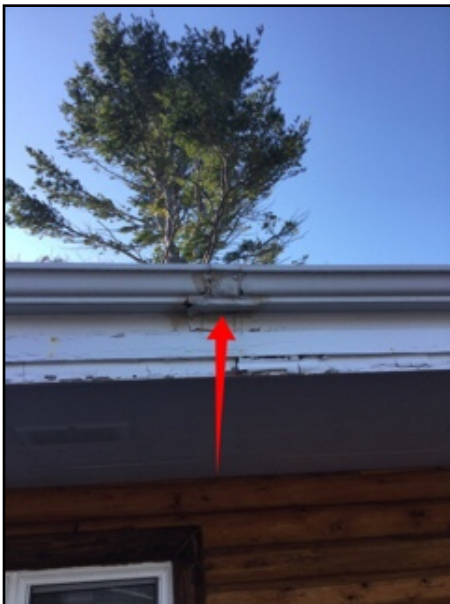
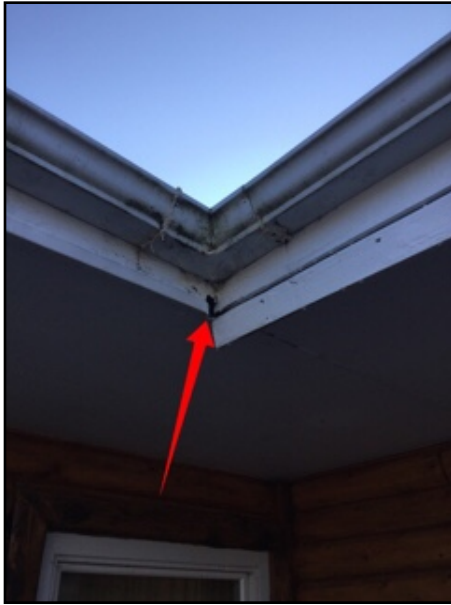
Gutter joints are leaking and rotting the fascia board at various locations.

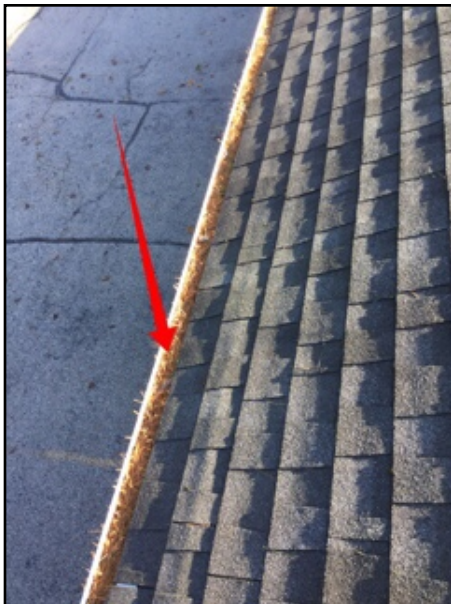
Figure 26-1

The gutters around the motel are in need of cleaning.

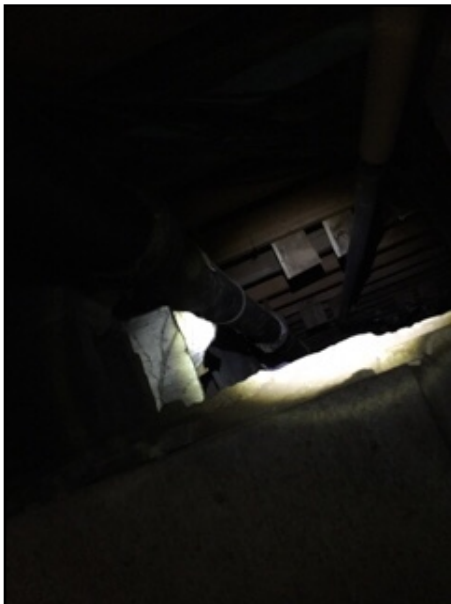
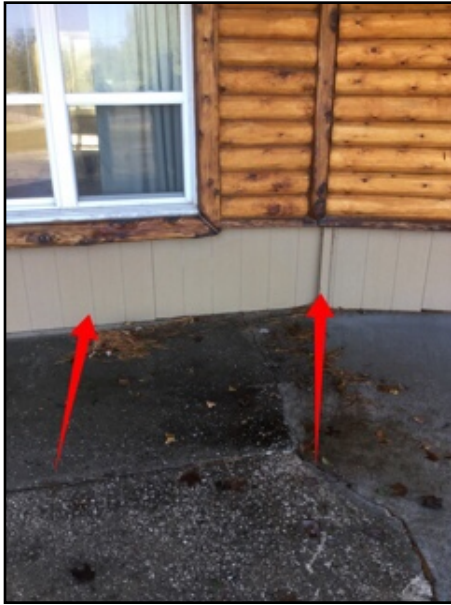
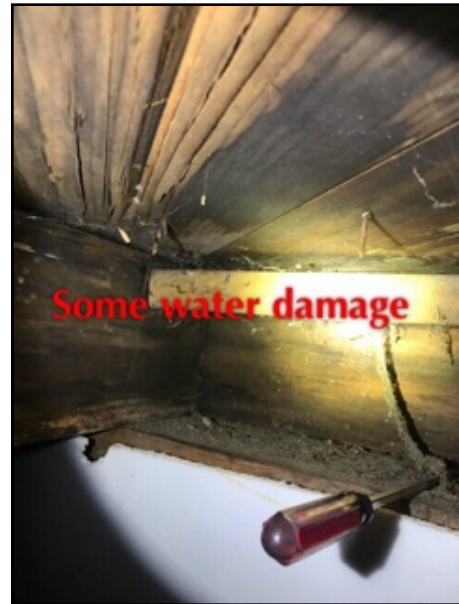
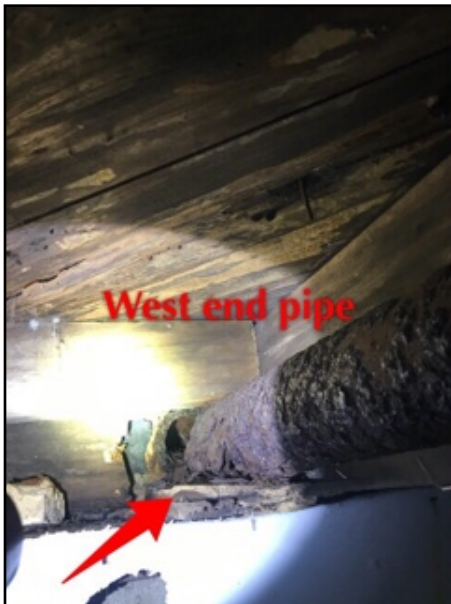
The sill plate is damaged from water intrusion at the east end/front of the building where an old drain pipe is located. This pipe is rusted through and no longer in use. Both ends of the building have a pipe like this with similar problems except the west ends sill plate is not damaged as bad the red arrows show the area where the sill plate is damaged.

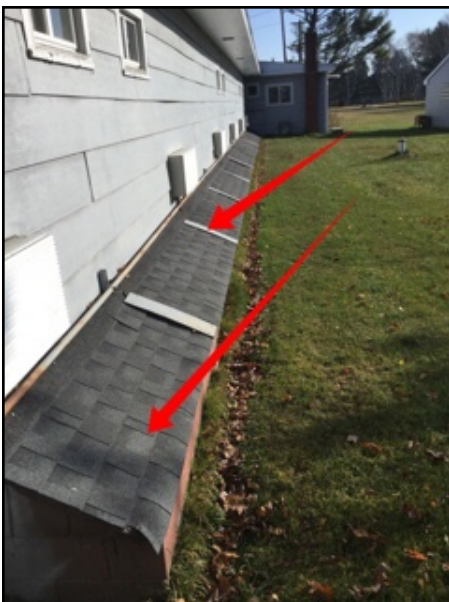
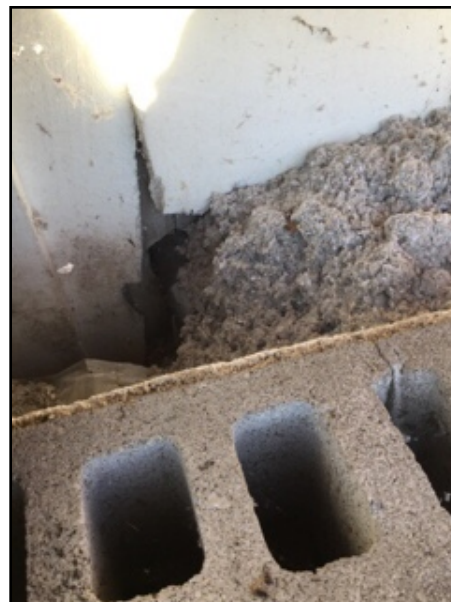
This cavity bending the building contains mechanical pipes. There is blown cellulose throughout the cavity. Freezing is the concern with this setup but we cant tell if there is any problems until a winter is experienced in the motel.

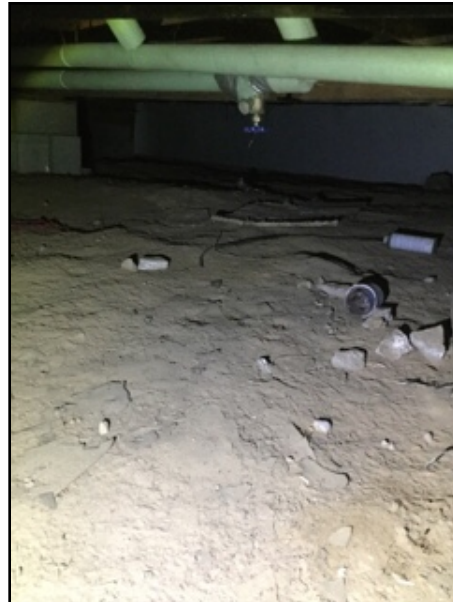
Figure 32-2

East end crawl space area was in good dry condition at the time of inspection.

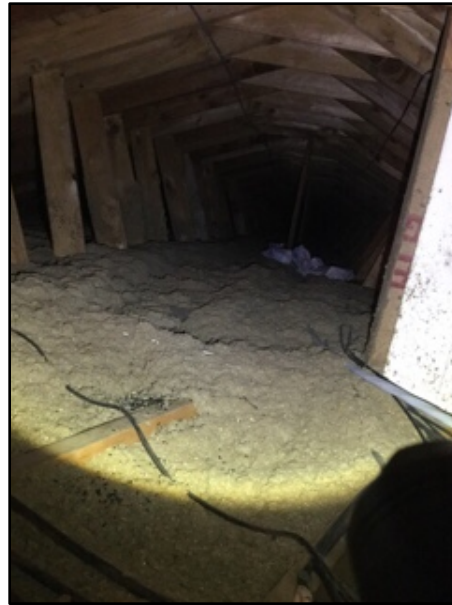
Figure 33-2

No visible issues found in the attic areas, venting and insulation was present. The blown cellulose insulation could be added too.

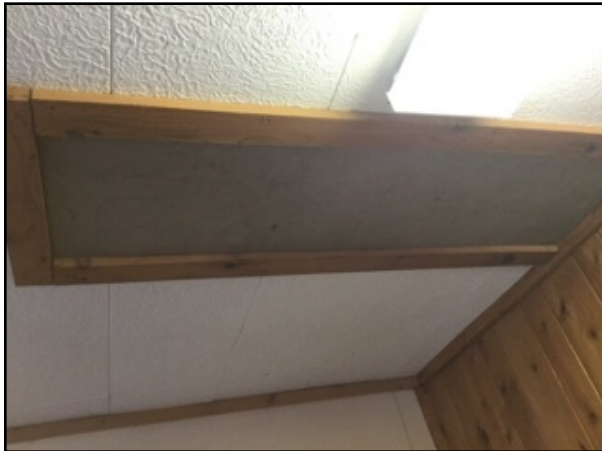
Figure 36-1

Attic hatch in main office could be insulated to help keep heat and avoid condensation formation in the attic area.

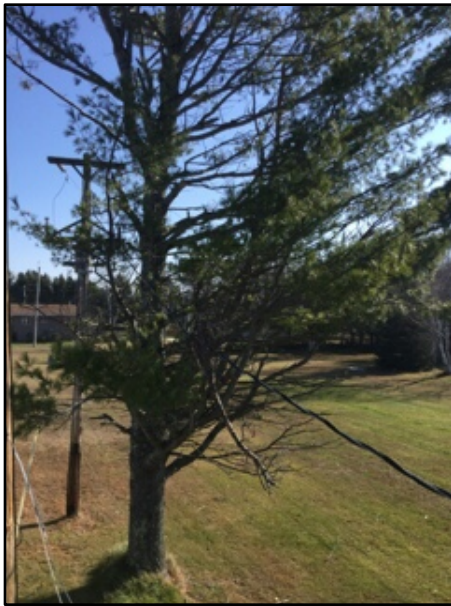
Figure 37-1

Tree branches are growing into the service line.

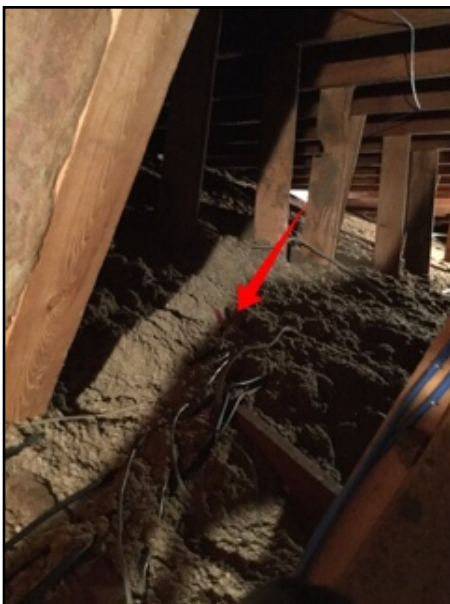
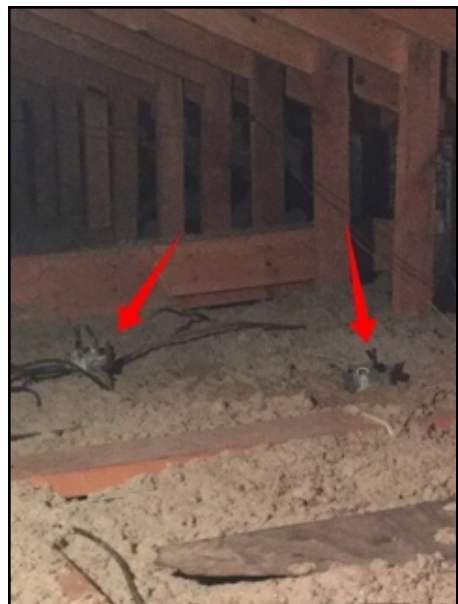
There were wires in the attic that are terminated but not in a sealed junction box. An electrician could review and make repairs.

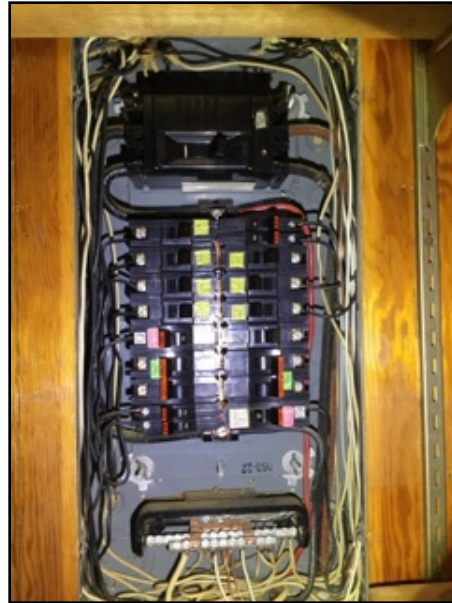
Figure 45-2

Main house electrical panel was in good condition except for some double tapped breakers. I'm not sure why the motel has so many non-grounded outlets in the motel and an electrician could review and make recommendations.

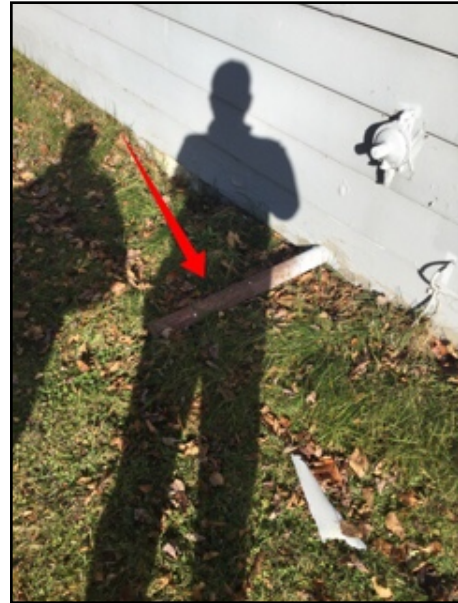
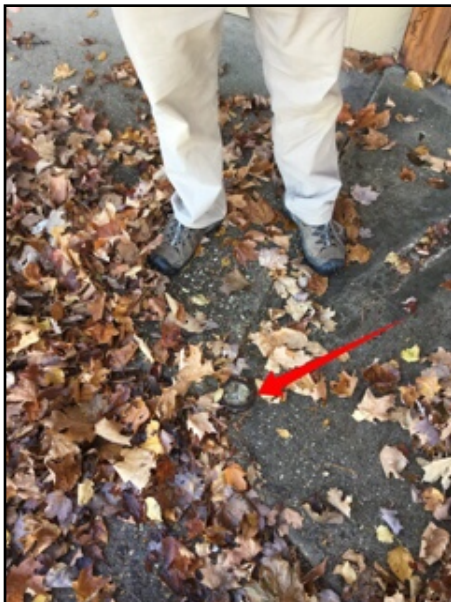
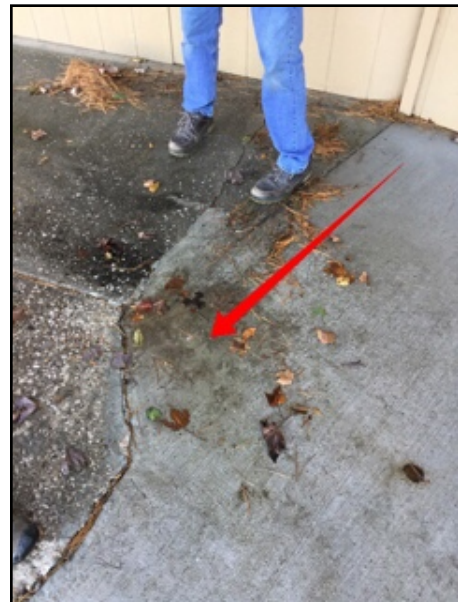
These two pipes are drains from the front of the building. There is water damage on the North side of the building where this pipe come through the sill plate.

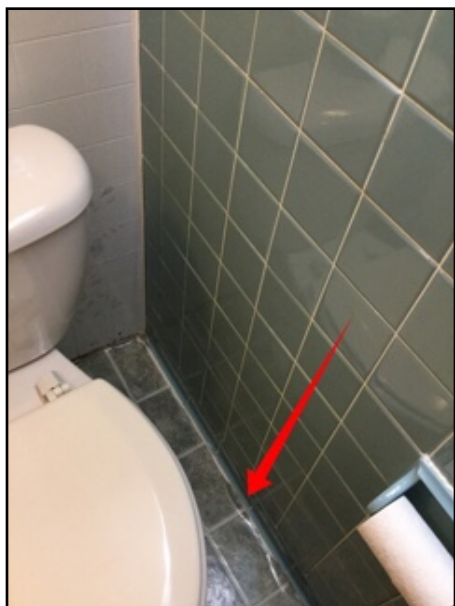
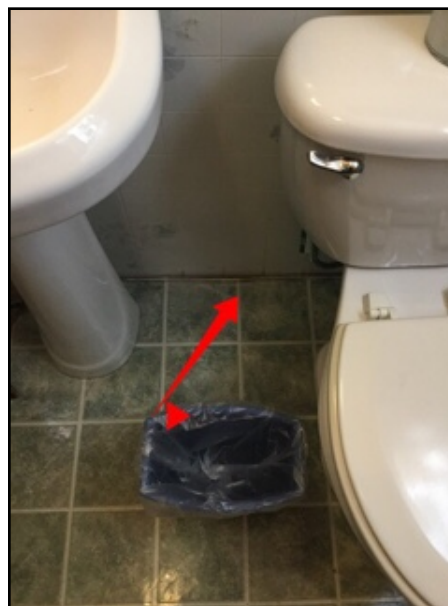
Figure 63-1

The vinyl floor is pulling up along the walls of the bathroom.

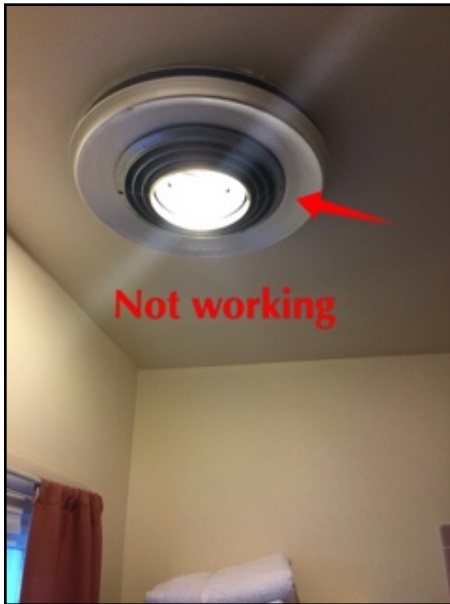
Figure 69-1

This is a heater not a ventilation fan. The heater was not working at the time of inspection.

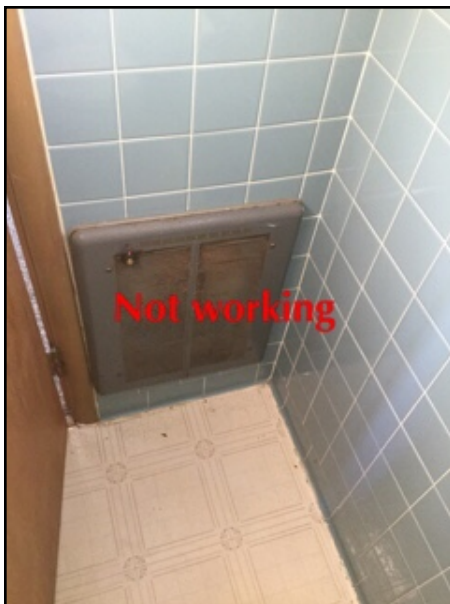
Figure 70-1

Comment 70:
Electrical heater did not operate .

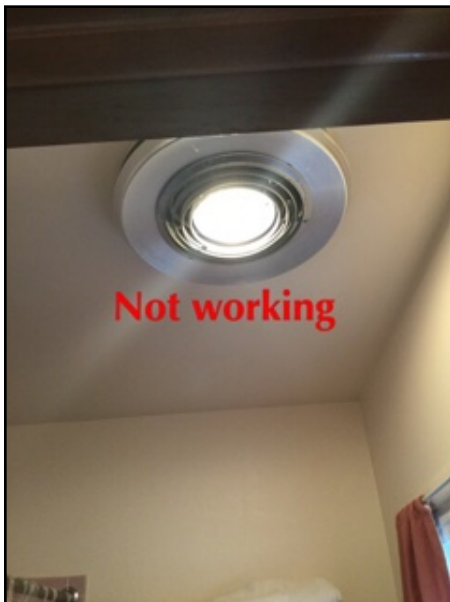
Figure 75-1

Comment 75:
Ceiling heater not working .

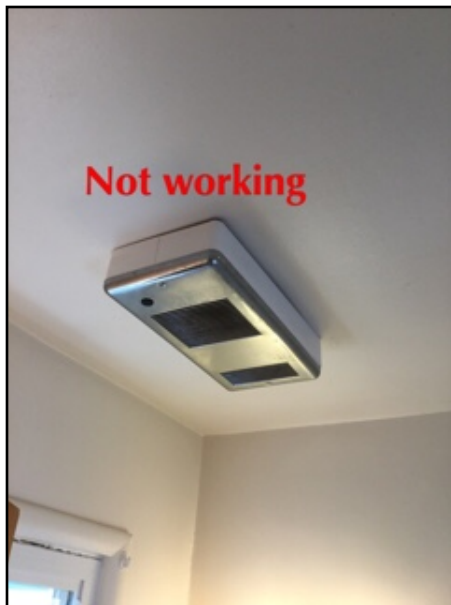
Figure 77-1

This ceiling appliance did not work at the time of inspection.

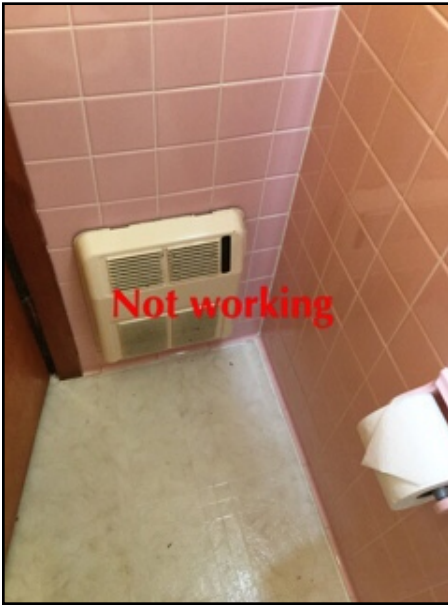
Figure 81-1

This electric heating unit did not work at the time of inspection.

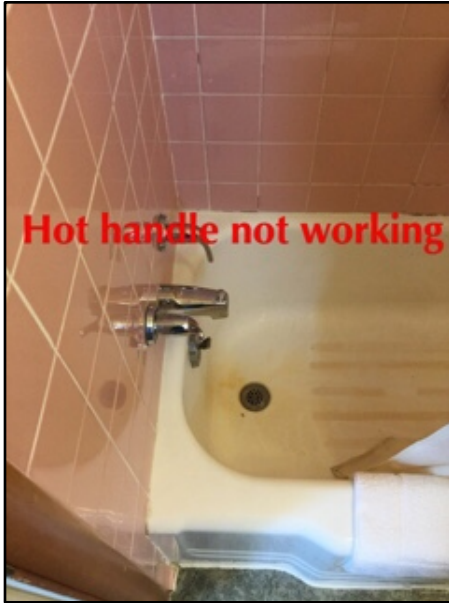
Figure 86-1

The hot water handle did not work at the time of inspection.

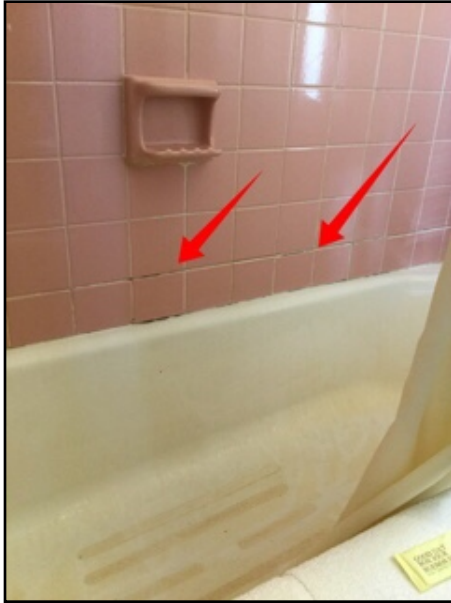
Figure 87-1

Comment 87:
Grout needs touch up.

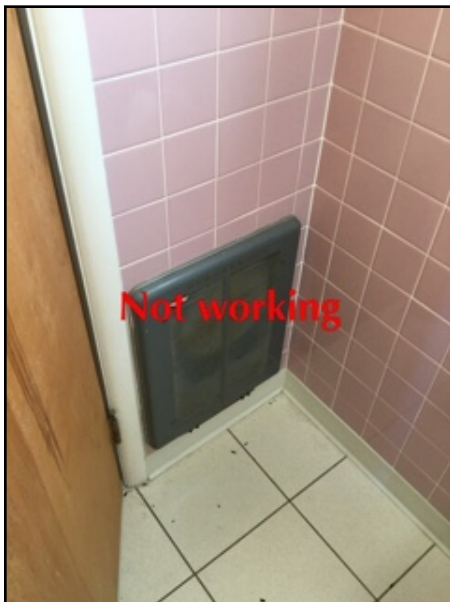
Figure 94-1

This bathroom heater did not work.

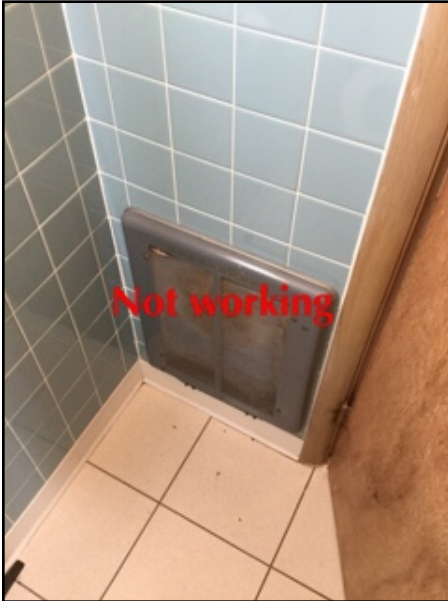
Figure 99-1

The electric heater did not work .

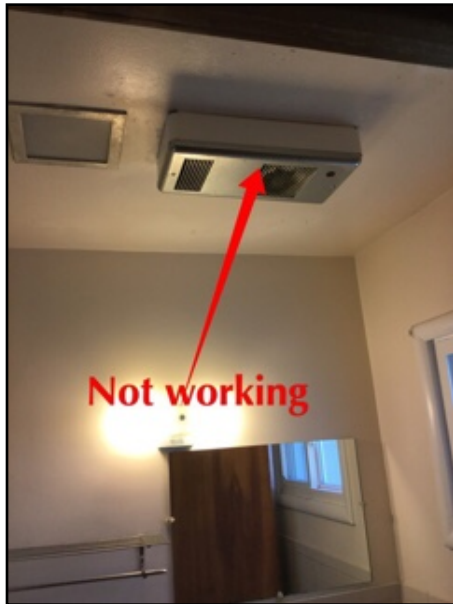
Figure 101-1

This heater was not working at the time of inspection.

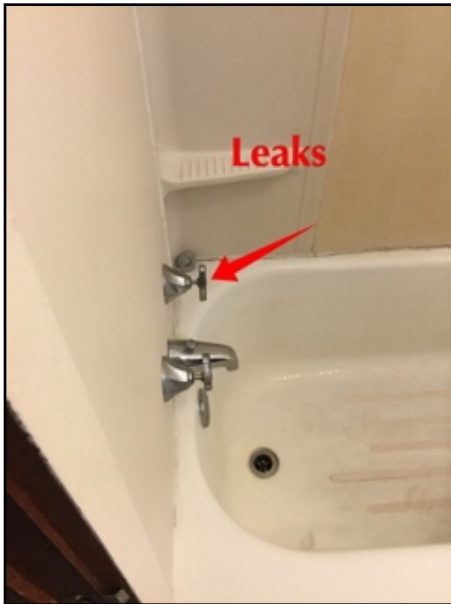
Figure 104-1

Comment 104:
This bathtub faucet does not work.

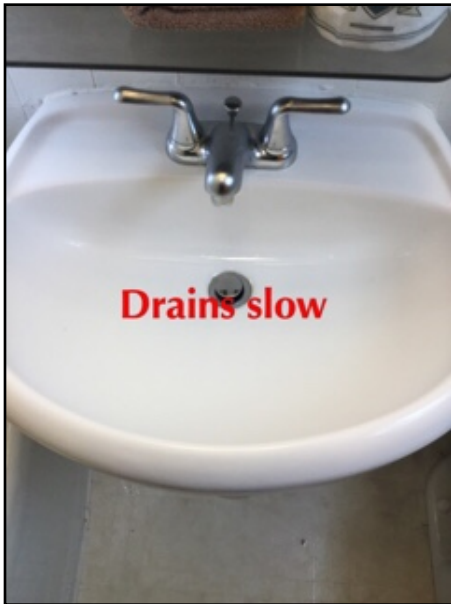
Figure 105-1

Comment 105:
This sink drains slow.

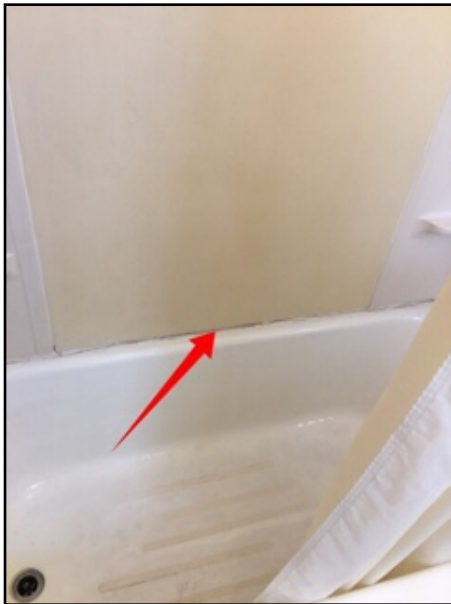
Figure 106-1

This seam along the tub can should be sealed.

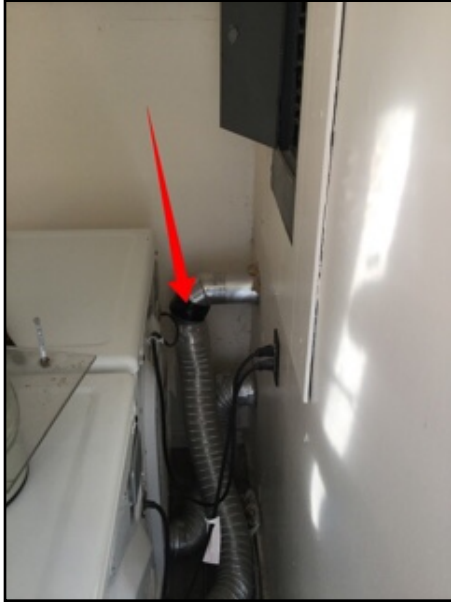
Figure 110-1

Duct tape is used on the dryer vent, this should be aluminum foil type tape. Duct tape will dry out and come apart over time.

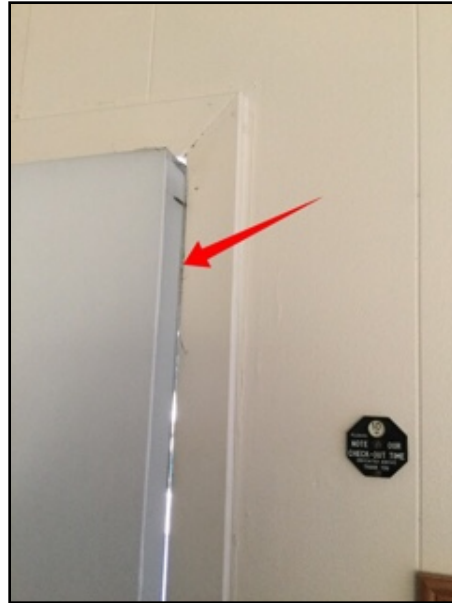
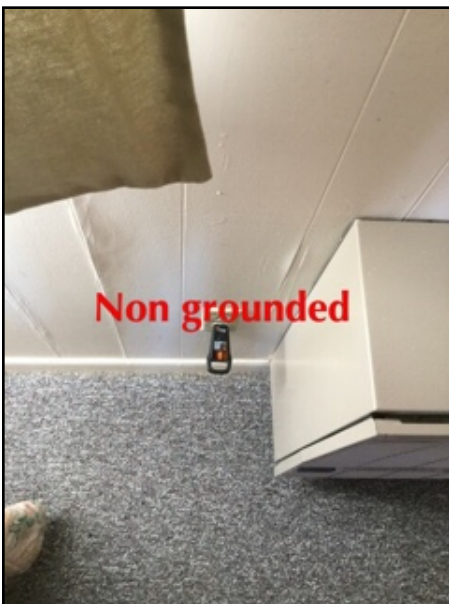
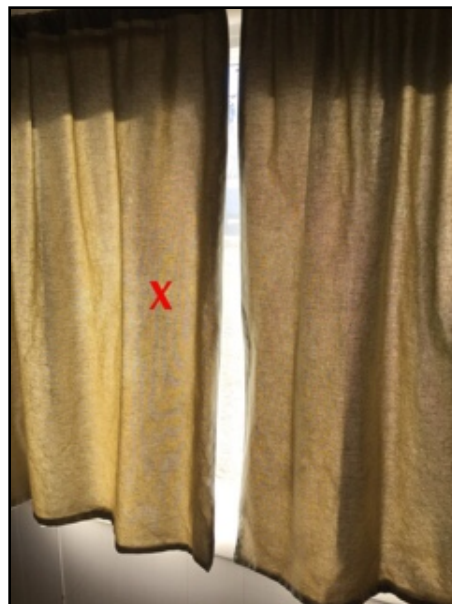
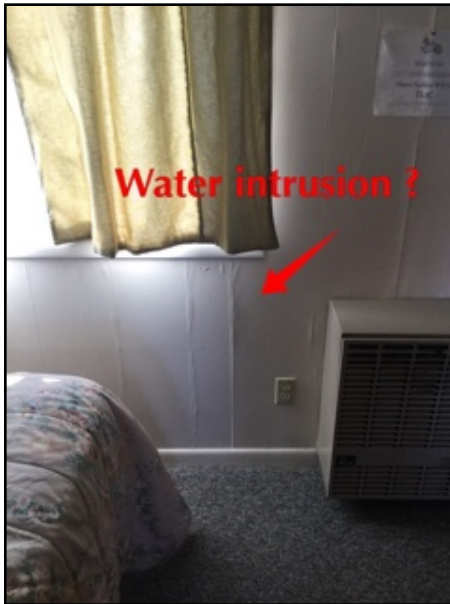
The red x signifies the window is missing a screen.
