Home Evaluation Services

Commercial Inspection

Sample Report

Inspected on Wed, Jan 13 2021 at 8:50 PM

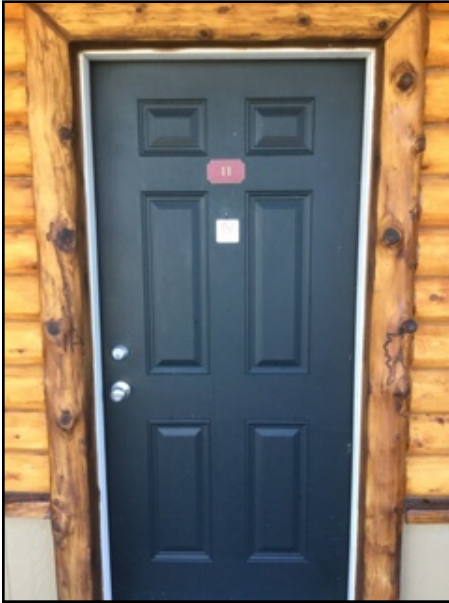
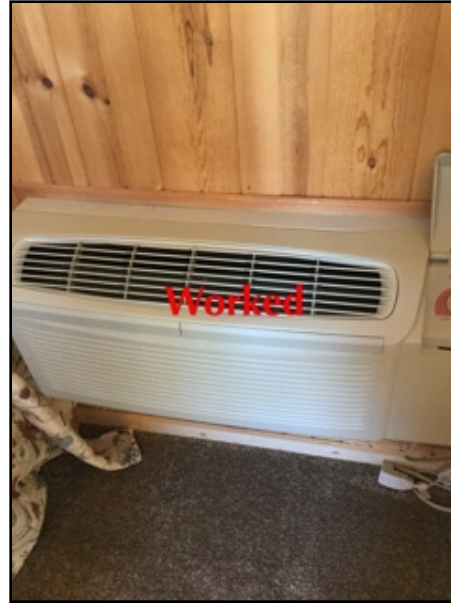
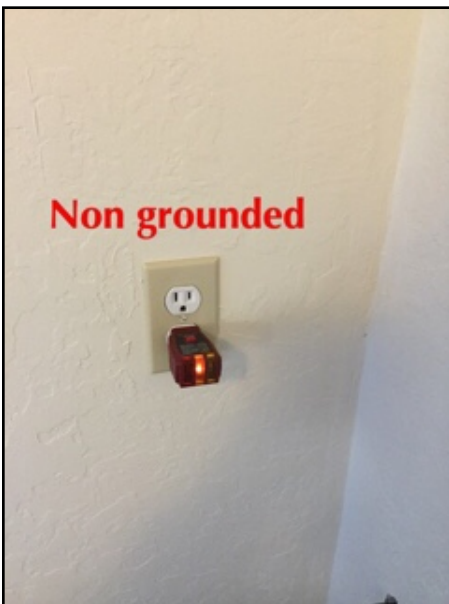
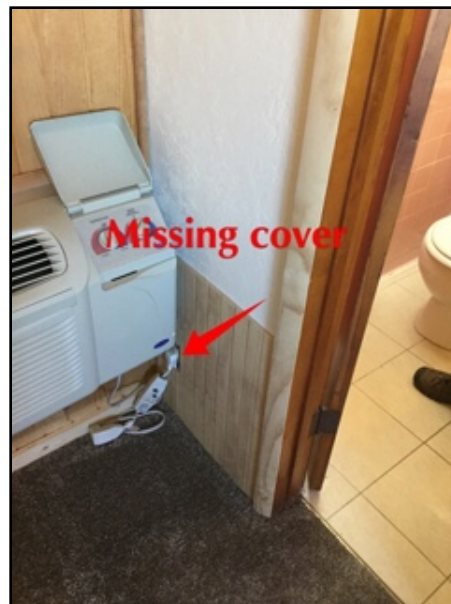
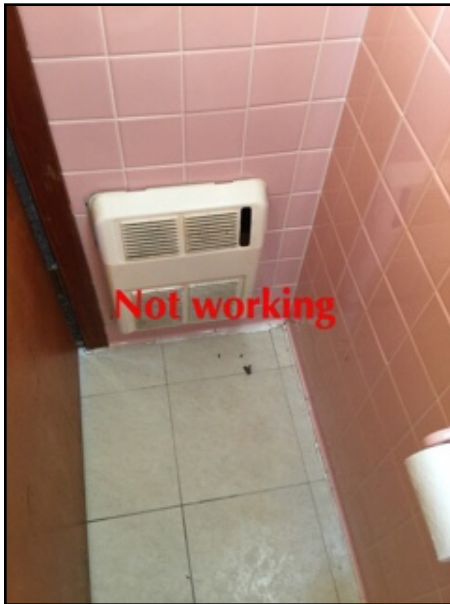
Figure 125-1

Comment 125:
Rm #11.

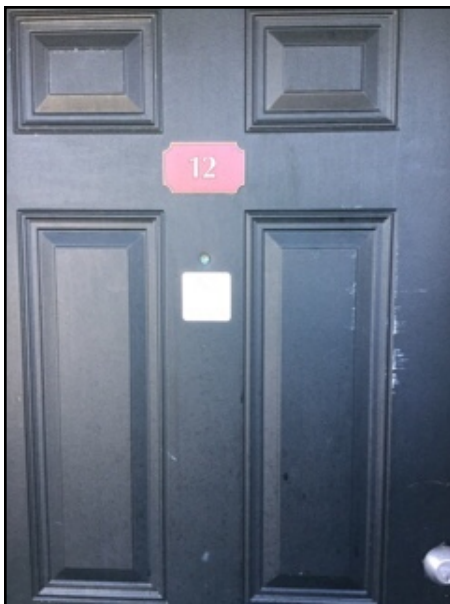
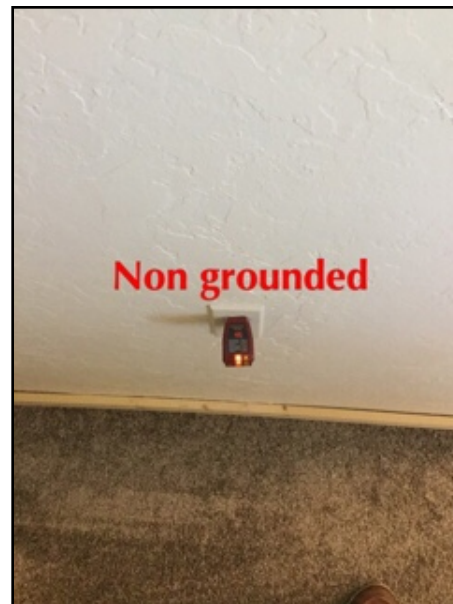
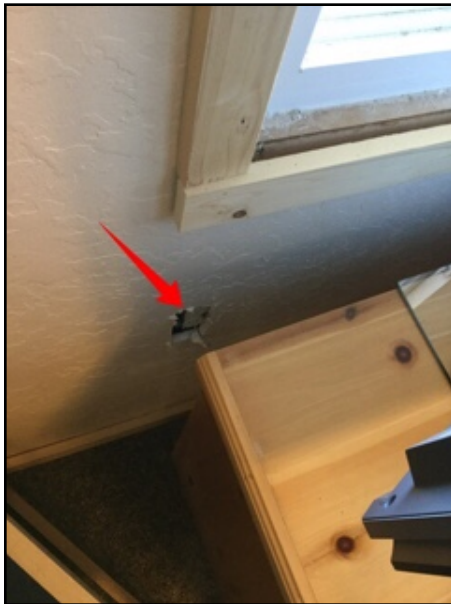
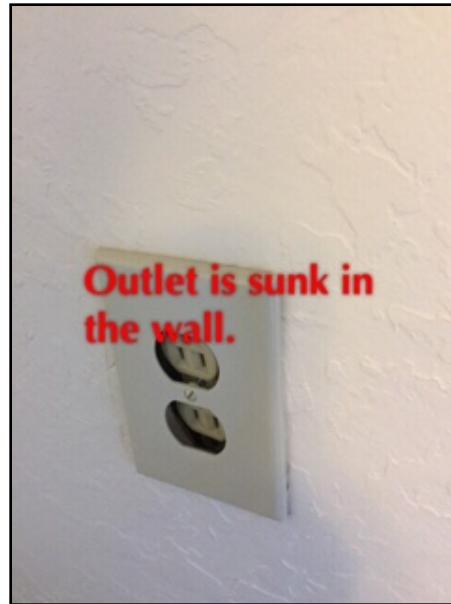
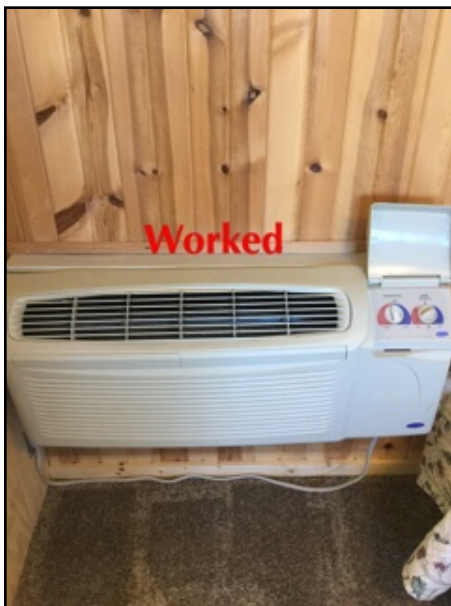
Figure 126-1

Comment 126:
Rm #12.

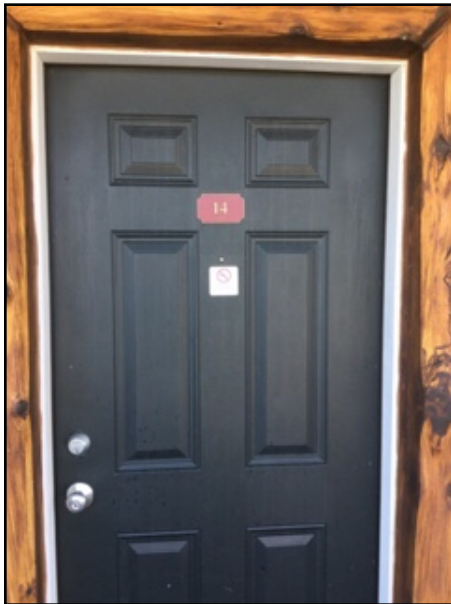
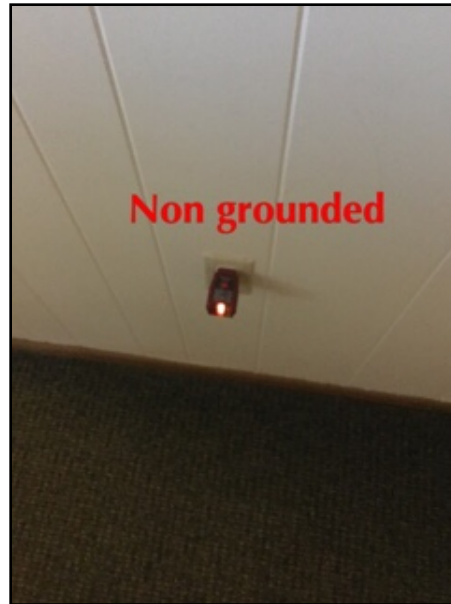
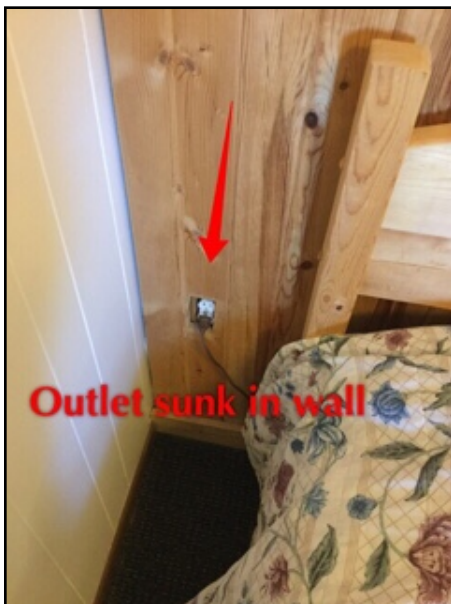
Figure 127-1

Comment 127:
Room #14.

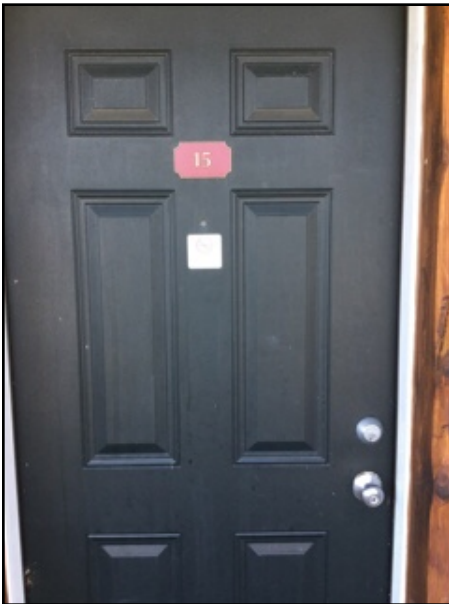
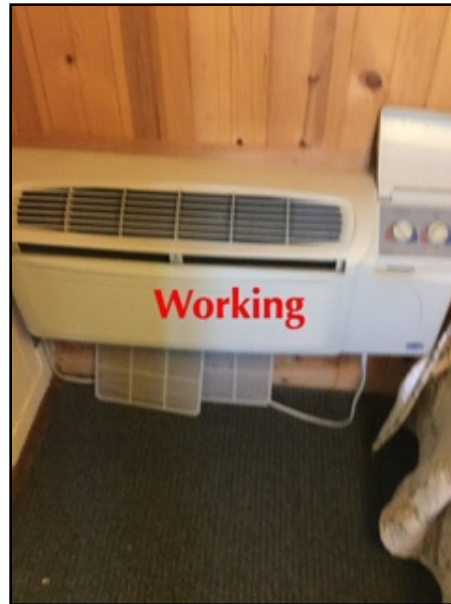
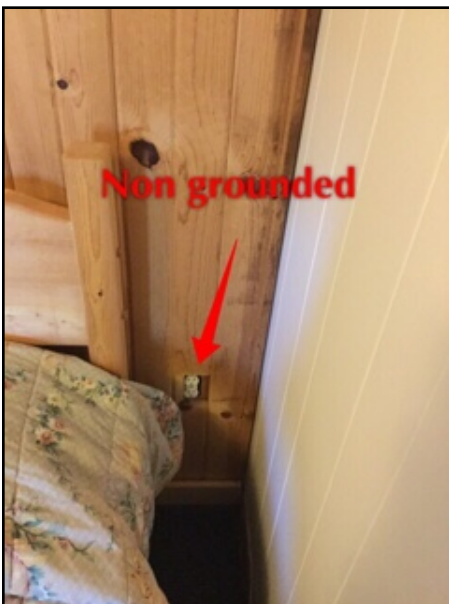
Figure 128-1

Comment 128:
Room #15.

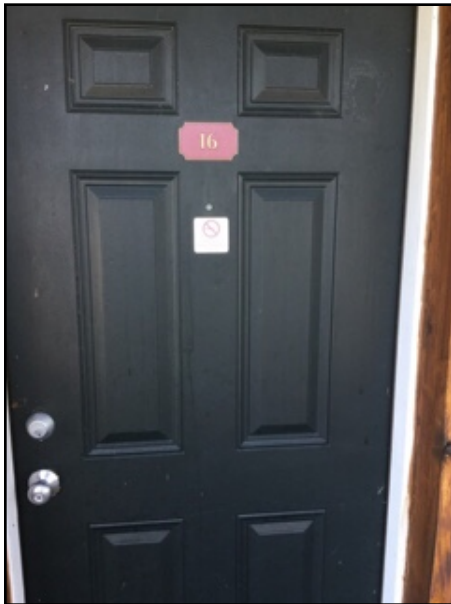
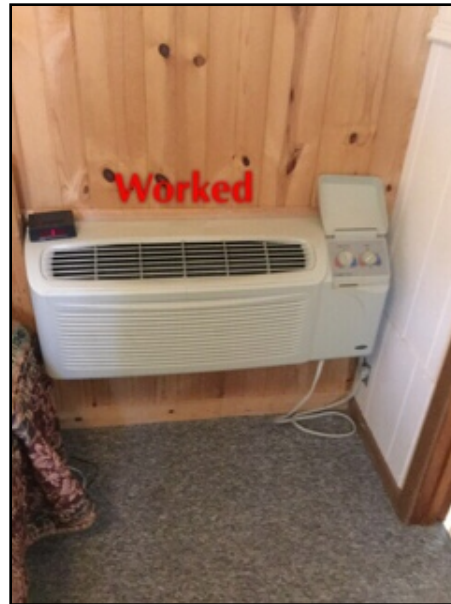
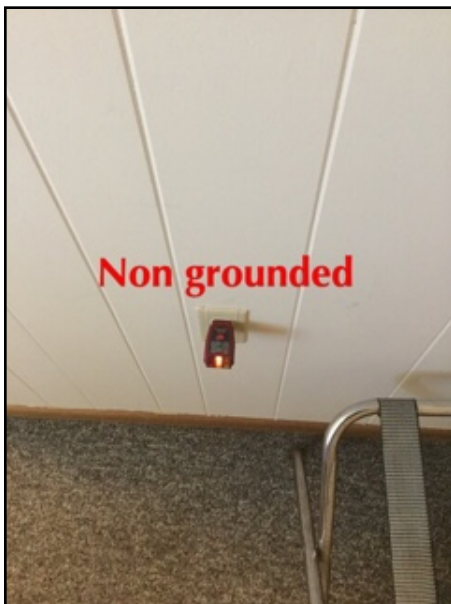
Figure 129-1

Comment 129:
Room #16.

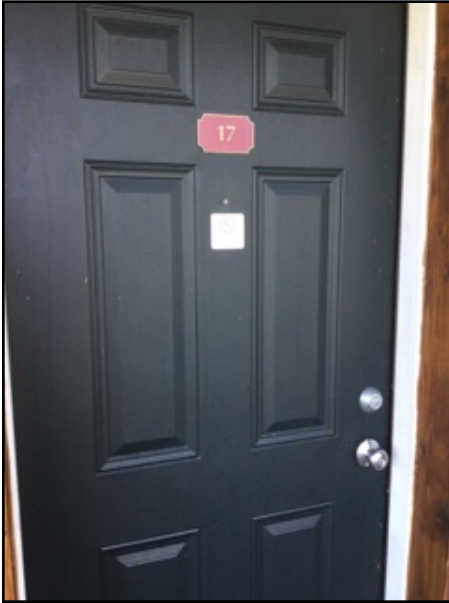
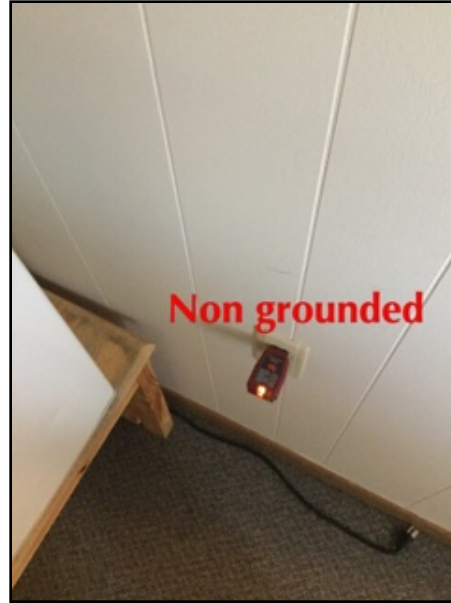
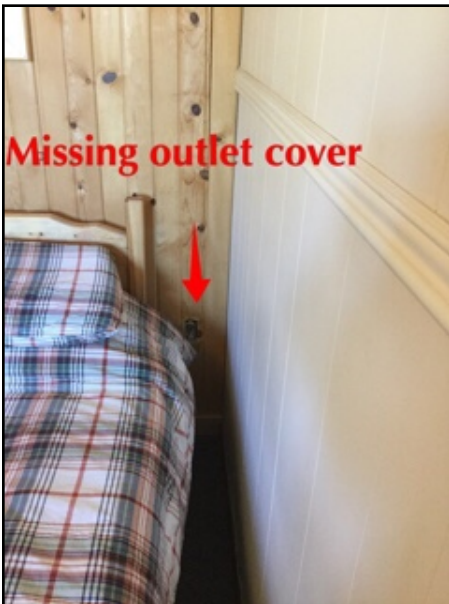
Figure 130-1

Comment 130:
Rm #17.

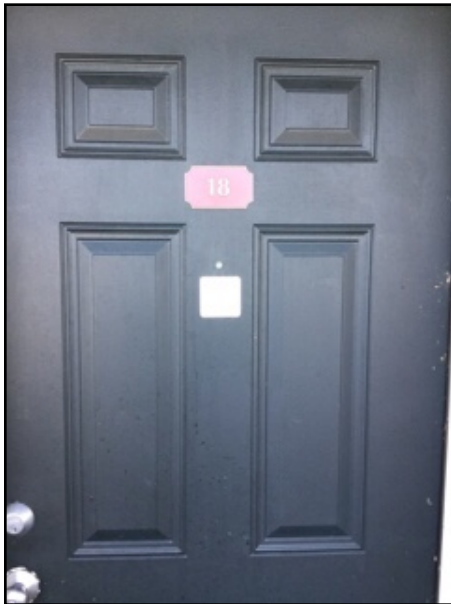
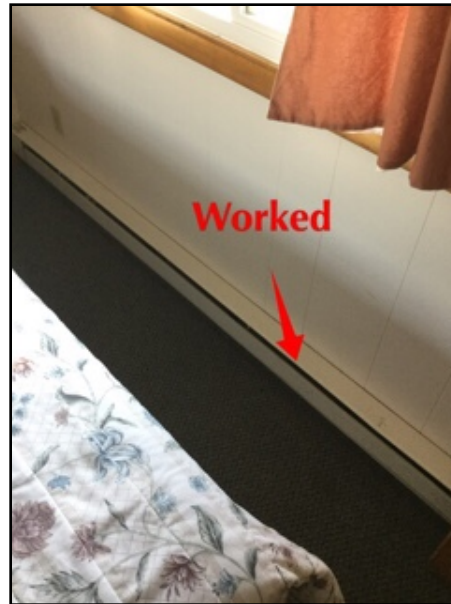
Figure 131-1

Comment 131:
Room #18.

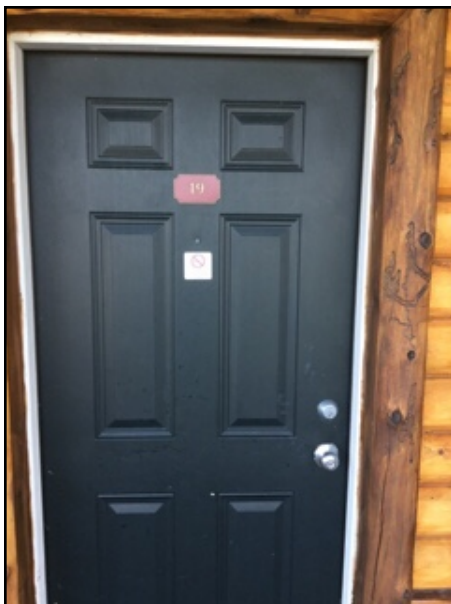
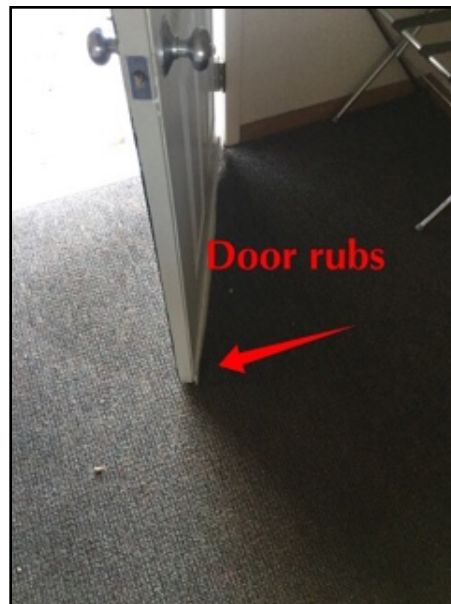
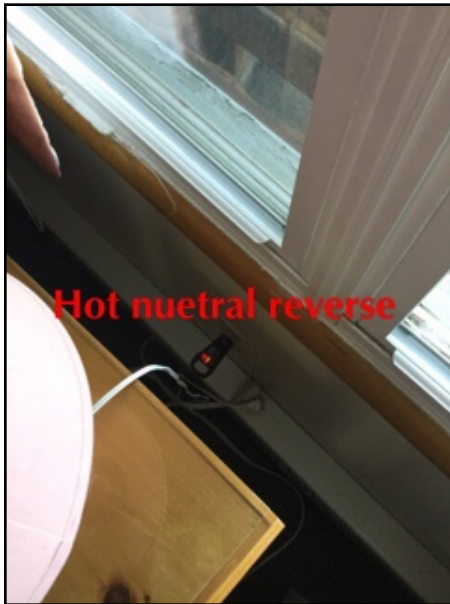
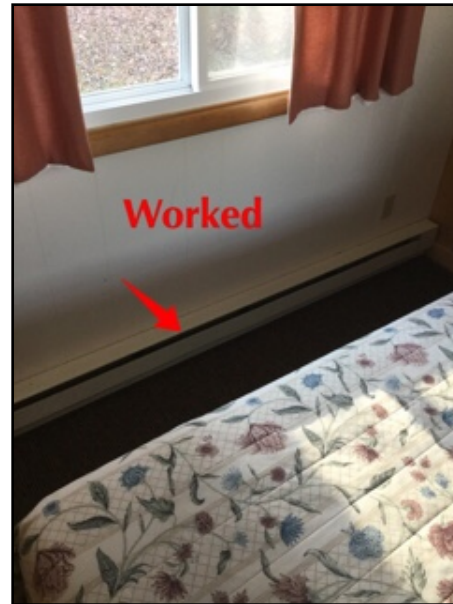
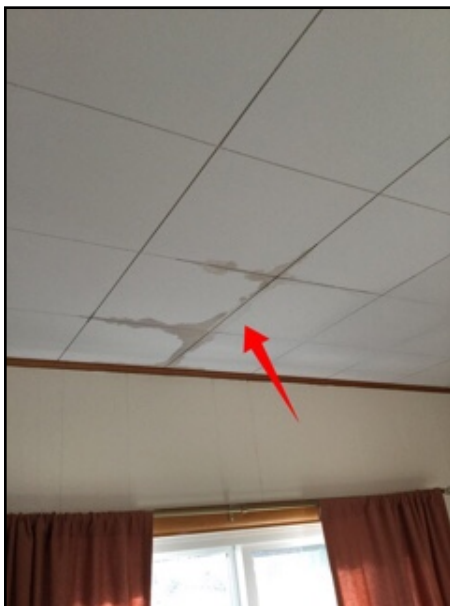
Figure 132-1

Comment 132:
Rm #19.

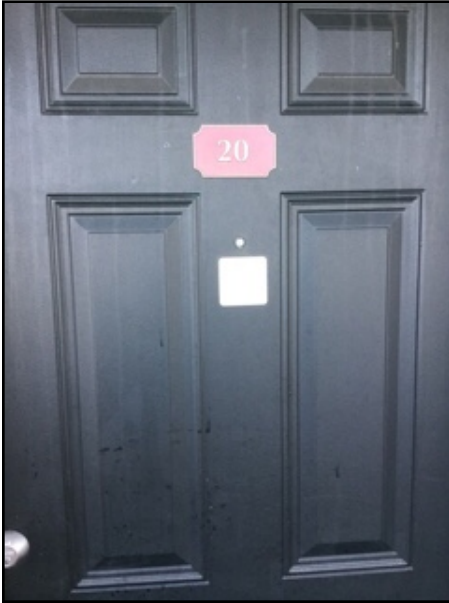
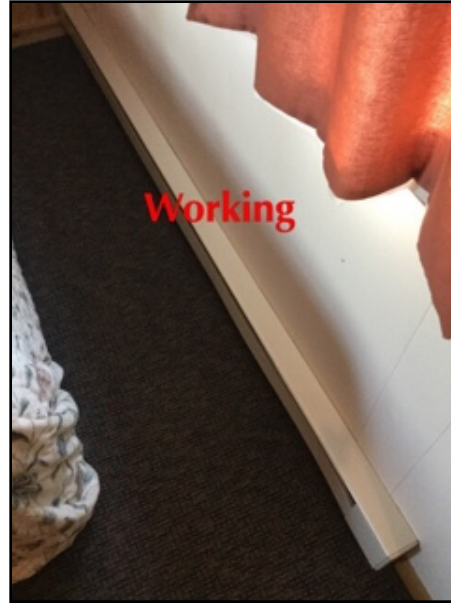
Figure 133-1

Comment 133:
Rm #20.

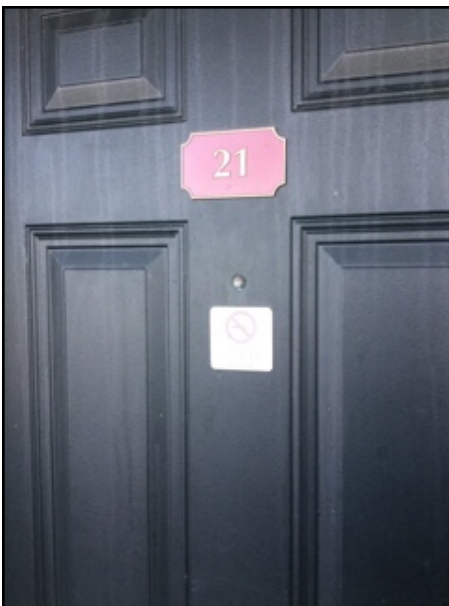
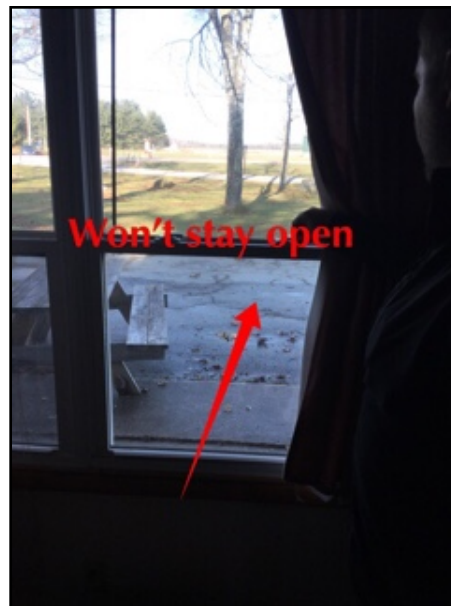
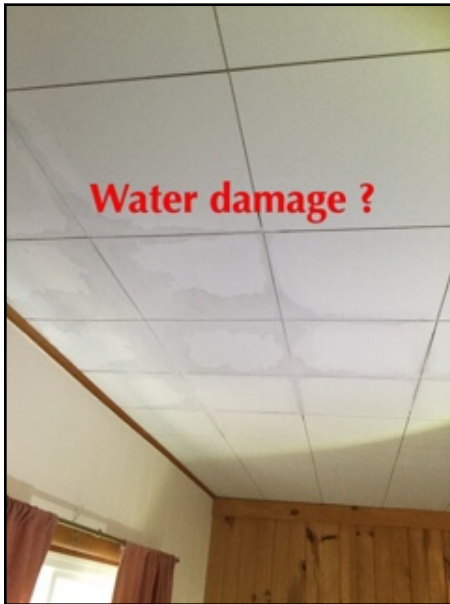
Figure 134-1

Comment 134:
Rm# #21.

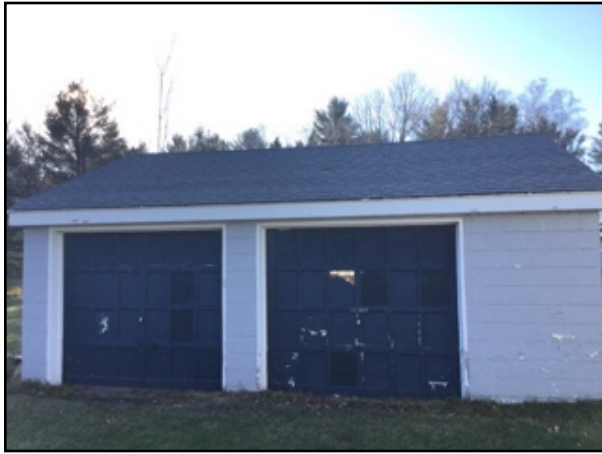
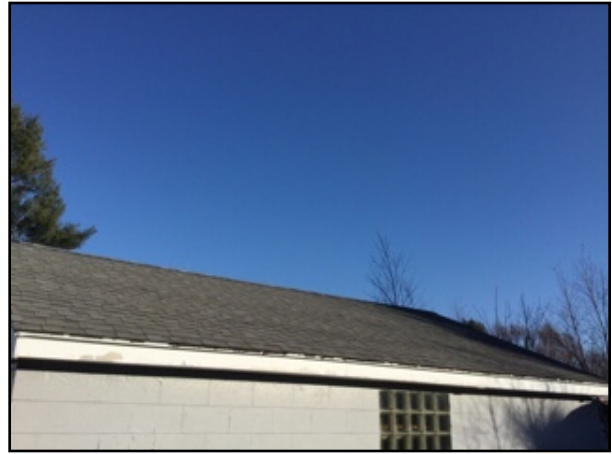
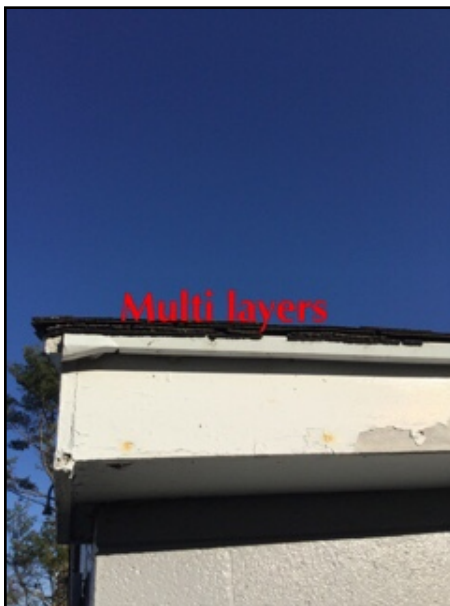
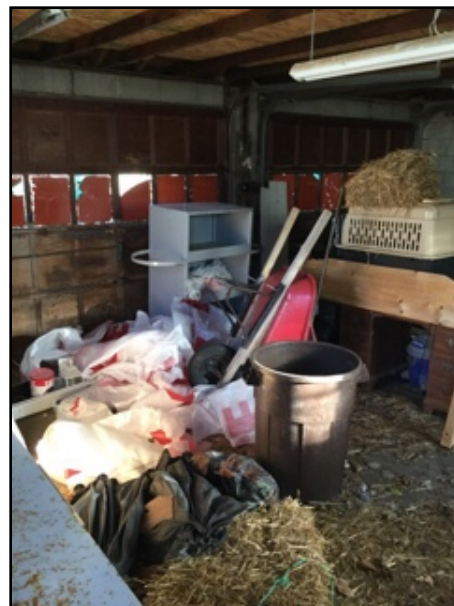
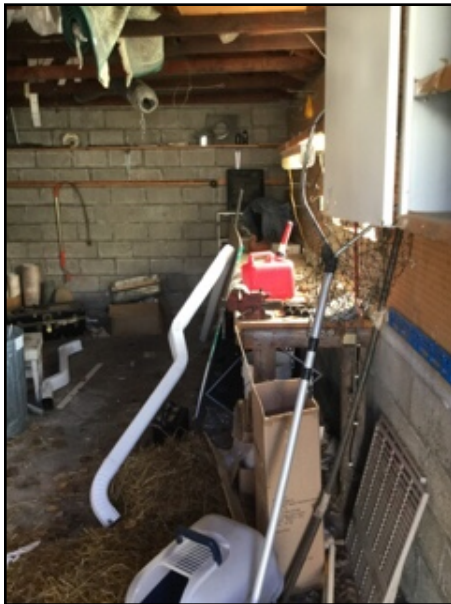
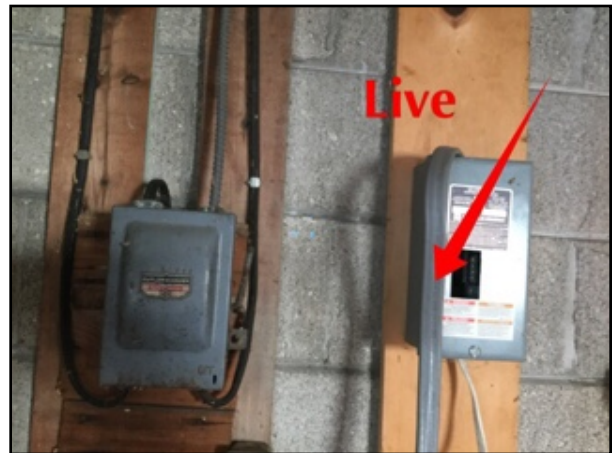
Figure 135-1

Comment 135:
Garage views.

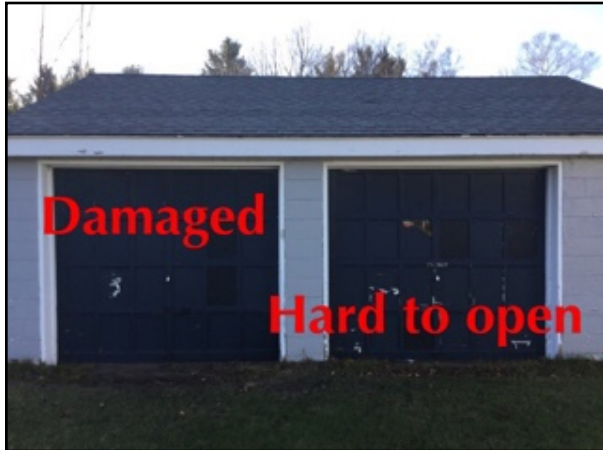
Figure 135-9

The springs for the overhead garage door do not have a safety cable running through them. This cable would prevent damage or injury should the springs ever break.
